INCIDENT

Aircraft Type and Registration:	Airbus A320-232, HA-LPB	
No & Type of Engines:	2 IAE V2527E-A5 Turbofan engines	
Year of Manufacture:	2001	
Date & Time (UTC):	1 October 2006 at 1947 hrs	
Location:	London (Luton) Airport	
Type of Flight:	Public Transport (Passenger)	
Persons on Board:	Crew - 6	Passengers - 159
Injuries:	Crew - None	Passengers - None
Nature of Damage:	Abrasion marks on lower fuselage skin and on two adjacent frames	
Commander's Licence:	Airline Transport Pilot's Licence	
Commander's Age:	40 years	
Commander's Flying Experience:	5,458 hours (of which 3,012 were on type) Last 90 days - 251 hours Last 28 days - 57 hours	
Information Source:	AAIB Field Investigation

Synopsis

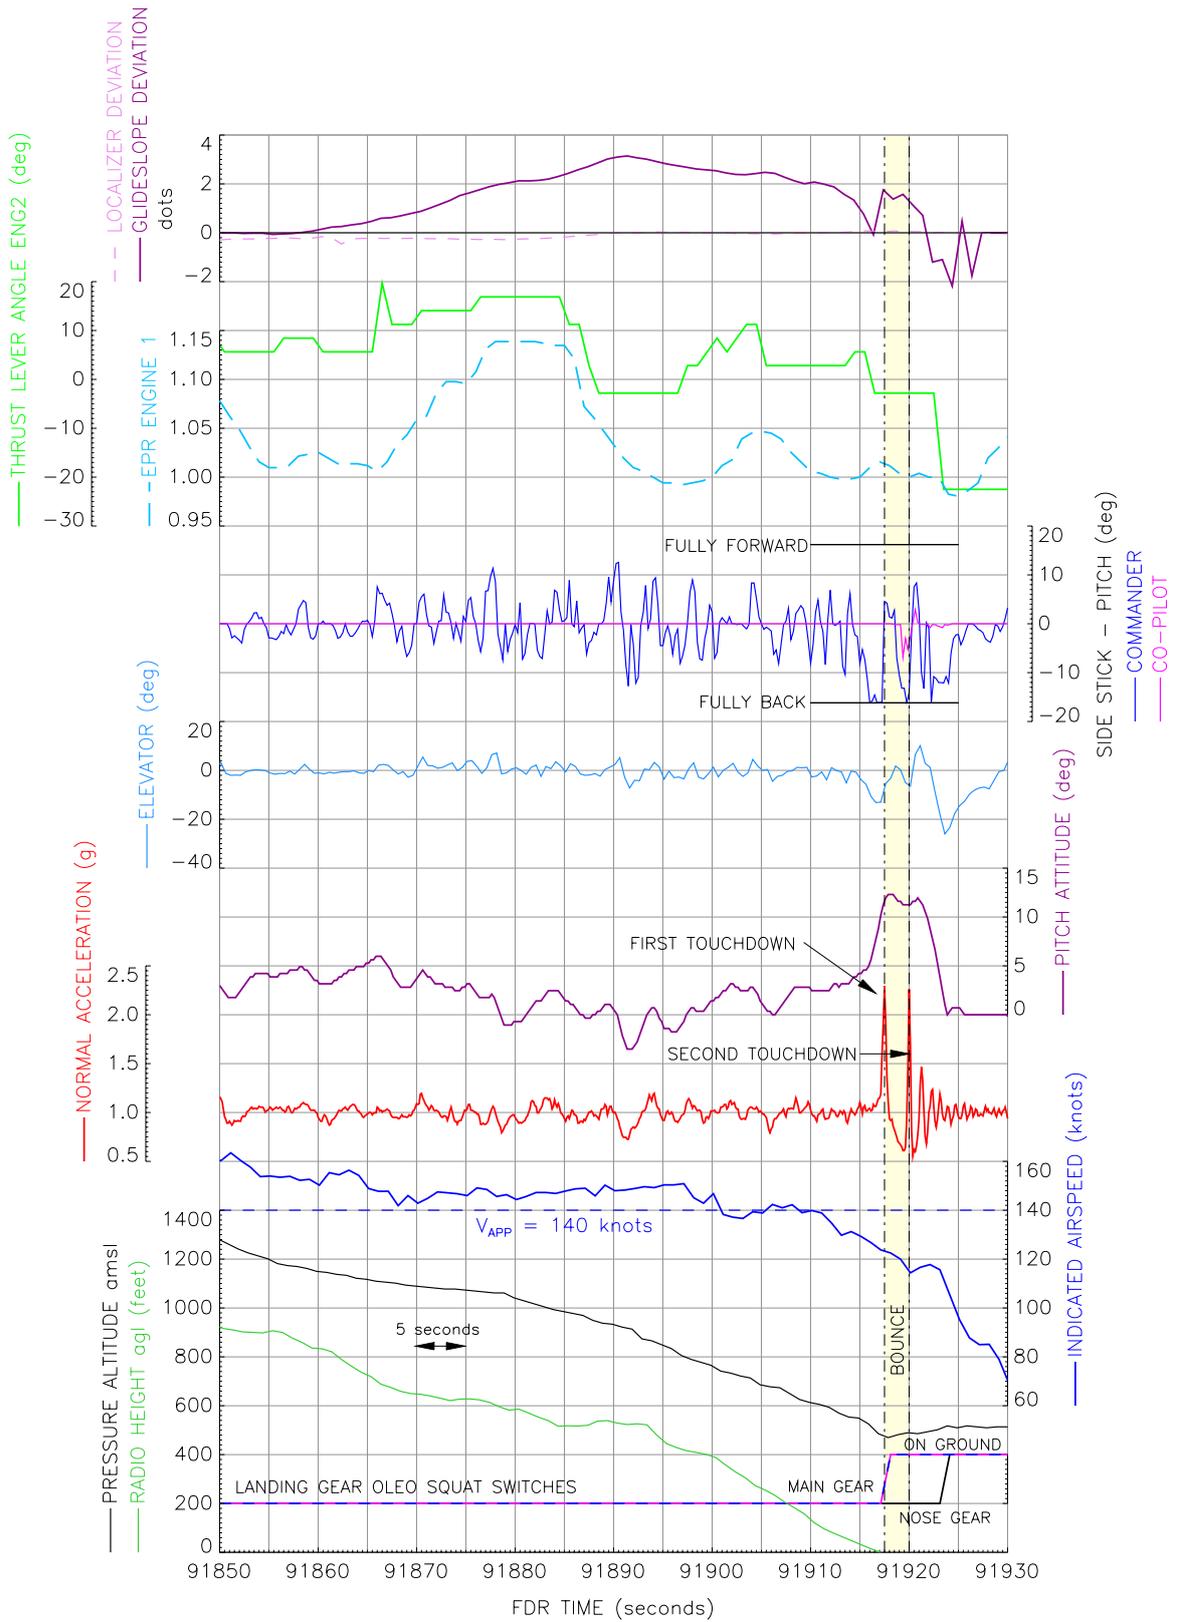
Figure 1
 Salient FDR Parameters
 (Accident to HA-LPB on 1 October 2006)

A time history of the relevant parameters during the incident is shown at Figure 1. The data presented starts with the aircraft at 1,300 ft amsl, with both autothrust and autopilot disconnected (at 6,000 ft and 4,300 ft amsl respectively), on the ILS approach to Runway 26 with the commander flying. At this point the aircraft's descent rate was approximately 750 ft/min, the airspeed was reducing through 160 kt, the pitch attitude was just above 2°, and the flaps were at 20°. Throughout the approach the aircraft remained within 1 dot of the localiser; pitch attitude predominantly varied between -1° (nose down) and +5° (nose up).

As the aircraft descended through 1,200 ft amsl, the descent rate slowed and the aircraft started to deviate above the glideslope. At 1,100 ft a small amount of thrust² was applied just as the flaps extended to 40°. At this point the descent rate had slowed to 270 ft/min and the airspeed was 150 kt.

As the aircraft passed through 1 dot above the glideslope, the first officer called "GLIDE". The commander then momentarily reduced the pitch attitude before returning to a pitch of 2.3° nose up. The aircraft's descent rate began to increase but glideslope deviation continued to increase; at 2 dots above the glideslope the first officer called "GLIDE GLIDE". The thrust levers were then pulled back to the flight-idle position (-2.5° TLA) and the commander again momentarily reduced the pitch attitude. However, the aircraft continued to deviate further above the glideslope reaching 3.1 dots³ at 530 ft agl (calculated to be between 130 ft and 144 ft above the 3° glideslope) before stabilising back at 2 dots above as pitch attitude was again reduced and the descent rate increased to 900 ft/min.

At 400 ft agl, the commander started to pitch the aircraft's nose up while applying small amounts of thrust (10° TLA giving 1.05 EPR), allowing the airspeed to slow to 140 kt (the calculated approach speed V_{APP}) while still maintaining the 900 ft/min descent rate. The thrust levers were pulled back to +2.5° TLA as the aircraft passed through 300 ft agl and just as the first officer advised against using any further thrust. At 150 ft agl the airspeed started to reduce, gradually decaying to 130 kt at 50 ft agl.

The commander commenced the flare at 50 ft just as the first officer shouted "PULL". The commander then rapidly applied and held full aft sidestick (-16°) with the aircraft at 30 ft agl and coincident with the first officer shouting "PULL PULL PULL PULL". The descent rate from 75 ft agl to touchdown averaged 975 ft/min. One second before touchdown, at 11 ft agl, the aircraft passed through the glideslope from above.

The aircraft touched down with +2° of roll attitude (right main landing gear first) with a vertical load factor of +2.3g and at an indicated airspeed of 125 kt. The aircraft reached a maximum pitch attitude of 12.3° nose-up. The spoilers deployed just as the aircraft bounced⁴, and the pitch attitude started to reduce. The commander then made a nose-down sidestick input (+4.6° then +2.7°) before again applying full aft sidestick, and just as the first officer applied -7° aft sidestick. As neither of the priority takeover pushbuttons were pressed, the sidestick inputs from both crew would have been additive in effect.

The aircraft then touched down for a second time with a vertical load factor of +2.3g and a pitch attitude of 12° nose up. The nose was then gently lowered and the aircraft was slowed to a taxi speed. No windshear warnings were recorded during the approach and landing.
