**SERIOUS INCIDENT**

<b>Aircraft Type and Registration:</b>	Airbus A320, G-DHJZ
<b>No &amp; Type of Engines:</b>	2 CFM56-5B4/P turbofan engines
<b>Year of Manufacture:</b>	2003
<b>Date &amp; Time (UTC):</b>	5 July 2007 at 1205 hrs
<b>Location:</b>	Kos Airport, Greece
<b>Type of Flight:</b>	Commercial Air Transport (Passenger)
<b>Persons on Board:</b>	Crew - 6                      Passengers - 180
<b>Injuries:</b>	Crew - None                      Passengers - None
<b>Nature of Damage:</b>	Severe damage to main landing gear
<b>Commander's Licence:</b>	Air Transport Pilot's Licence
<b>Commander's Age:</b>	47 years
<b>Commander's Flying Experience:</b>	12,100 hours (of which 950 were on type) Last 90 days - 174 hours Last 28 days - 38 hours
<b>Co-pilot's Age</b>	34 years
<b>Co-pilot's Flying Experience</b>	381 hours (of which 147 were on type) Last 90 days - 154 hours Last 28 days - 49 hours
<b>Information Source:</b>	AAIB Field Investigation, at the request of the Greek Air Accident Investigation & Aviation Safety Board

**Synopsis**

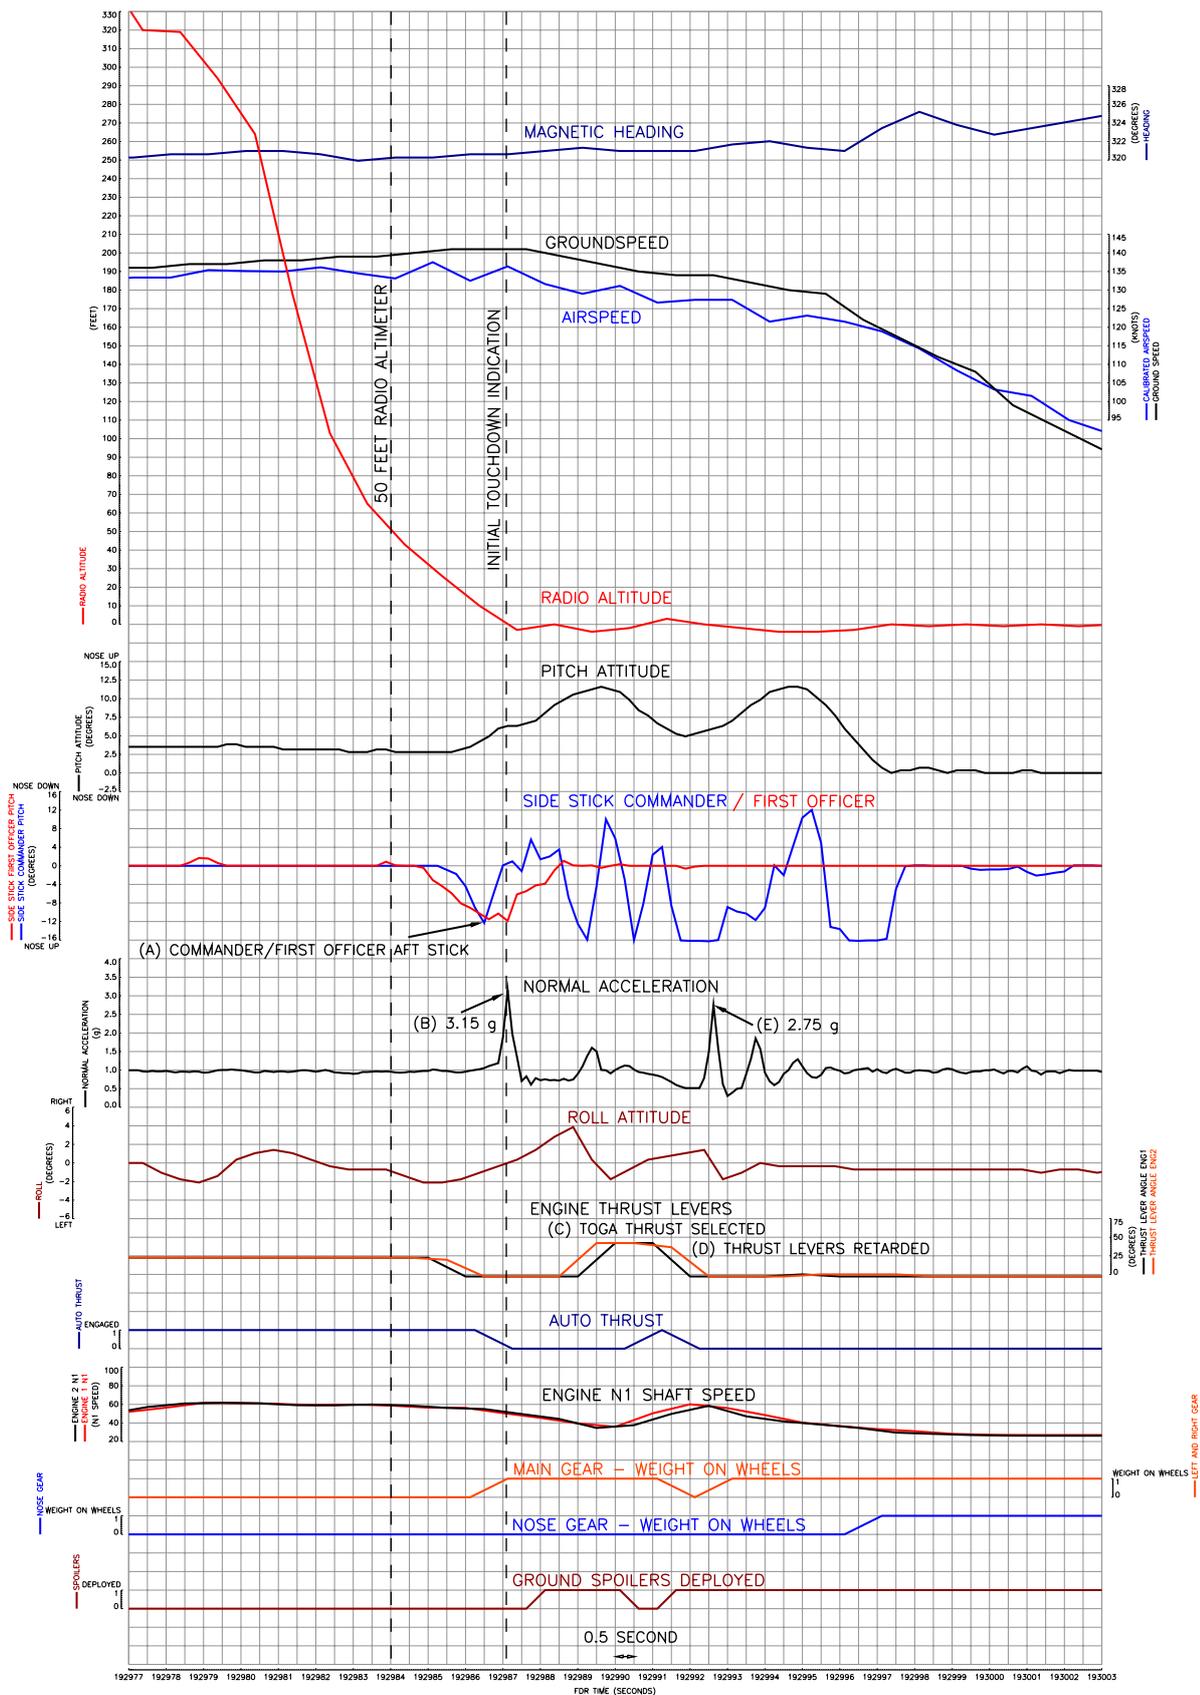
Figure 1

It was apparent that the commander was ‘coaching’ the co-pilot somewhat during the final approach but he stopped mid-sentence at the automatic FIFTY callout from the RA. The subsequent FORTY, THIRTY and TWENTY callouts came in very rapid succession, with the touchdown occurring almost immediately after the TWENTY callout. At about 35 ft aal, approximately three seconds before main gear touchdown, the co-pilot retarded the thrust levers and started the flare, progressively moving the sidestick aft about two thirds of full travel; the airspeed was 133 kt. Almost co-incidentally, the commander applied nearly full aft sidestick, (A) Figure 1. The aircraft’s pitch attitude increased to about 6° before touching down with a descent rate of 900 ft/min. Normal acceleration was recorded at 3.15g, (B) Figure 1, as the aircraft touched down almost simultaneously on both main landing gears, following which it bounced.

The commander took control of the aircraft and decided to carry out a TOGA 10 manoeuvre<sup>4</sup> and placed his hand on the thrust levers. He did not state that he was taking control, but the co-pilot later said that he had been in no doubt that the commander was taking over at that instant. The commander advanced the thrust levers to the TOGA position, (C) Figure 1, and attempted to stabilise the pitch attitude at 10° nose up. The co-pilot’s sidestick returned to the neutral position. The takeoff configuration warning then sounded, and the commander retarded the thrust levers, (D) Figure 1. The aircraft momentarily became airborne before touching down a second time with a normal acceleration value of 2.75g being recorded (E) Figure 1. During the bounce, the aircraft’s pitch attitude reached 11.6°. (The pitch attitude at which a tail strike occurs, with the main gear compressed, is 11.7°.)

Time history of relevant data covering the landing at Kos

Analysis of the landing at Kos showed that the 'FIFTY' callout, occurred only three seconds before touchdown with little or no flare having occurred. In the previous landing at Thessaloniki, the interval was seven seconds.

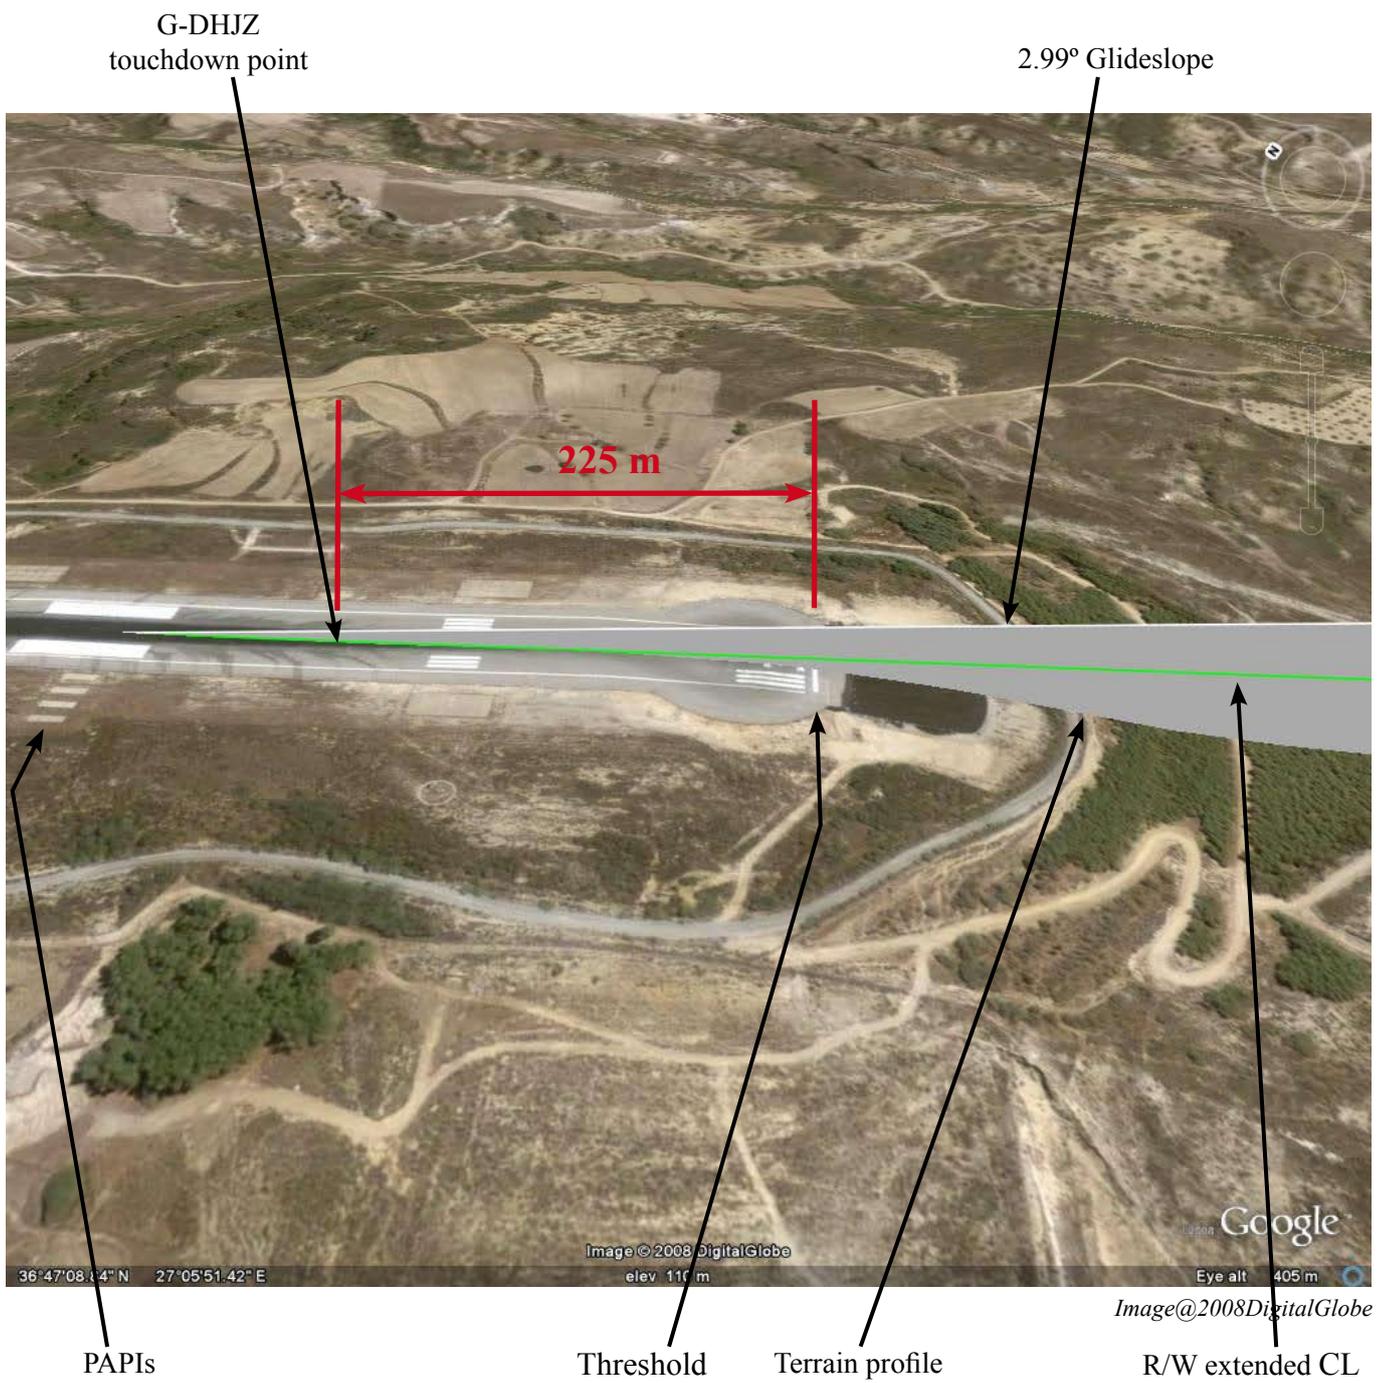
**Figure 2**  
Threshold region of Runway 32 at Kos

The approach to Runway 32 is unusual, in that it is over a ravine which is aligned with the runway extended centreline (Figure 1) and the ground rises steeply towards the runway threshold. This not only results

in the misleading perspective by night, as mentioned in the airfield brief, but also means that the ‘picture’ by day is unusual. Guidance provided by the aircraft manufacturer warns that an upslope towards the touchdown aiming point may lead pilots to increase the rate of descent inappropriately, with the consequent risk of a hard landing.

The nature of the terrain also causes the automatic height callouts from the RA during the approach, when above 50 ft RA, to occur more rapidly and closer to the moment of touchdown, than would otherwise be the case.
