AVIATION INVESTIGATION REPORT

A04O0016

NOSEWHEEL AXLE FAILURE

AIRBUS A321-211, C-GJWI

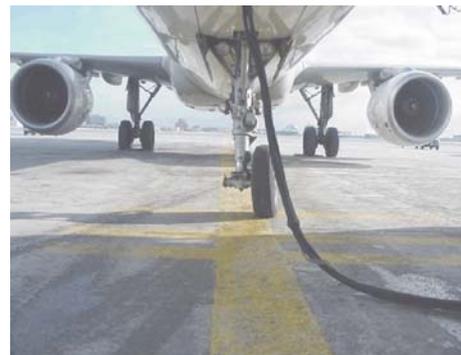
Photo 1. Aircraft at gate shortly after arrival

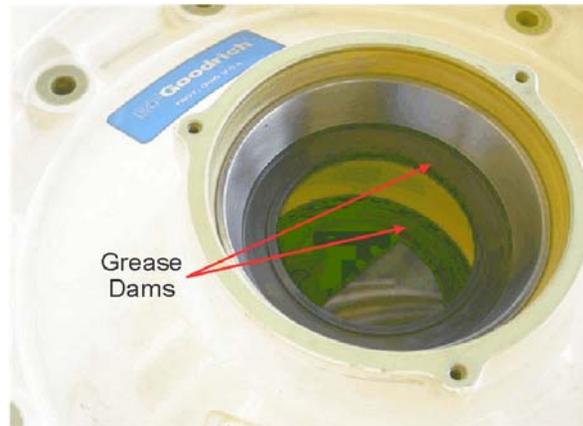
The inner wheel assembly was found to be covered with discoloured grease. The inner bearing grease dam, normally positioned next to the bearing to reduce grease migration and subsequent bearing damage or failure, was found dislodged and sitting against the outer bearing grease dam. The two contacting surfaces were clean and free of grease. The grease dams (see Photo 2) are rubber-like and are held in place by a protruding ridge moulded on the circumference of the dam. When installed, the ridge fits into a channel in the wheel assembly. The dam can be displaced during wheel installation as the wheel is being slid onto the nose landing gear axle. If this happens, the displacement may go undetected since the dam is not visible to the installer because of its location within the wheel assembly.

Photo 2. Dam location in wheel assembly

1. The dislodged inner-bearing grease dam allowed grease to migrate from the inboard roller bearing of the right nosewheel to the inside of the nosewheel assembly. A reduction in lubrication increases the cage loads and may lead to bearing failures.

Air Canada has also issued a maintenance alert and revised its wheel installation job card to stress the importance of a wheel inspection prior to installation and to ensure the recommended wheel installation tools and torques are used in accordance with the *Aircraft Maintenance Manual*. The Air Canada wheel shop manuals were revised to raise the awareness of the importance of grease dams and seal installations.

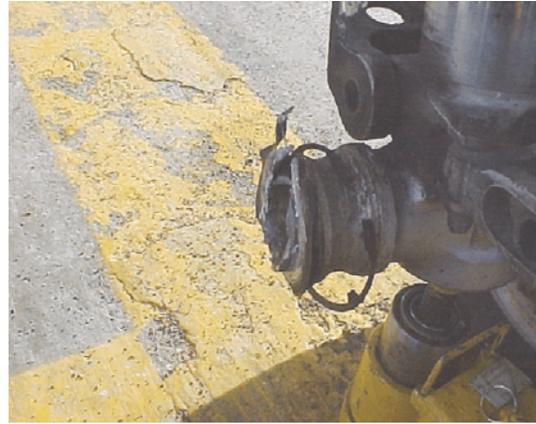
The nose landing gear wheel axle was examined and found to be fractured circumferentially in the vicinity of the collar (see Photo 3 and Appendix A). Both of the fracture surfaces appeared rugged with stains radiating from the inside diameter surface. In addition, the fracture was covered with a carbonaceous residue. There were indications that the axle had been subjected to high temperatures as the paint on both the inner and outer surfaces was blistered, flaking and discoloured, and the cadmium plating had melted and resolidified to form beads. The fracture originated on the inside diameter surface of the axle. The inner and outer diameters of the axle are cadmium plated for corrosion protection.

Photo 3. Close-up view of axle

A scanning electron microscope was used to examine the fractured surface of the axle. The stained portion of the surface was a blocky, intergranular fracture typical of embrittled steels. The remaining surface was ductile in appearance.

The energy dispersive x-ray spectrum of the intergranular surface revealed the presence of cadmium, confirming that the mode of failure of the axle was a result of liquid metal (cadmium plating) embrittlement. The microstructures of the axle material conformed to a typical high-strength steel, as specified for this application.

1. The nosewheel right inboard roller bearing failed. It is likely that the lack of lubrication as a result of the grease dam being dislodged from its normal position was a contributing factor.
2. The friction temperatures created by the failed roller bearing exceeded the cadmium melting point. Cadmium penetrated and weakened the intergranular structure of the nose landing gear axle, causing it to fail due to liquid metal embrittlement.

Air Canada has taken steps to have the axles for its nose landing gears coated with SermeTel® to reduce the likelihood of axle failures from cadmium infusion as a result of high friction heat generated from bearing failures. SermeTel® is an anti-corrosive and chemical-resistant base applied as an initial coating prior to decorative coatings of epoxy resin and polyurethane paints. It is an inorganic formula, consisting of an aqueous carrier containing a mixture of magnesium chromate, phosphates and silicates, and aluminum powder.
