## AVIATION INVESTIGATION REPORT

A03P0332

### MAINTENANCE ERROR – IN-FLIGHT FUEL LEAK

AIRBUS A330-300 C-GHKX

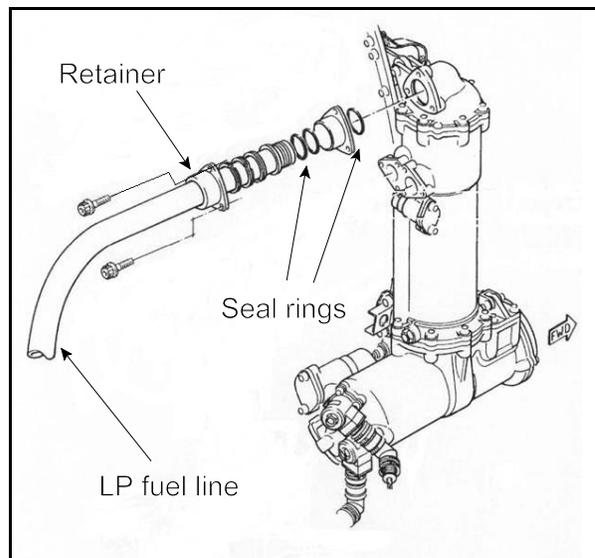
Figure 1. Fuel/oil heat exchanger

Transportation Safety Board of Canada (TSB) investigators and Air Canada maintenance personnel examined the engine and found that the LP inlet fuel line to the fuel/oil heat exchanger of the number 2 engine had detached. Although the fuel-line coupling appeared to be intact and the three bolts holding the coupling together were tight, the retainer was missing. The missing retainer was found further down the detached fuel line, obscured from view. The engine manufacturer, Rolls-Royce, indicated that it is possible, within the tolerance range of all the LP components, that the three bolts that hold the LP connection in place may not bottom out if the retainer is omitted. It is, therefore, possible to achieve torque of the proper value. In light of this scenario, the compression on the seal rings is possibly sufficient to prevent leakage at idle power. The flight data recorder (FDR) was removed from the aircraft and sent to Air Canada's maintenance facility in Dorval, Quebec, for downloading. The downloaded information was analysed by the TSB Engineering Laboratory.

Because of the conflict in written tasks between the job board and the aircraft logbook, combined with the technicians not using the TSM to resolve the problem, the LP fuel line to the fuel/oil heat exchanger was unnecessarily disconnected. Once the LP fuel line was disconnected, the technicians did not refer to or follow all of the reinstallation procedures in the available AMM. During the time it took for the replacement seal rings to arrive, the retainer, which cannot be removed from the fuel line, slid down the fuel line and became obscured from view. The LP fuel-line coupling was then reassembled without the retainer in place.

can appear secure without the retainer in place, along with the technicians unfamiliarity with this particular fitting, it would have been difficult to detect whether the retainer was missing, even from an elevated position. The seal rings on the LP fuel line had been compressed sufficiently to prevent any leaks, rendering the developer, if it had been used, ineffective in detecting the missing retainer.

As the engine power levers were advanced for take-off, an increase in fuel pressure, flow rate, and, perhaps, engine vibration caused the LP fuel line to detach from the fuel/oil heat exchanger because the retainer was missing. The fuel leak resulted in a large vapour trail, noticeable to other aircraft crew and observers on the ground (see Appendix A). A high-power ground run performed after the maintenance work had been completed would have greatly increased the probability of detecting the incorrect installation.

In addition, Air Canada conducted an internal safety review of the circumstances surrounding this incident, including pro-active recommendations to prevent a recurrence. Since this occurrence, Air Canada has completed SB A330-28-3080 on approximately 50 per cent of the A330 fleet and has had plans to have all remaining A330 aircraft modified by the autumn of 2004.

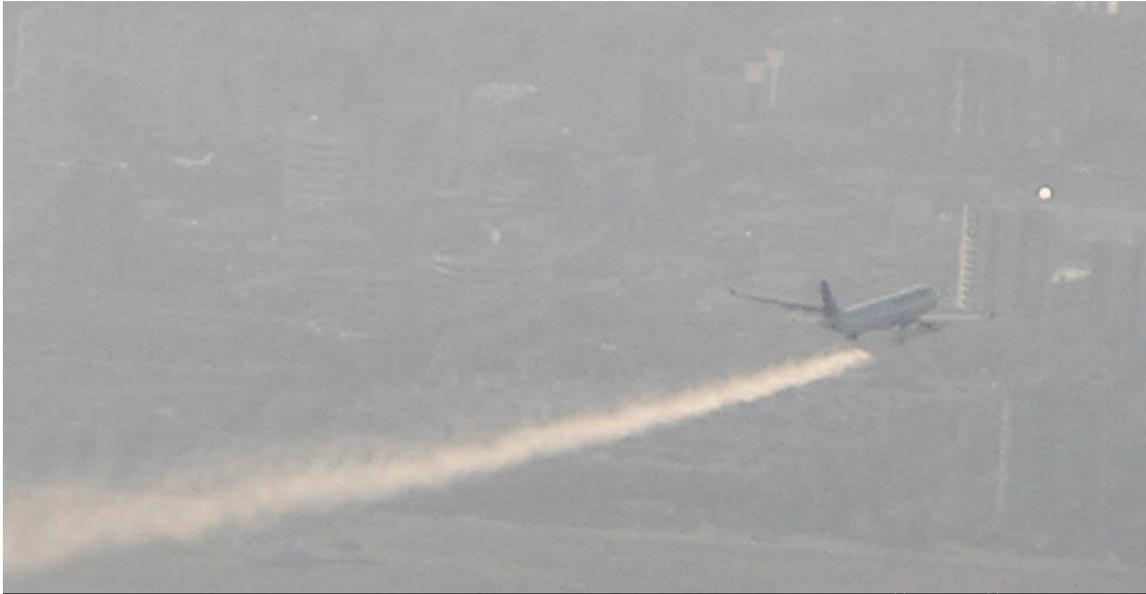
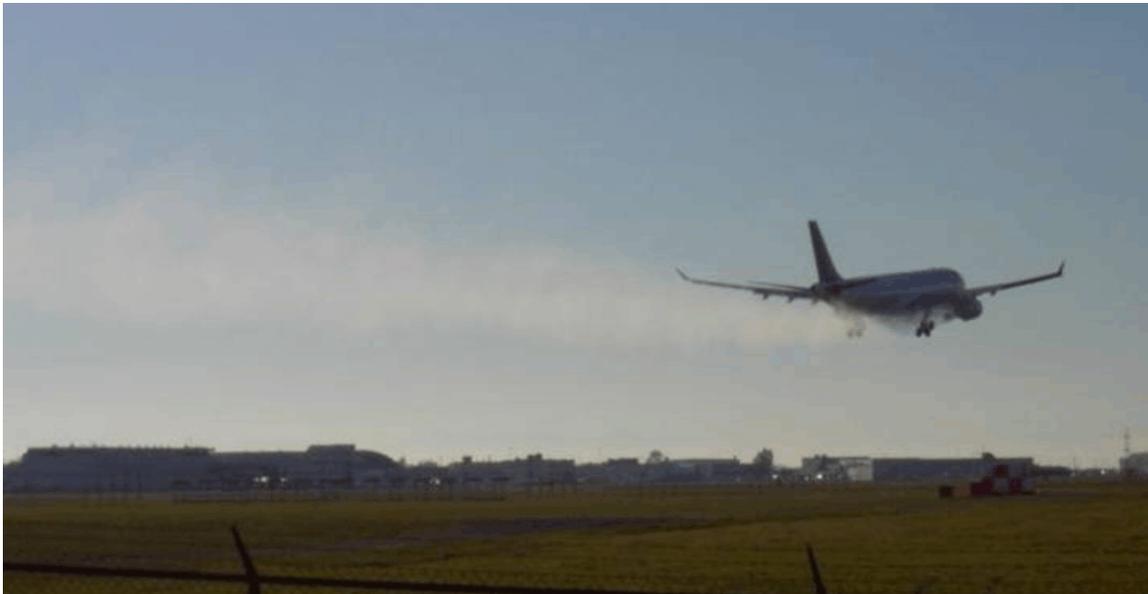
*Appendix A – Visible Fuel Leak from Flight ACA216*

The following day, the aircraft departed for Calgary, Alberta, as Flight ACA216. The taxi and the take-off roll were normal. The departure was during daylight hours and in clear weather conditions, and pilots of another aircraft waiting to depart observed a fuel leak from ACA216 as a significant vapour trail (see Appendix A). The pilots of that departing aircraft informed the Vancouver tower of the vapour trail coming from the number 2 engine of ACA216, and, in turn, the Vancouver tower relayed this information to ACA216.

The vapour trail was brought to the attention of the crew, and they took appropriate action. Without this alert, it could have taken some time for the pilots to detect that the fuel was disappearing, since there was no indication of a fuel problem from on-board equipment, and the differential fuel remaining may not have been noticed in a timely manner. Air Canada had not implemented Airbus SB A330-28-3080, which alerts pilots to a potential fuel leak once there is a loss of 3500 kg of fuel. Implementation of this SB would reduce the risk of fuel exhaustion, engine shutdown and fire. On this flight, a fuel loss totalling 3500 kg occurred in fewer than five minutes following departure.
