## Freighter Strikes Trees During Nighttime 'Black-hole' Approach

*Fatigue and a color-vision deficiency that affected the ability of the pilot flying to observe glide-path-indicator lights contributed to the flight crew's failure to conduct a stabilized approach.*

[FSF editorial note: This article, except where specifically noted, is based on U.S. National Transportation Safety Board Aircraft Accident Report NTSB/AAR-04/02, *Collision With Trees on Final Approach; Federal Express Flight 1478; Boeing 727-232, N497FE; Tallahassee, Florida; July 26, 2002*. The 132-page report contains illustrations and appendixes.]

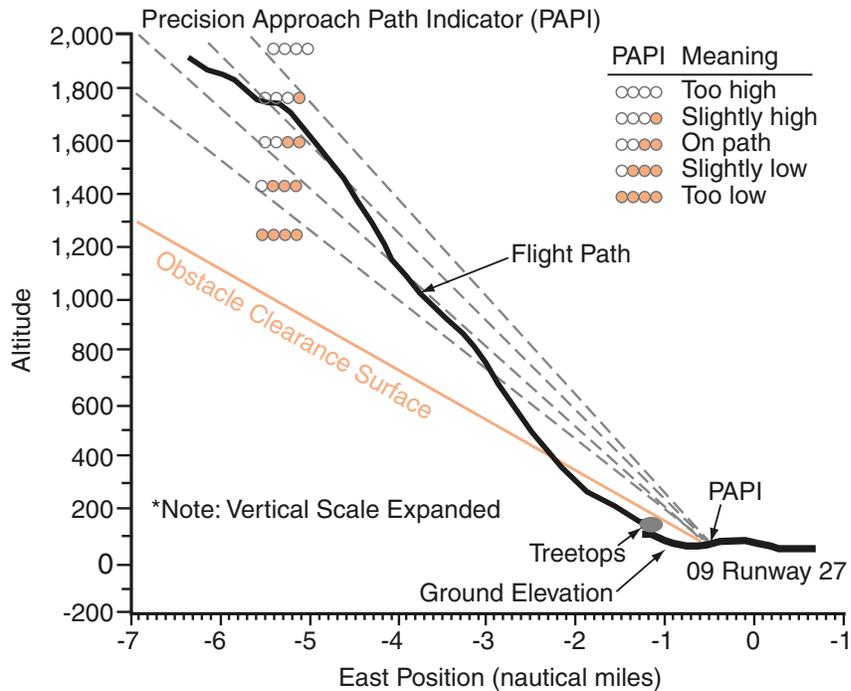
**Figure 1**

About 0536:37, the airplane was being turned from a left-base leg to final approach 2.5 nautical miles (4.6 kilometers) from the airport. A performance study conducted by investigators indicated that about this time, the PAPI — which consisted of four light boxes located near the runway threshold and arranged perpendicular to the runway centerline — likely displayed one white light and three red lights, as viewed from the flight deck, indicating that the airplane was slightly low (Figure 1, page 5). Three seconds later, the PAPI likely displayed four red lights, indicating that the airplane was too low. (A PAPI display of two white lights and two red lights indicates that the aircraft is on a three-degree glide path to the runway.)

At 0536:48, the CVR recorded a GPWS callout of 500 feet and the captain saying “stable.” The performance study indicated that the airplane was 1.8 nautical miles (3.3 kilometers) from the runway and descending at 1,248 feet per minute; airspeed was 152 knots.

“Although the airplane’s airspeed was within the target range, the airplane did not meet FedEx’s criteria for a stabilized approach because its rate of descent was greater than FedEx’s recommended 1,000 feet per minute, the engines’ power settings were less than the expected 1.3 [EPR] to 1.45 EPR, and its glide path was low, as indicated by the PAPI light guidance,” the report said.

At 0536:49, the first officer said, “I’m going to have to stay just a little bit higher, or I’m going to lose the end of the runway.” Flight data recorder (FDR) data indicated that engine power increased from 1.17 EPR to 1.20 EPR. The descent rate decreased from 1,400 feet per minute to about 960 feet per minute, but the airplane remained below the proper glide path.

## Flight Path of FedEx Flight 1478; Boeing 727-200F; July 26, 2002

"Indeed, on the night of the accident, the first officer did fly a concave approach, with a steeper-than-normal initial descent, which is characteristic of a black-hole approach. ... PAPI lights ... are a recognized countermeasure for use in black-hole conditions and should have been, but were not, effectively used to maintain an appropriate glide path."
