Improper Installation of Elevator Bolt Causes DC-8 Freighter to Pitch Up Uncontrollably

Absence of the bolt caused the right elevator control tab to become disconnected. The control tab then jammed as the flight crew began a night takeoff. During the crew's attempt to return to the airport, the aircraft struck the ground and was destroyed. All the crewmembers were killed.

—
FSF Editorial Staff

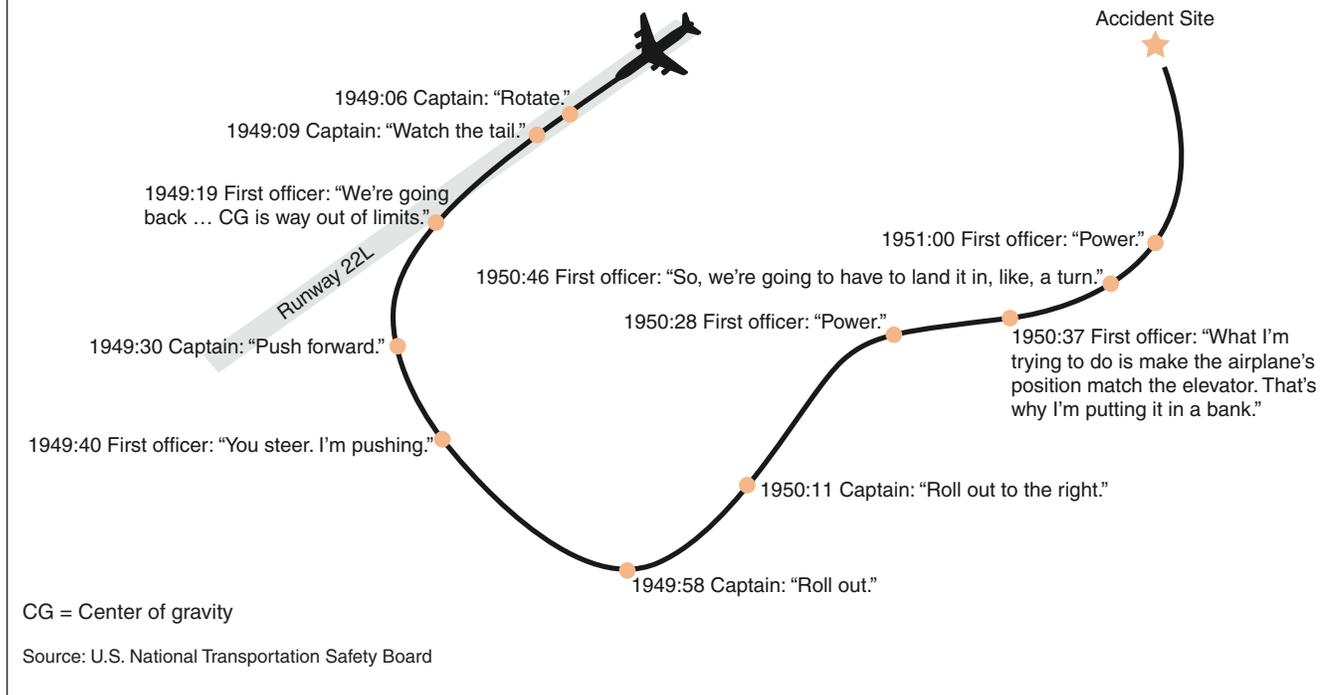
Figure 1

At 1949:02, the captain said, “V one.” V_1 (takeoff decision speed) was 126 knots. Four seconds later, he said, “Rotate” (Figure 1, page 4). Rotation speed was 146 knots.

The report said that flight data recorder (FDR) data and CVR data indicate that although neither pilot had moved his control column aft, the airplane began to pitch up before reaching rotation speed. About the time the airplane reached rotation speed, the first officer began to move his control column forward to counter the unusual pitch-up. About four seconds later, the first officer began to apply nose-down stabilizer trim.

***About the time the
airplane reached
rotation speed, the first
officer began to move
his control column
forward to counter the
unusual pitch-up.***

Ground Track and Selected Cockpit Voice Recordings; Emery Worldwide Airlines Flight 17; McDonnell Douglas DC-8-71F; Rancho Cordova, California, U.S.; Feb. 16, 2000
