During Three-engine Takeoff in DC-8, Captain Makes Premature Liftoff, Resulting In Stall and Collision With Terrain

FSF Editorial Staff

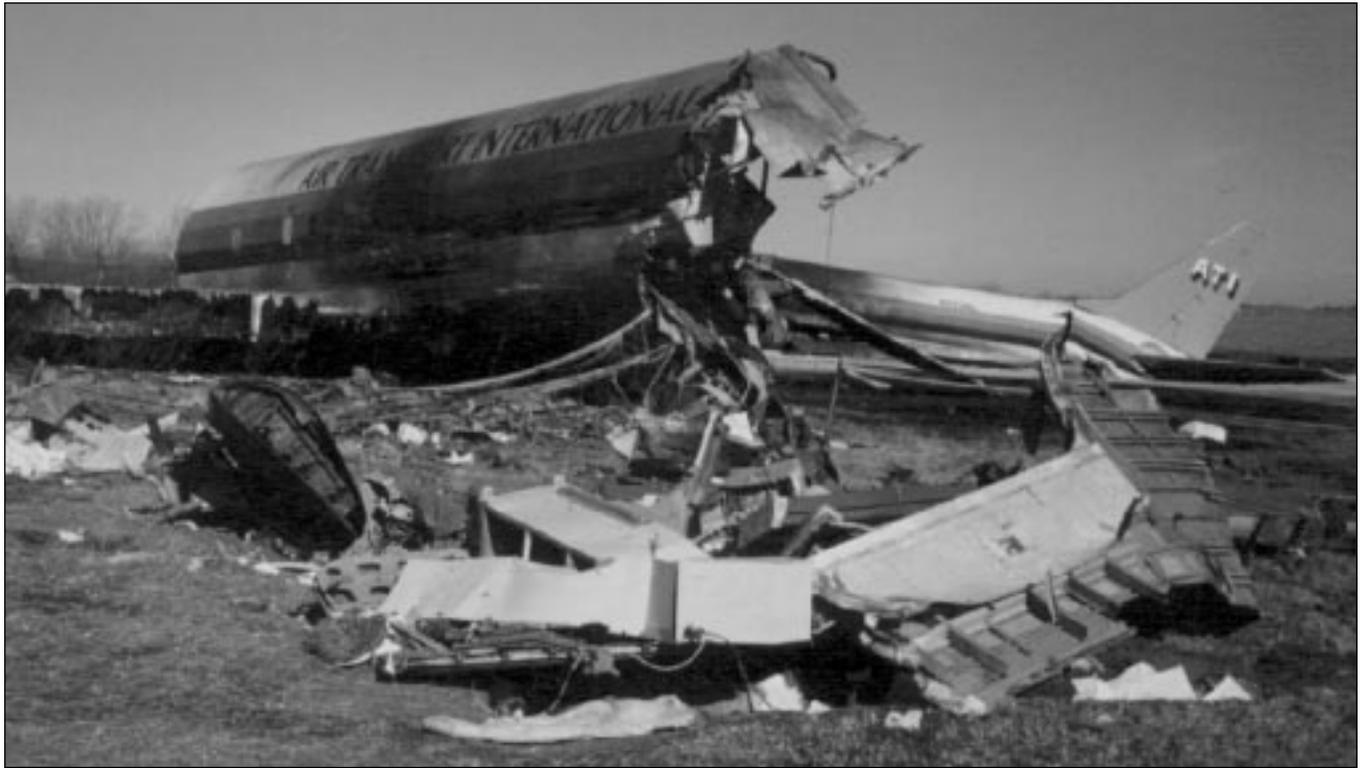
The airplane's fuselage broke into two large sections on impact.

During the crash sequence, the airplane fuselage broke into two large sections and the cockpit, the report said. “The cockpit and forward fuselage suffered severe impact damage. The upper cockpit structure remained recognizable, but the lower cockpit structure, radome and fuselage were mostly broken into smaller pieces. The upper, forward section of the cockpit was found upside down, and the front windows were shattered,” the report said.

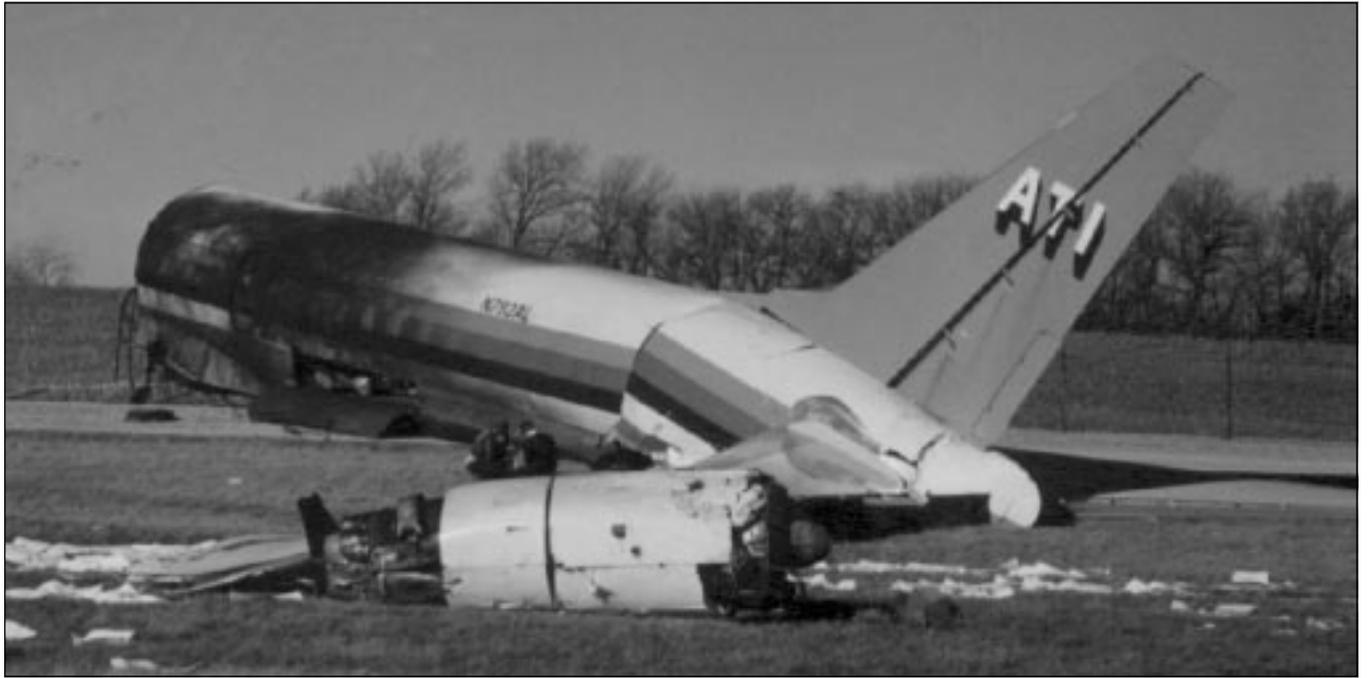
An engine rests near the aft section of the fuselage.

right sides were sooted, more so on the left side and near the wings, but no soot and only minor deformation were observed on the interior of the fuselage. ... The aft fuselage section remained intact, and with the empennage attached. Some postcrash sooting was observed. The cabin structure remained intact, with no fire penetration. The fuselage belly sustained considerable crushing damage," the report said.

During the crash sequence, "all four engines and pylons and the landing gear assemblies separated from the airplane," the report said.

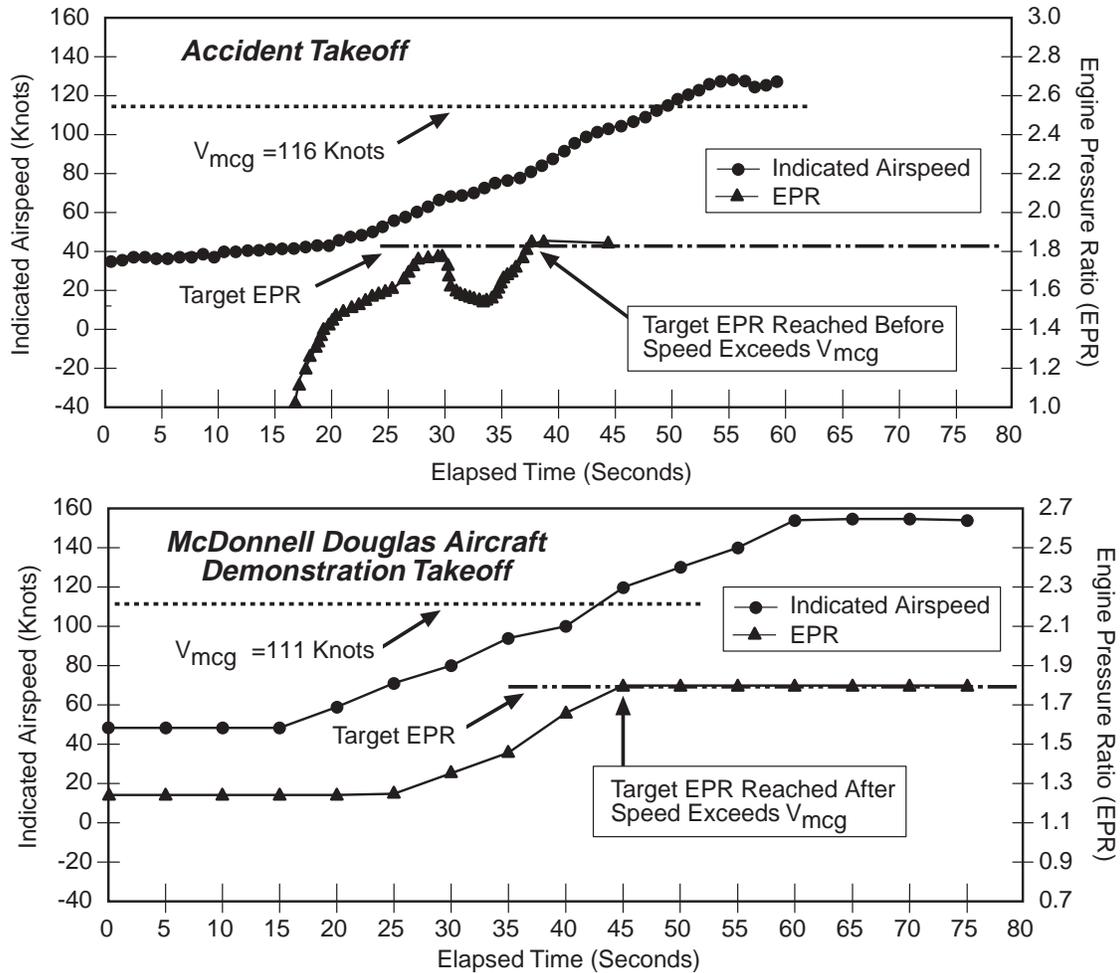
Asymmetric Engine Power/Airspeed, Accident Takeoff vs. McDonnell Douglas Demonstration Takeoff

During the takeoff, “the power on No. 4 engine was increased by the flight engineer at a more rapid rate than on the first takeoff,” the report said.

The report described the takeoff: “Shortly after the first officer called airspeed alive, there was an abrupt turn to the left, followed quickly by a correction to the right. After the first officer called ‘90 knots,’ the airplane started to turn left again. Following the 100-knot call, the FDR [flight data recorder] revealed a pitch change, indicating that the pilot rotated the airplane about 20 knots before the target rotation speed of 123 knots.”

Investigators experimented with having a flight engineer apply asymmetric power in a DC-8 simulator, and “found it extremely awkward and somewhat disconcerting,” the report said. “The [NTSB] believes that allowing someone not even in nominal control of the airplane to apply the asymmetric power required the captain to constantly react to an unknown quantity of thrust and an unknown rate of thrust application during the accident takeoff roll. This increased his mental workload dramatically and probably contributed directly to the accident,” the report said.
