Hard Landing Results in Destruction of Freighter

Inadequate crosswind-landing technique by the pilot flying and inadequate monitoring by the pilot not flying were cited in the collapse of the Boeing MD-10's right main landing gear on touchdown.

FSF Editorial Staff

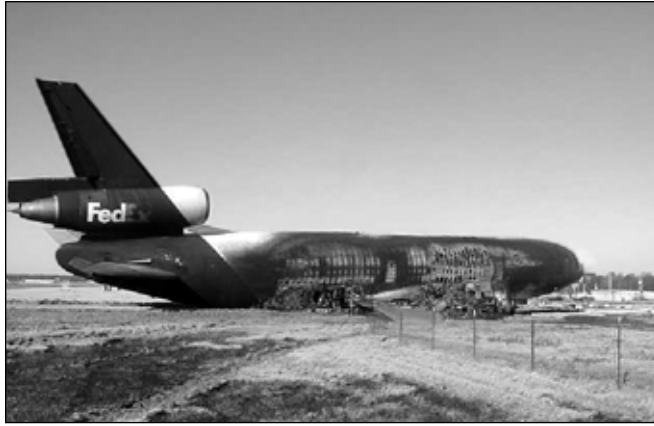
The left side of the fuselage and the left wing received minimal damage by the impact and fire. (Photo: U.S. National Transportation Safety Board)
