Aircraft Accident Investigation Report  
KNKT/07.06/07.02.35

**NATIONAL  
TRANSPORTATION  
SAFETY  
COMMITTEE**

**BOEING 737-497**

**7 MARCH 2007**

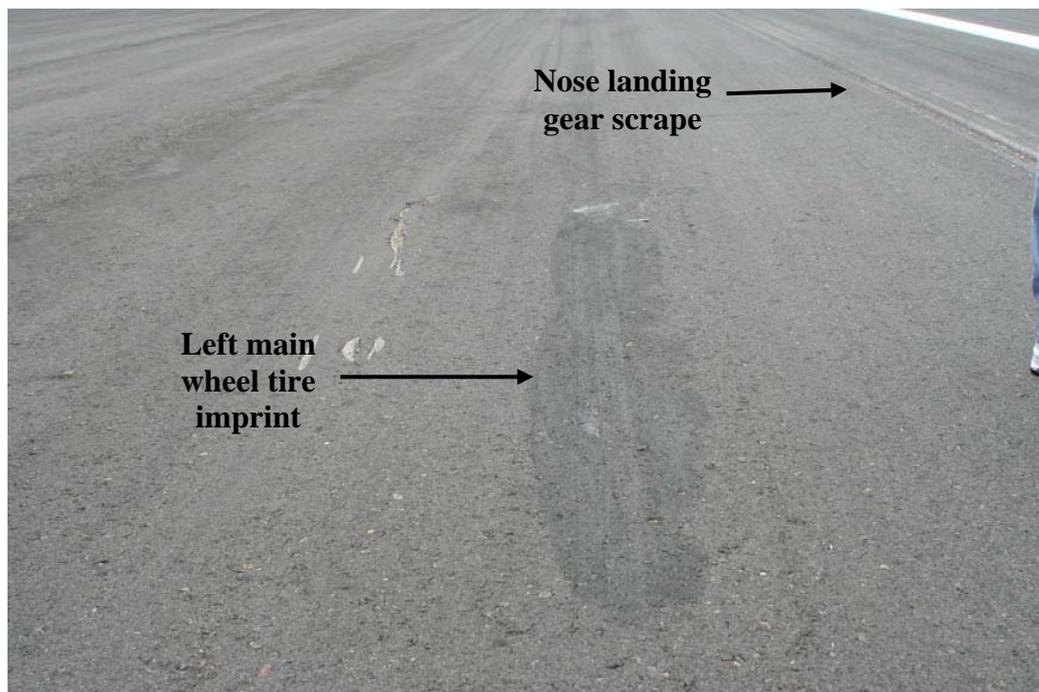
Main-wheel tire marks and nose-wheel axle and oleo impact and scraping marks were found along the runway (Figure 3 and Figure 4). The aircraft initially tracked along the runway centerline, but it left the sealed runway about 10 meters to the right of the runway centerline leaving nose landing gear wreckage (Figure 5) along the runway.

**Figure 3: Nose and left main landing gear impact marks on the runway**

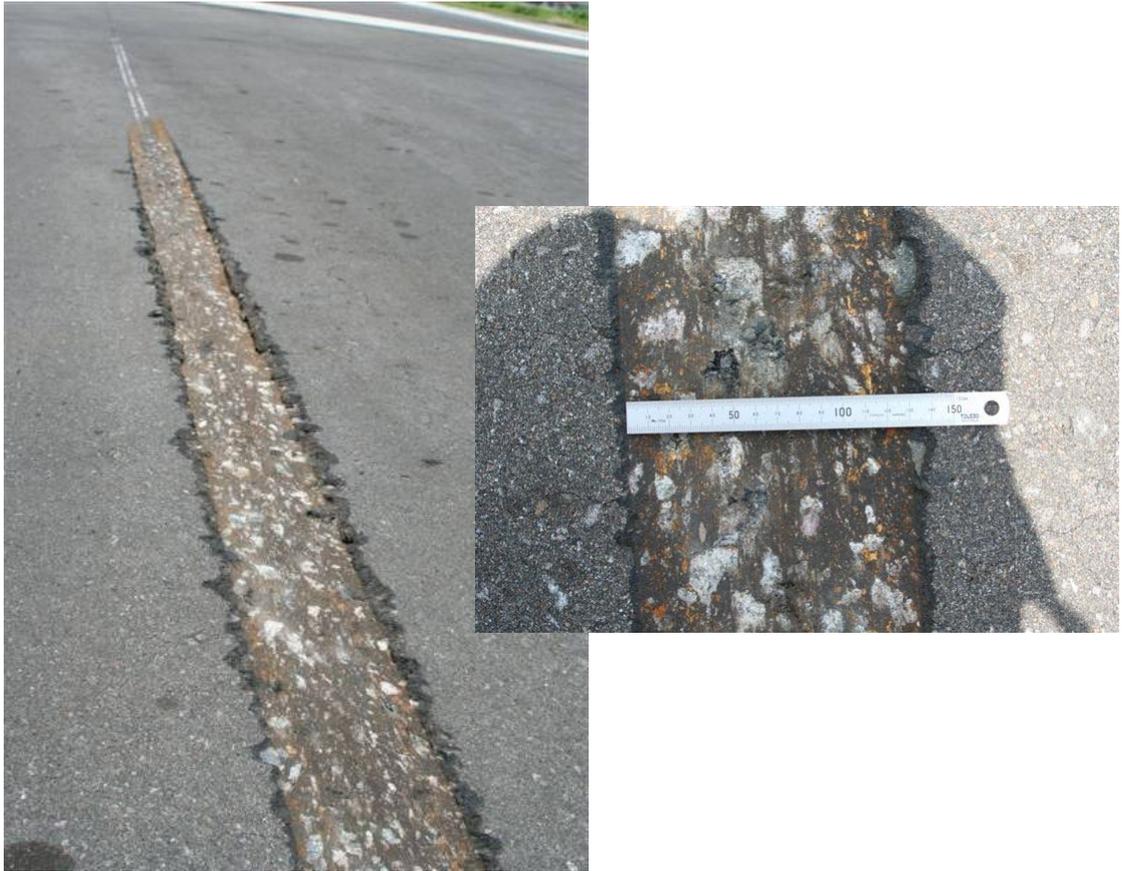
**Figure 4: Nose landing gear scrape on runway approximately 15 cm wide**

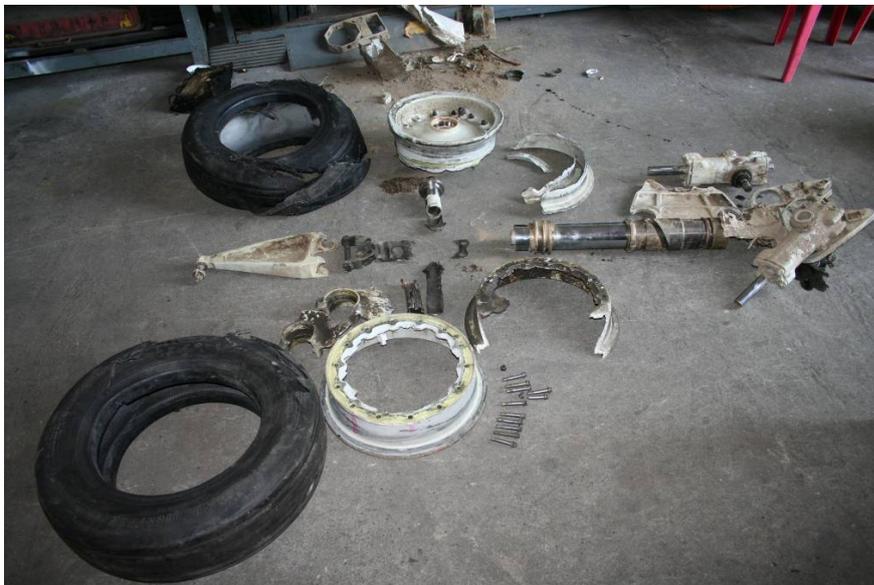
**Figure 5: Nose landing gear wreckage layout**

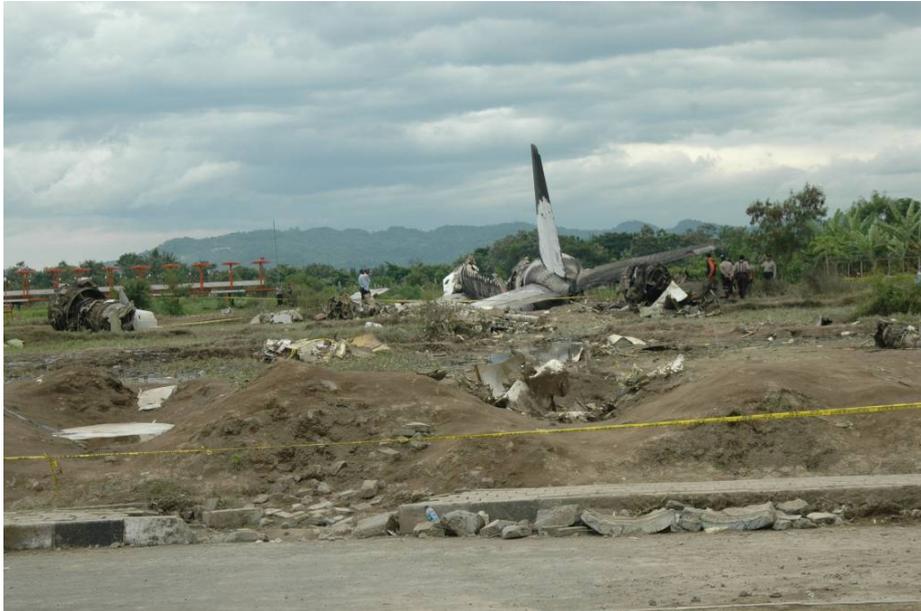
About 160 meters from the end of runway 09, the aircraft crossed a road and the nose of the aircraft impacted an embankment as the engines impacted a concrete gutter (Figure 6).

**Figure 6: Left engine impact on road and gutter**

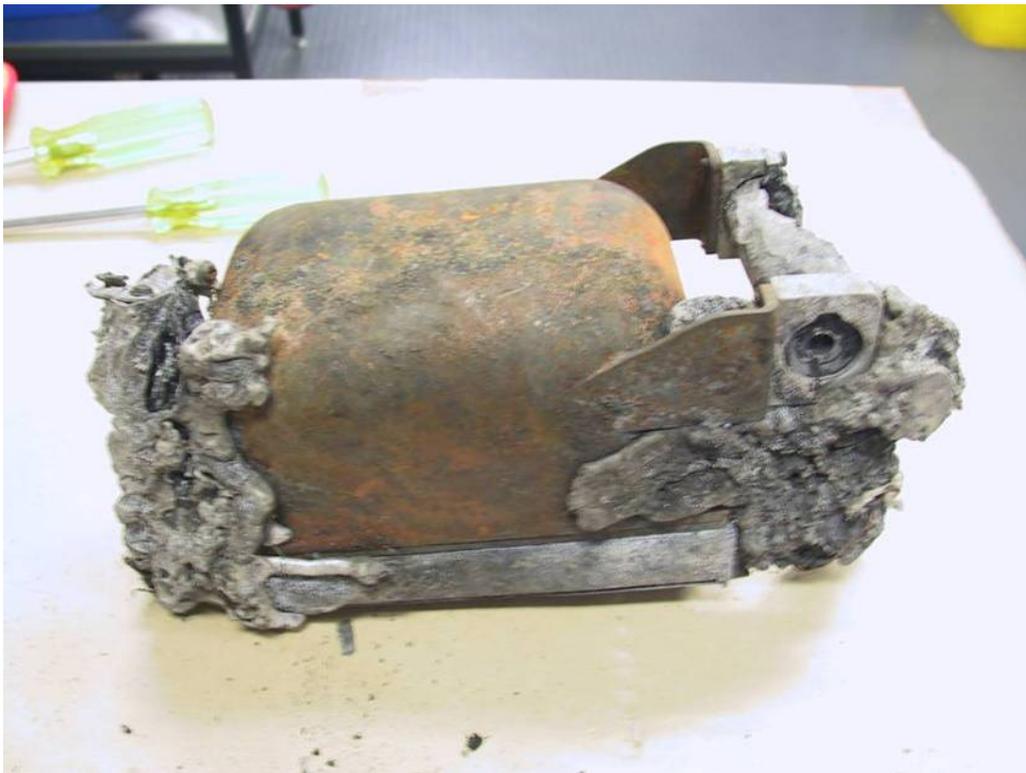
The SSFDR was severely burnt during the post-impact fire (Figure 13). However, the crash protection module survived the impact and fire. It contained 53 hours and 28 minutes of data<sup>11</sup>, including data relating to the entire accident flight and 31 previous flights.

**Figure 13: SSFDR from PK-GZC**

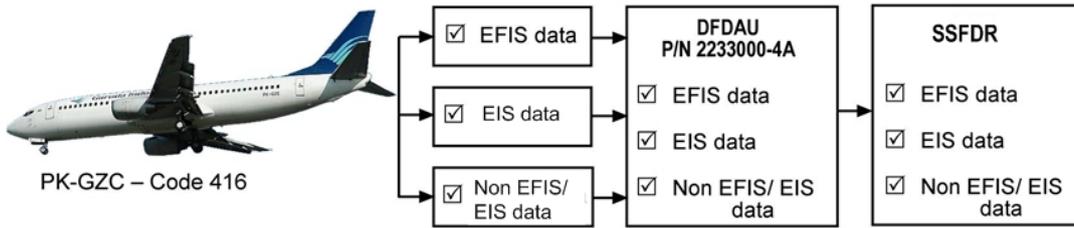
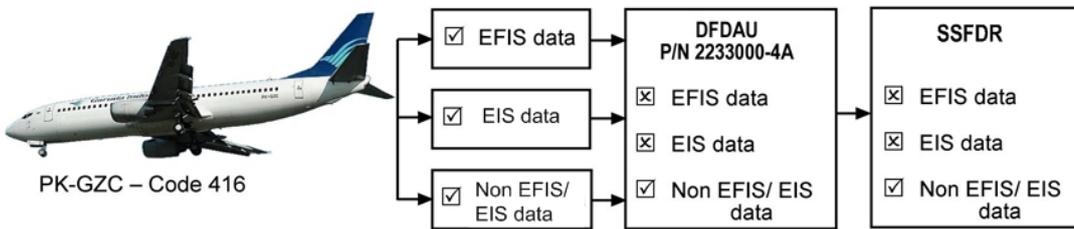
Teledyne P/N 2233000-4A, S/N 2377 was fitted. This was replaced by Garuda with Teledyne DFDAU P/N 2227000-45, S/N 895, on 16 June 2004.

**PK-GZC original fitment – DFDAU 2233000-4A effective on PK-GZC (Boeing 31-24-22-01B)**

**PK-GZC fitment at time of accident – DFDAU 2227000-45 NOT effective on PK-GZC (Boeing 31-24-22-01B)**

**Figure 14: PK-GZC flight recorder system mismatch resulting in SSFDR not recording EFIS and EIS parameters**

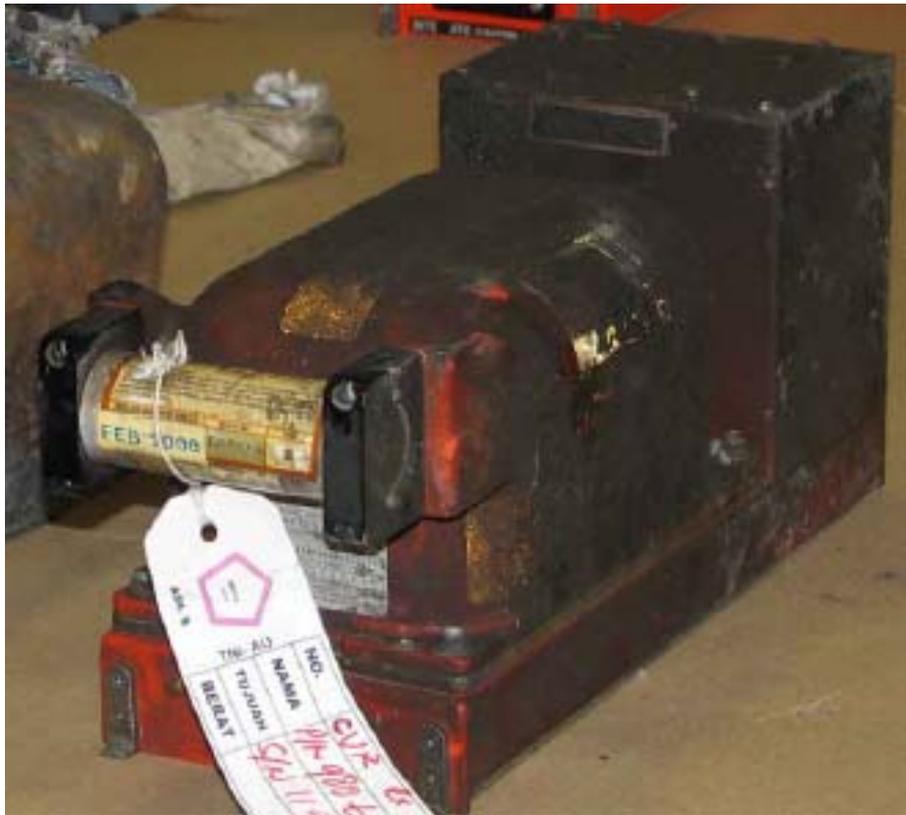
The SSCVR sustained heat damage during the post-impact fire, but it appeared to have survived the impact and fire (Figure 15). However, normal recovery methods were unable to facilitate the download of the SSCVR data.

**Figure 15: SSCVR from PK-GZC**

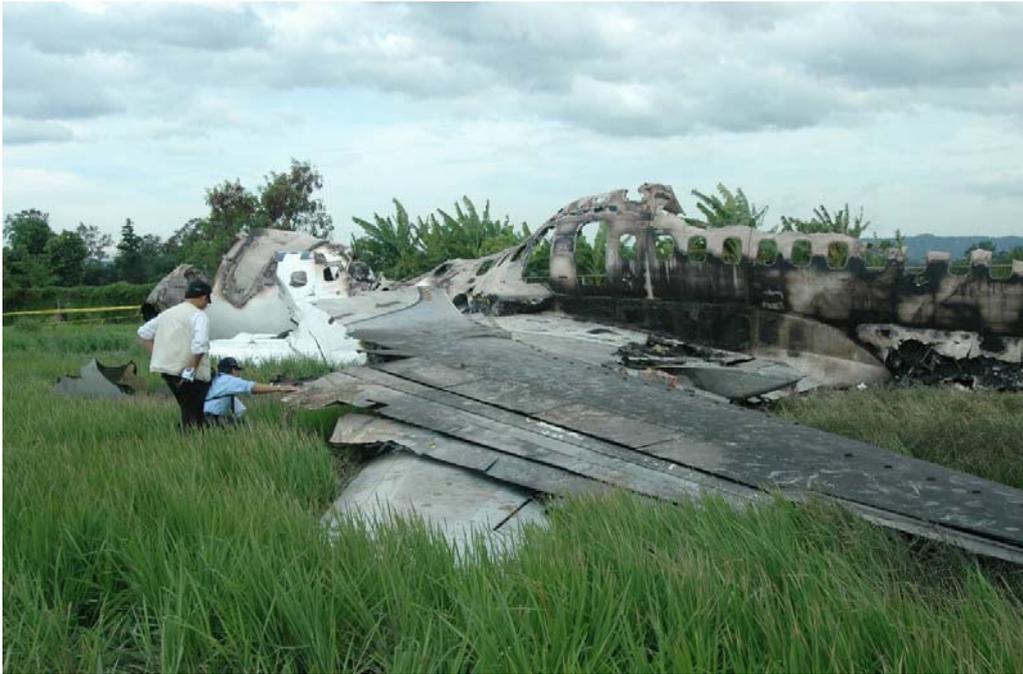
The nose wheel assembly separated from the aircraft on the runway. The engines and landing gear separated from the aircraft and were destroyed. The right wing was severed from the fuselage and swung around the fuselage and came to rest on top of the left wing (Figure 17).

**Figure 17: Severed right wing on the left wing**

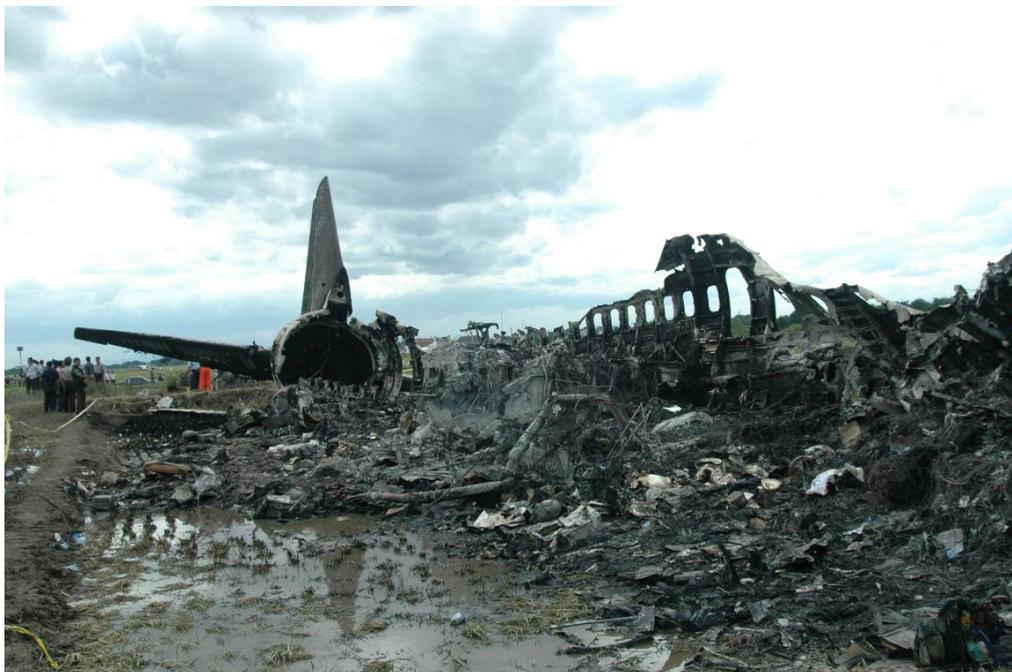
The cockpit area folded back and came to the rest inverted on top of the forward passenger cabin. The aircraft was destroyed by impact forces and the intense fuel-fed, post-impact fire (Figure 18).

**Figure 18: General view of the accident site looking back along the direction of the landing**

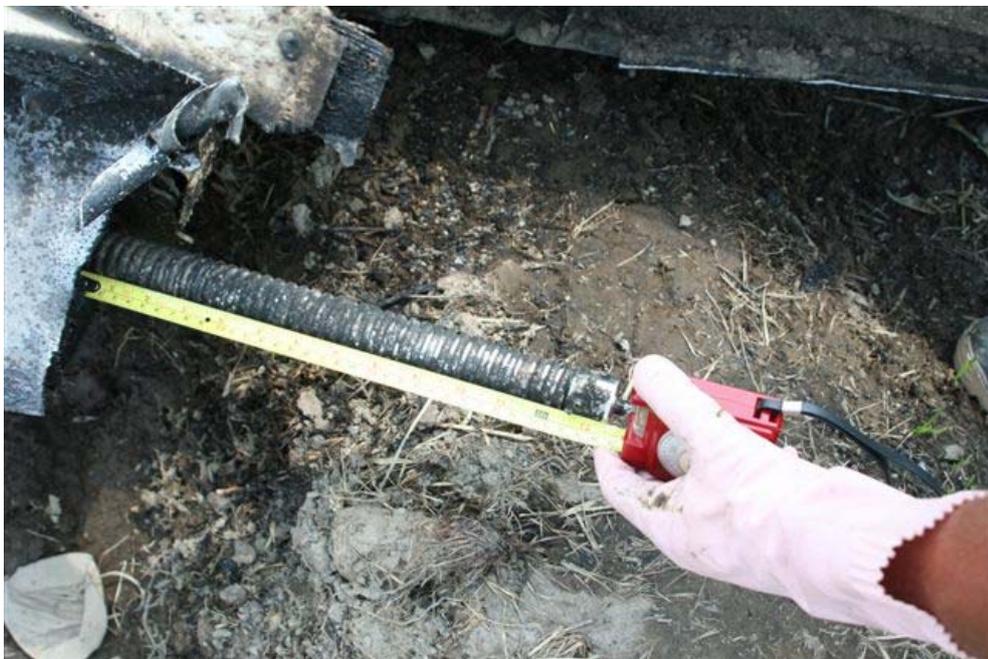
- Both thrust reversers were in the closed position; the stowed position.
- All ground spoilers were in the closed position.
- The auxiliary power unit (APU) was off, and the APU door was closed.
- The left rear door slide was out of its container and the slide bar was attached to door frame. No other evacuation slides were deployed.
- The right side of the fuselage was destroyed by the post-impact fire.
- The left over-wing emergency exit windows were opened.
- Both main landing gear assemblies separated from the wings during the impact.
- Flap position. The measurement was taken from the right inboard flap (outboard and inboard screw jacks). The outboard screw jack was at position 31.5 cm from the end stop, and the inboard screw jack was 31.5 cm from the end stop (Figure 19). The flap position corresponded to 5 degrees extended, or flap 5 position.

**Figure 19: Flap screw jack**

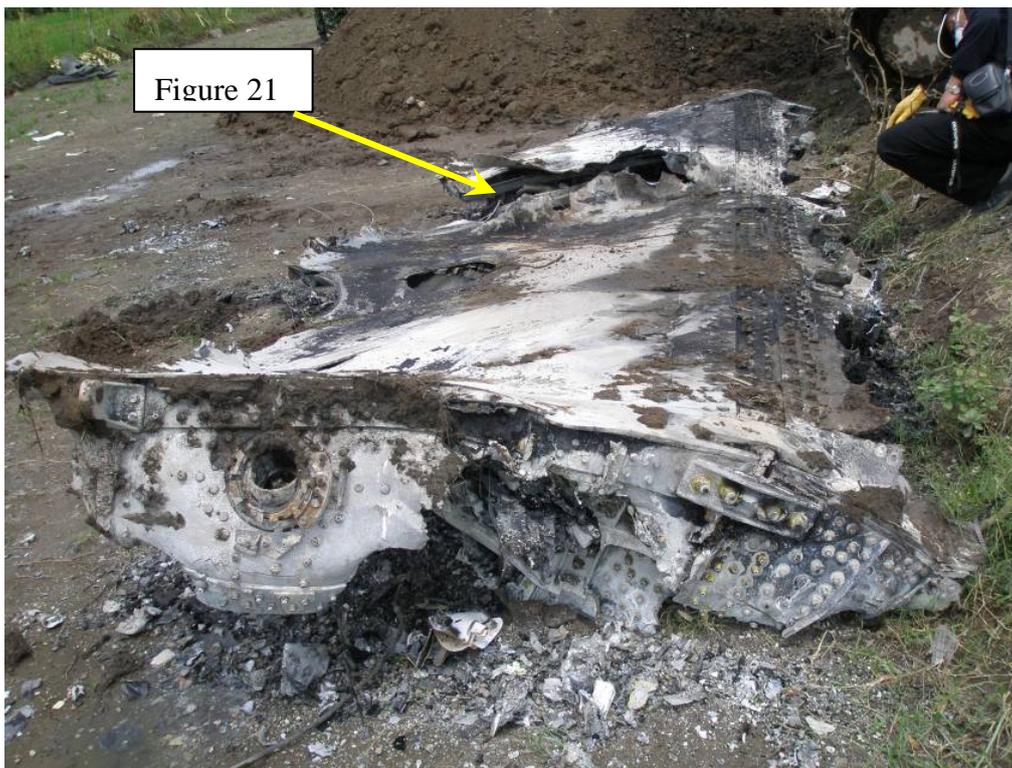
Fuel from the disrupted right wing fed the intense post-impact fire that consumed the aircraft. The right wing fuel tanks exploded during the impact (Figure 20 and Figure 21).

**Figure 20: Lower side of right wing at root end**

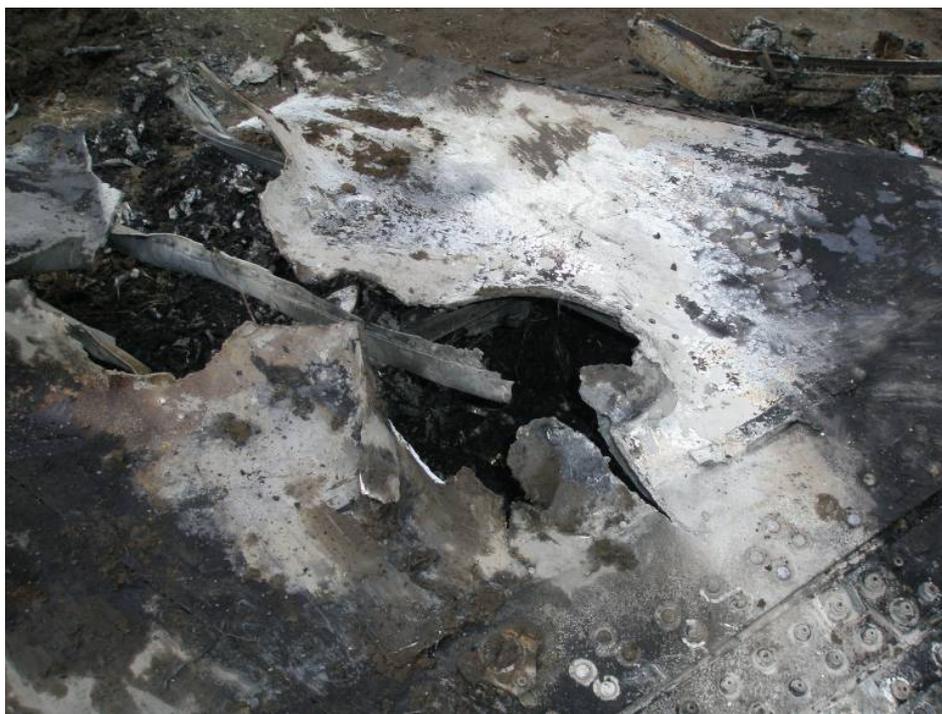
**Figure 21: Close-up view of fuel burn explosion damage to right wing**

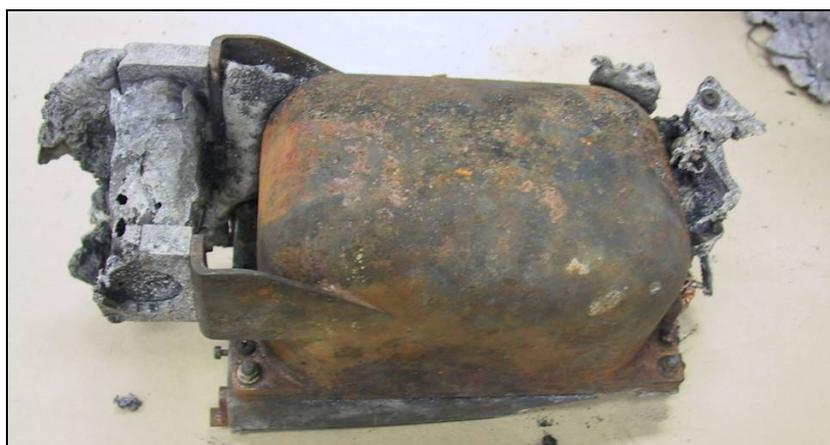
**Figure 2: PK-GZC flight data recorder as received at the ATSB on 9 March 2007**

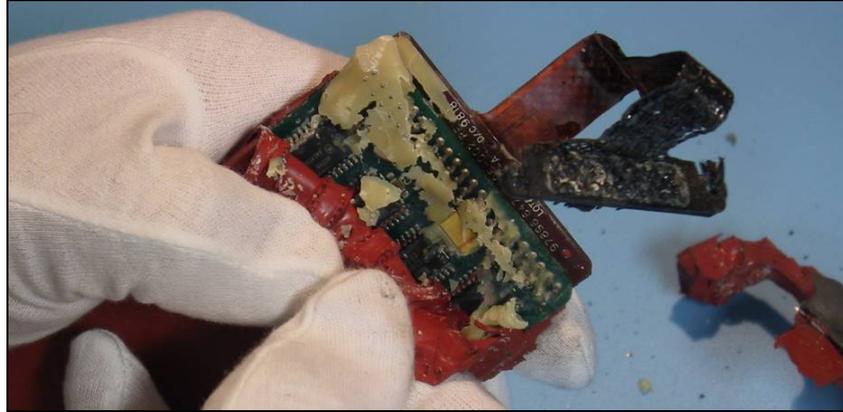
The memory board connector pins were cleaned and the flex cable replaced (Figure 4 and Figure 5)

**Figure 4: SSFDR memory board connector pins and damaged flex cable**
