National Transportation Safety Board
Washington, D.C. 20594

Aircraft Accident Brief

Accident Number:	CHI01MA006
Aircraft and Registration:	Bombardier CL-600-2B16 (CL-604), C-FTBZ
Location:	Mid-Continent Airport, Wichita, Kansas
Date:	October 10, 2000
Adopted On:	April 14, 2004

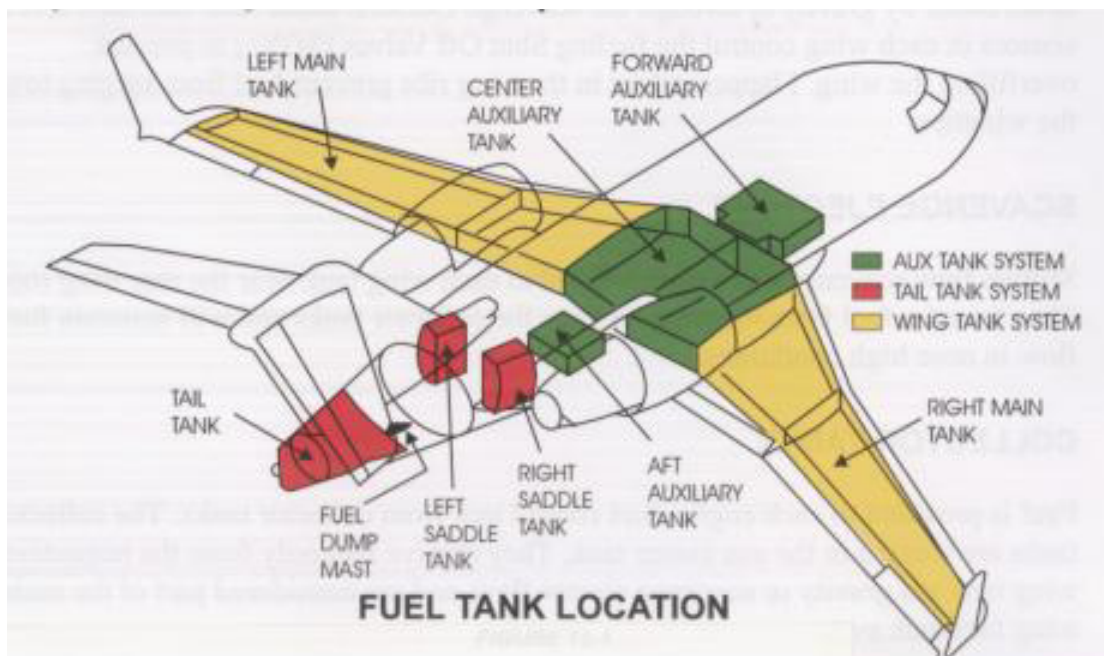
Figure 1. Airplane Fuel System Diagram

The airplane fuel tank system comprised a left wing tank, right wing tank, auxiliary fuel tank and tail fuel tank (see figure 1). The auxiliary fuel tank system beneath the center cabin had a forward, center, and aft tank that were interconnected by pipes and that were not isolated from each other by shutoff valves or check valves. The tail fuel tank system had two saddle tanks and a third tank at the rear of the tail cone. (see figure 1).

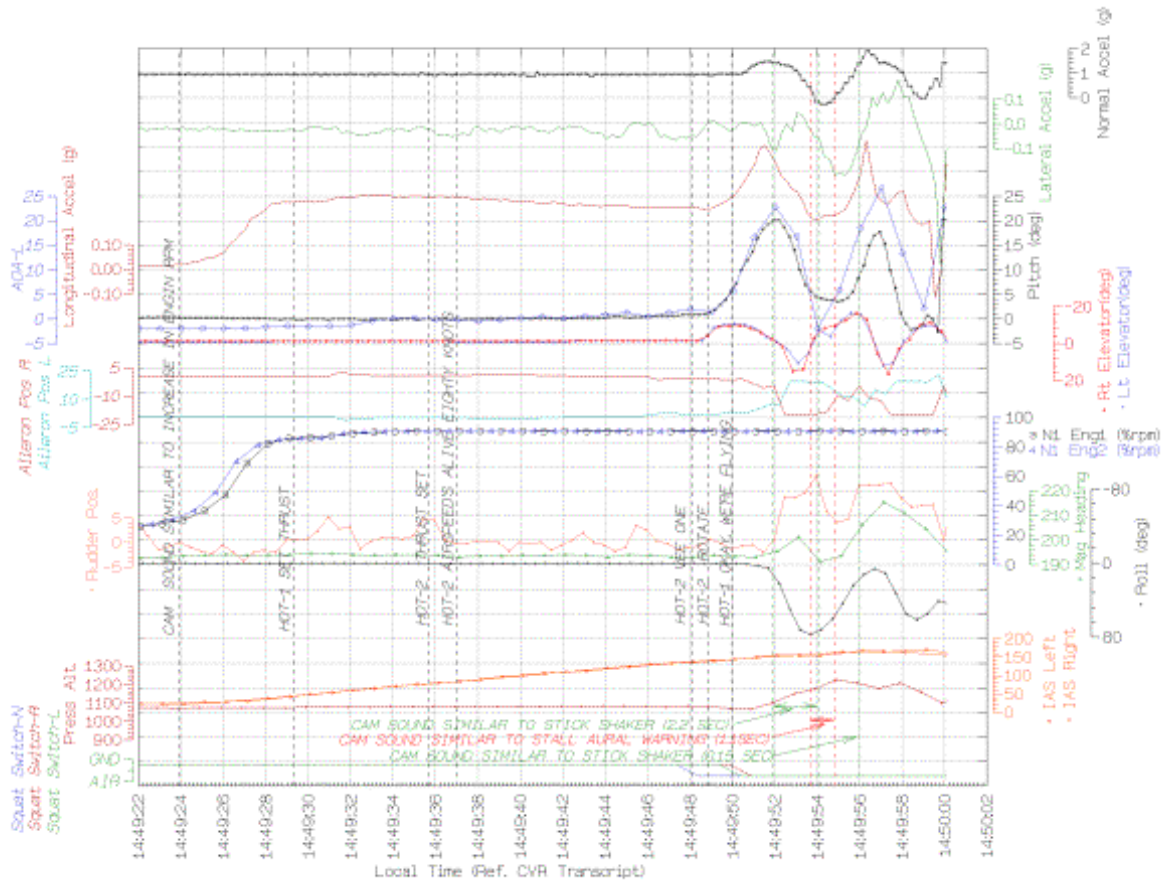
Figure 2.

The CVR recorded the intermittent activation of stick shaker, aural stall, and bank angle warnings beginning with the first pitch up to 20° until about 1 second before impact. After initial rotation, all elevator, rudder, and aileron inputs by the pilot were consistent with inputs to counter pitch and roll oscillations, according to FDR information. FDR data indicated a peak pitch rate of 8.4° per second. (The airplane's ADAS, which recorded test flight data at a higher sampling rate, indicated a pitch rate of 9.6° per second).

According to FDR data and information derived from the Safety Board staff's integration study of FDR data (flightpath integration), the airplane's peak airspeed was 170 knots. The flightpath integration indicated that the airplane's peak altitude was about 70 feet. FDR information indicated that the engines were operating at 90 percent fan speed until impact.
