Final Report by the Aircraft Accident Investigation Bureau

concerning the serious incident

to the DC-9-83 aircraft, HB-INV,
operated by Helvetic Airways under flight number OAW 8100
on 21 October 2004
in Pristina (Kosovo, Serbia-Montenegro)

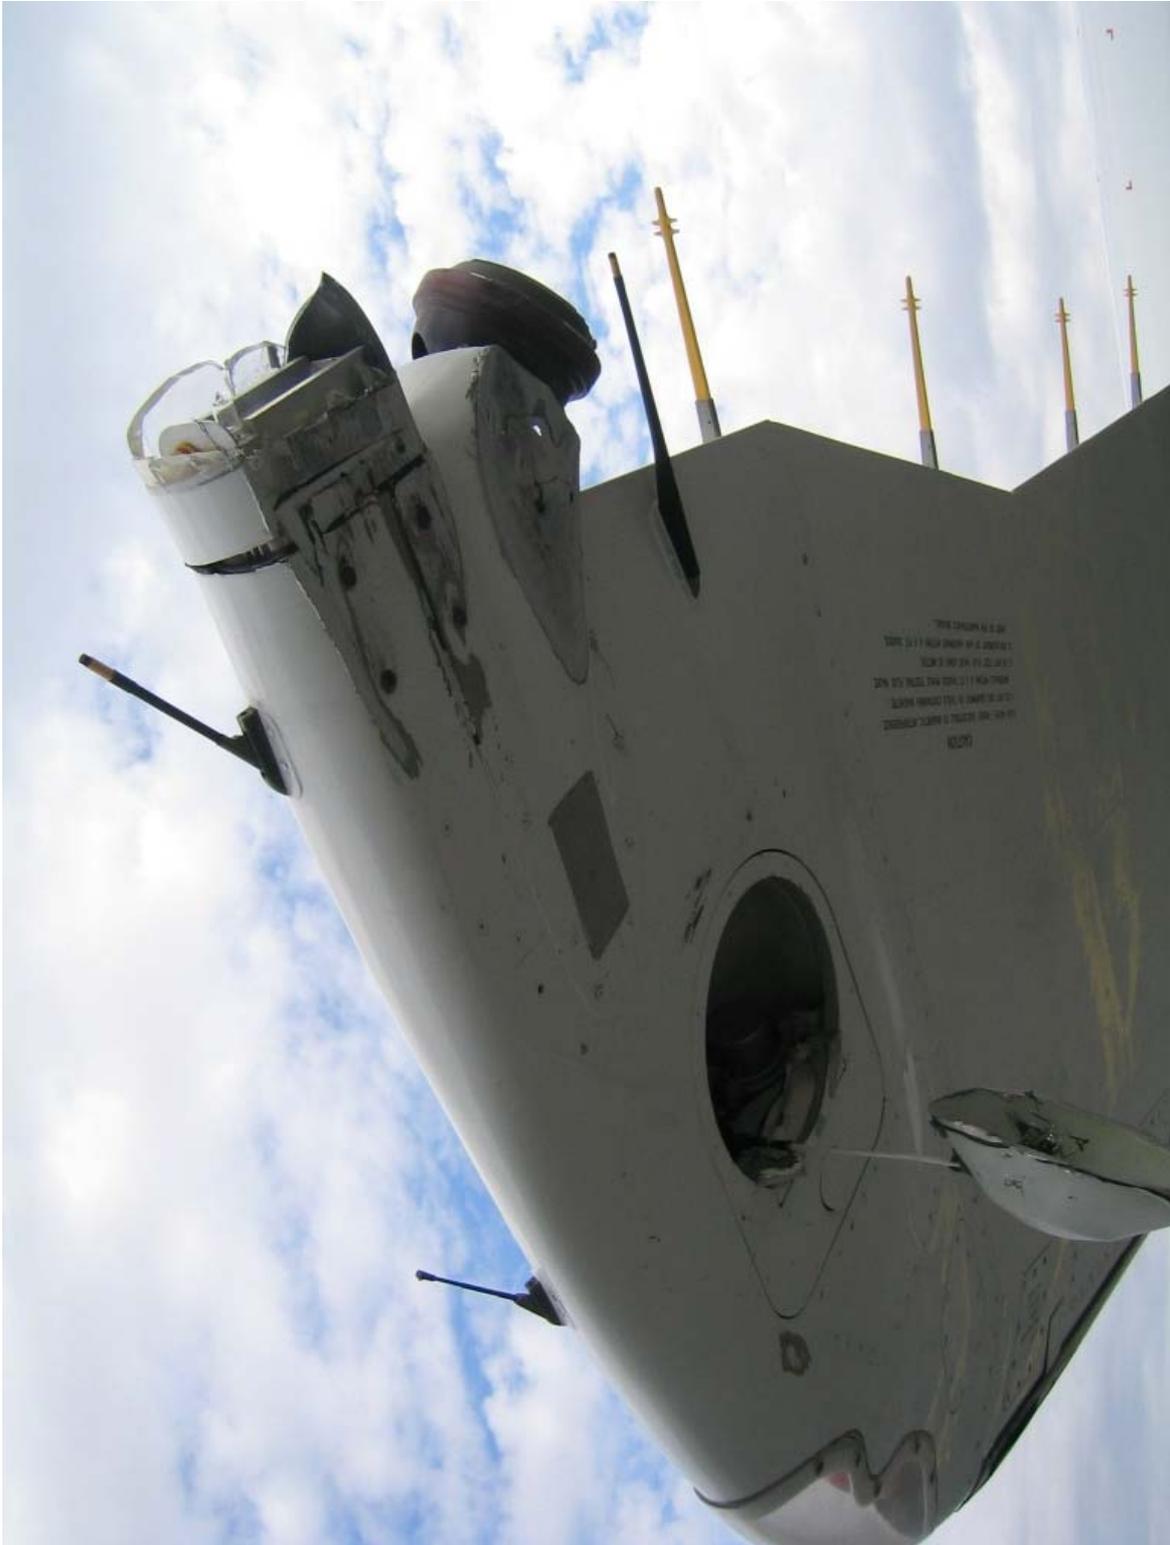
5.1 Damage to the left wing

As a result of the contact of the left wing with the runway surface, the extended left outboard slat (slat #5 left) was badly chafed. Part of the left wingtip was abraded, so that the skin was punctured (cf. Appendix 1).

The extended landing light was torn off and was left hanging from the electrical cables. The left wing strobe light and logo light were damaged.

After the serious incident the following checks and repairs were carried out in Pristina on the left wing:

- The damaged outboard slat #5 was replaced.
- In the area of outboard slat #5, a visual check of the structure, the electrical wiring, the slat tracks, the slat bearings and the anti-ice system was carried out.
- At the wingtip, a small puncture was sealed using high speed tape.
- The logo light, the strobe light and the landing light were repaired or replaced.

- Function check on the slats, flaps and aileron systems.
- Function check on the logo lights, strobe lights and landing lights.
- Airtightness check on the anti-ice system.
- Inspection according to AMM 05-51-01 ("A" check – high drag/side loads or unusual handling conditions)

After the ferry flight to Zurich, the wingtip was repaired definitively in accordance with the SRM (structural repair manual).

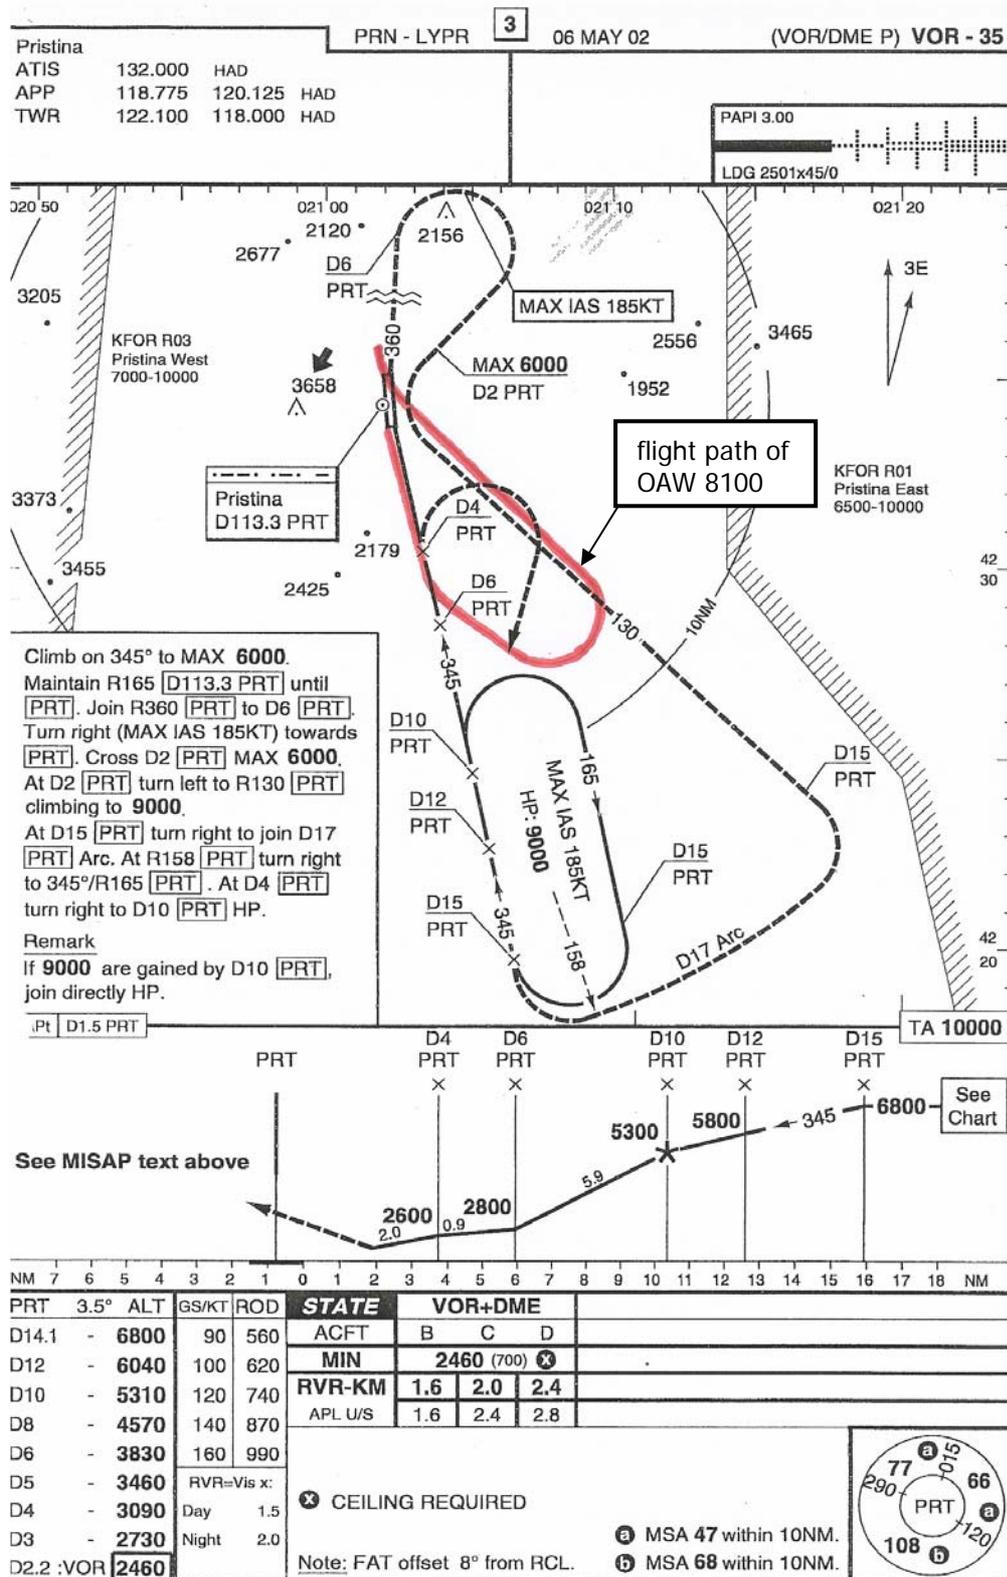
5.3 Reconstructed flight path of OAW 8100

The aircraft followed the radial 165° inbound (track 345°) for the VOR/DME approach, until reaching a radar altitude (RA) of 120 ft. At that time the aircraft had a heading of 342° and flew, with respect to the approach direction, left of the extended runway centreline of runway 35. According to the crew's statement they decided for a flight path through the runway centreline in order to avoid wisps of cloud. In order to get back onto the centreline the pilot flying initiated a right turn. While doing so, at about 100 ft RA, bank angles of more than 15° were reached. A Boeing 737 was waiting at the holding position west of runway 35, that means left of the runway centreline. The copilot stated that this might have influenced the crew to continue the right turn in a pronounced manner. This manoeuvre finally brought the aircraft in a position right of the runway centreline. The crew now commenced a left turn with considerable bank to get back on the runway centreline.

In order to avoid wisps of cloud the crew flew left of the extended runway centreline of runway 35. To get back onto the centreline the crew initiated a right turn at about 100 ft RA. This manoeuvre finally brought the aircraft in a position right of the runway centreline. The crew now commenced a left turn with considerable bank to get back on the runway centreline. From this position the crew initiated a go around. On this occasion the left wing made contact with the runway surface, whereby parts of the wing were damaged. There were no injuries to persons. According to the approach control officer's statement the runway visual range RVR was 2000 m at that time.

The reconstructed flight path of flight OAW 8100, presented on the VOR/DME approach chart runway 35.
