**INCIDENT**

<b>Aircraft Type and Registration:</b>	Dornier 328-100, TF-CSB	
<b>No &amp; Type of Engines:</b>	2 Pratt and Whitney PW 119B turboprop engines	
<b>Year of Manufacture:</b>	1997	
<b>Date &amp; Time (UTC):</b>	11 June 2006 at 1256 hrs	
<b>Location:</b>	Near Sumburgh Airport, Shetland	
<b>Type of Flight:</b>	Public Transport (Passenger)	
<b>Persons on Board:</b>	Crew - 3	Passengers - 17
<b>Injuries:</b>	Crew - None	Passengers - None
<b>Nature of Damage:</b>	None	
<b>Commander's Licence:</b>	Airline Transport Pilot's Licence	
<b>Commander's Age:</b>	61 years	
<b>Commander's Flying Experience:</b>	18,000+ hours (of which approximately 280 were on type) Last 90 days - 120 hours Last 28 days - 36 hours	
<b>Information Source:</b>	AAIB Field Investigation

**Synopsis**

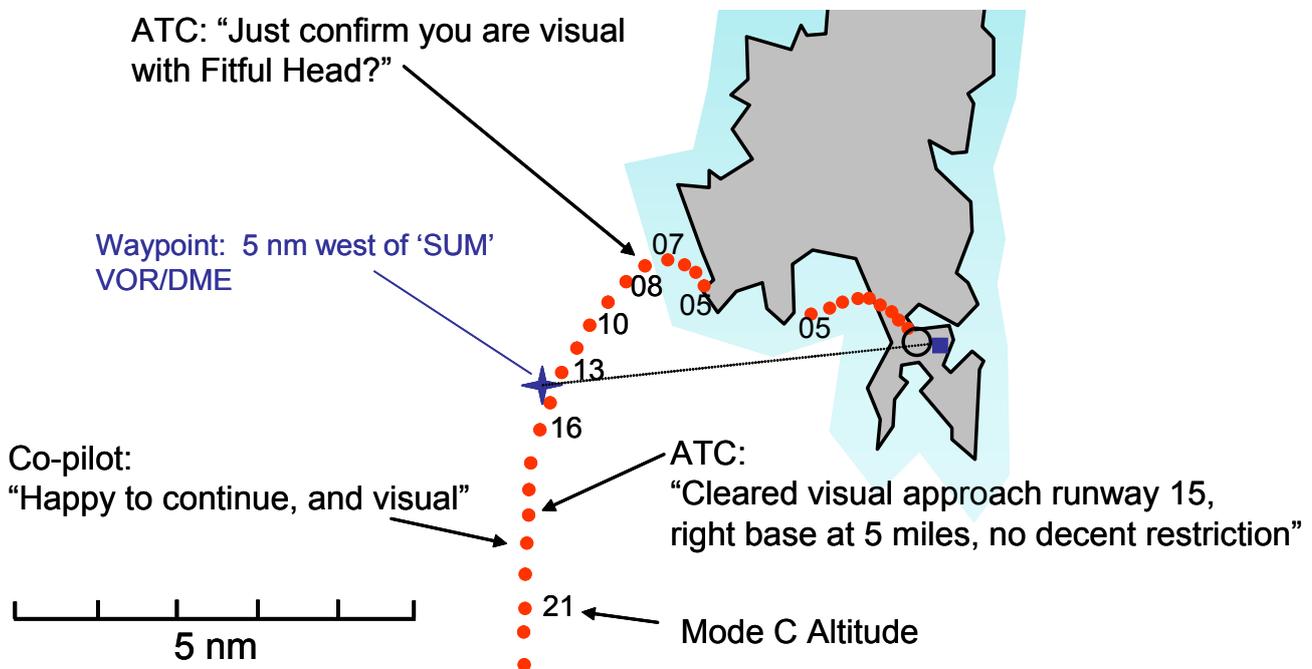
Figure 2 shows the aircraft's radar track and significant R/T exchanges. When the co-pilot contacted the Sumburgh Approach controller he was told that the aircraft would be radar vectored for the Localiser/DME procedure for Runway 09. The co-pilot acknowledged this, but requested a visual approach to Runway 15, if it was possible. The commander then transmitted "...WE'VE SET UP OUR NAV BOX TO PUT US ON A

As it approached the FMS waypoint, the aircraft commenced a gentle turn to the right. It passed about 0.2 nm to the east of the waypoint, whilst descending at about 1,500 ft/min through a Mode C altitude of 1,300 ft. The aircraft continued in a very gentle right turn towards the high ground of Fitful Head. The average descent rate reduced as the aircraft descended below 1,000 ft, to about 1,000 ft/min. When the aircraft was about 0.6 nm from the coastline as shown on the radar display, and at a Mode C altitude of 700 ft, the Approach controller asked "... JUST CONFIRM YOU ARE VISUAL WITH FITFUL HEAD?" The co-pilot replied with the single word "AFFIRM" and the subsequent radar returns showed the aircraft's turn rate to the right increased significantly until the aircraft had turned to track approximately

Radar plot and significant R/T exchanges

parallel to the coastline. The indicated altitude remained at 700 ft initially, then reduced to 500 ft. At that point radar contact was lost, as the aircraft became masked by the high ground.

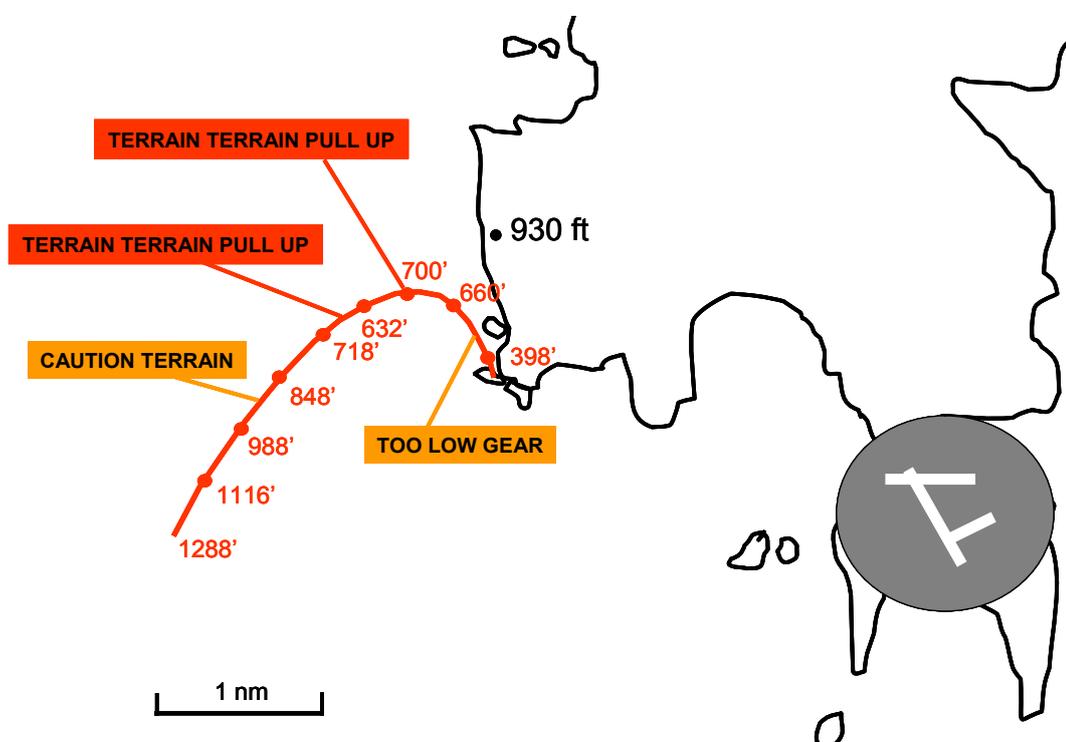
**Figure 3**  
EGPWS record

The position of warnings and cautions generated by the EGPWS are depicted at Figure 3; values in red are radio altitudes. Figure 4 shows the aircraft’s vertical profile for the same period. Flight data for each significant event, commencing with the start of the recorded data, is given in Table 1. Two recorded parameters were common to each event, these were: landing gear up and landing flaps not selected.

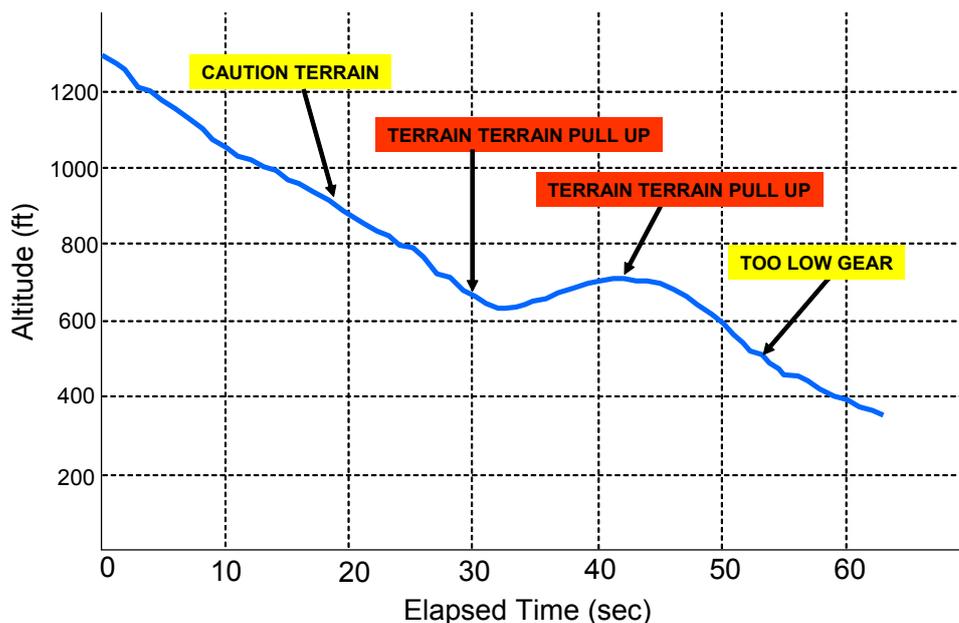
**Figure 4**

Aircraft vertical profile
