## FINAL REPORT

**AAIU Formal Report No: 2005-015**

| <b>Model:</b> | F 27 – 500 |
| <b>Registration:</b> | G-ECAT |

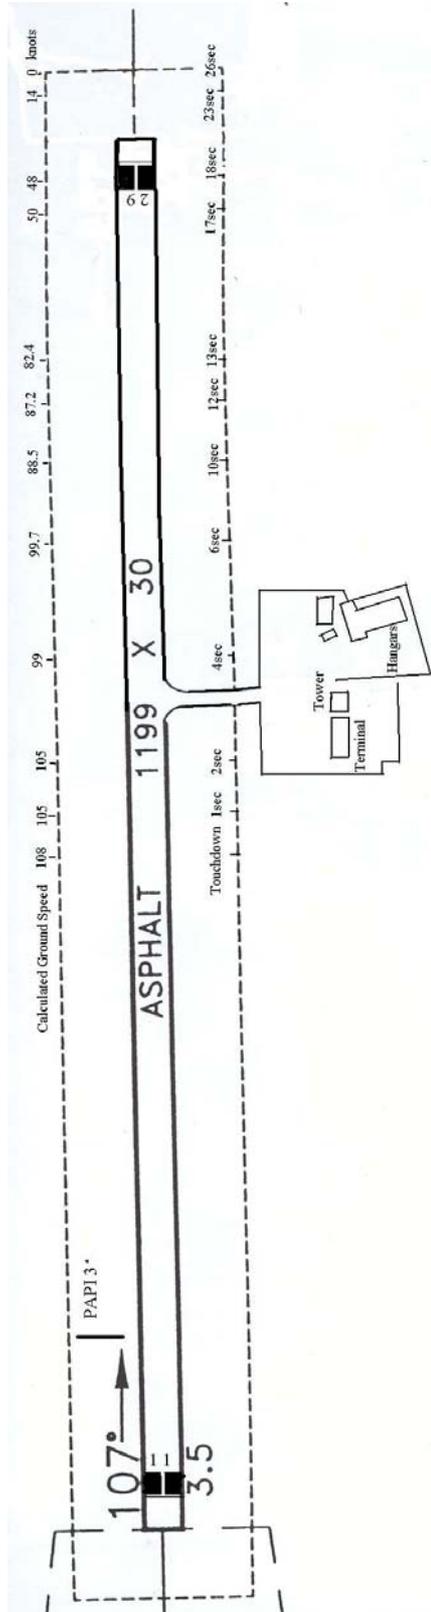
## APPENDIX C

The point at which these forces return to normal were found to coincide with the point at which the heading ceased turning and this was taken as the point where the aircraft came to rest. The final deceleration was in the region of 8 ft/sec/sec and existed for 294 metres (967 ft). The total landing roll therefore, was 753 metres (2470 ft). The position at which the aircraft came to rest was measured as 50.5 metres from the runway pavement. This would indicate that the aircraft touched down about 460 metres from the threshold of RWY 11 (**Appendix C**).

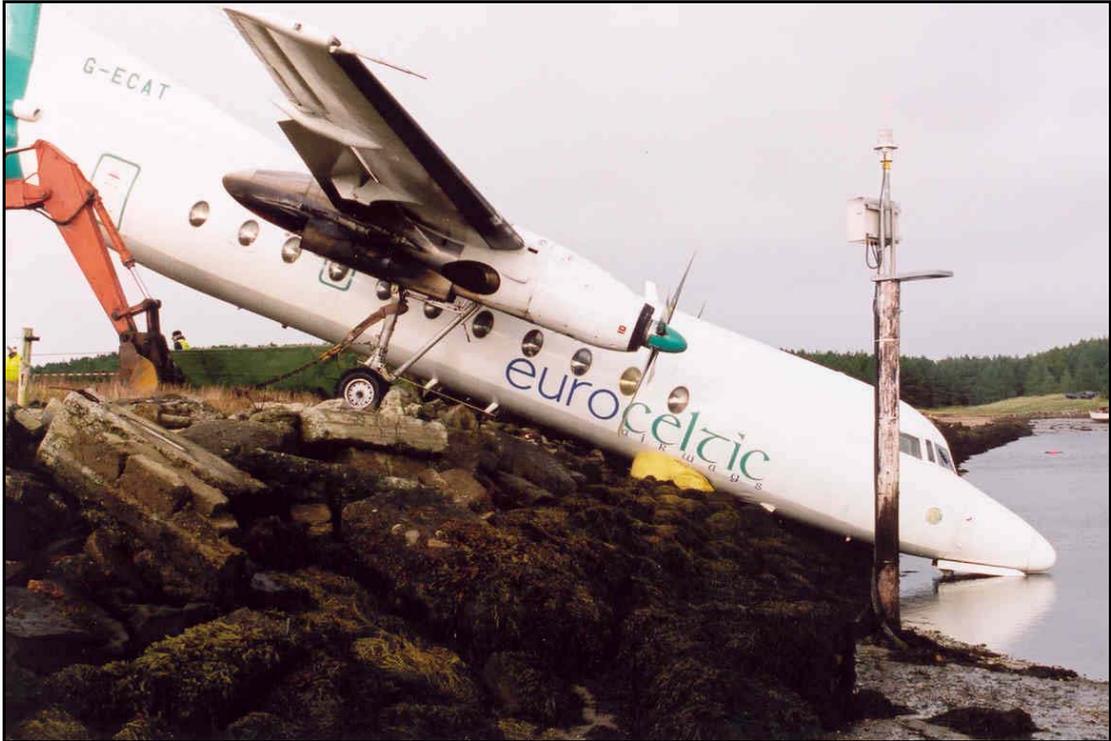
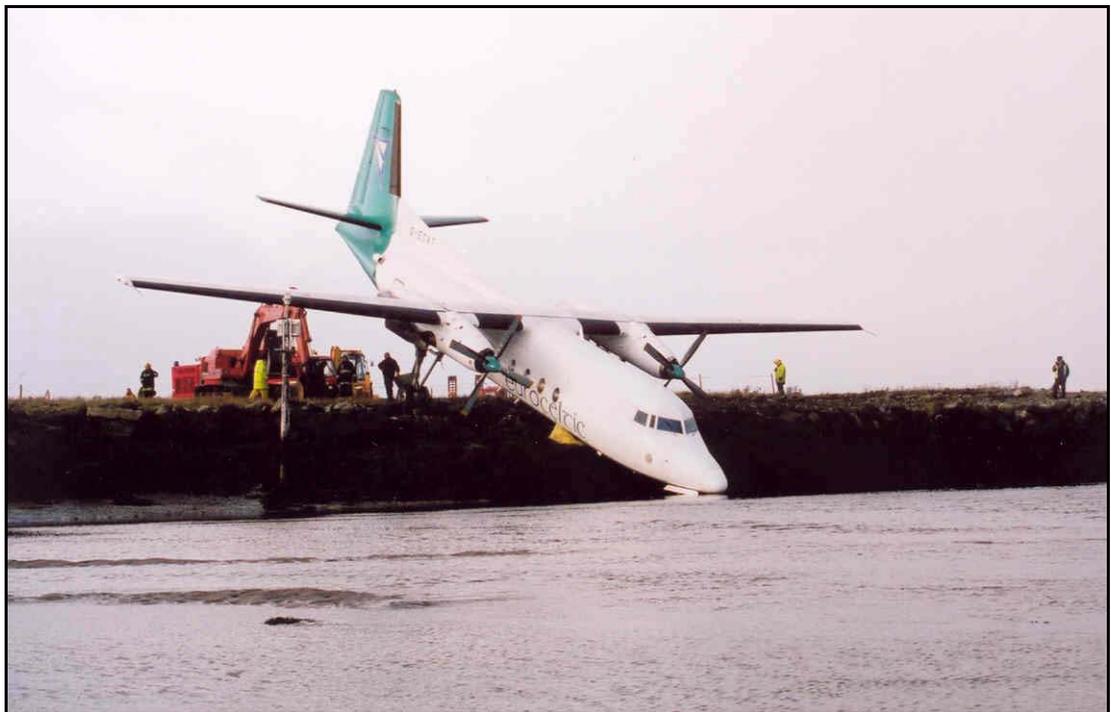
**APPENDIX D**

The aircraft came to rest at the seawall embankment off the end of RWY 11. Large boulders, which formed part of the embankment, arrested the further travel of the aircraft. However, the nose section of the aircraft came to rest on the out-going tidewater. On initial inspection the aircraft sustained extensive braking damage to the four main wheels and impact damage to the nose wheel. Some damage was caused to the forward underside of the fuselage due to resting contact with the boulders. During the night of the accident the rise and fall of the tide immersed the cockpit and forward section of the cabin. This salt water caused immediate visible corrosion in the cockpit and rendered the airframe a total economic write off.

The underside of the aircraft suffered extensive puncture damage, which was consistent with the nose sinking, thereby bringing the underside into contact with the stone embankment. When the aircraft came to rest, the nose wheel was not in ground contact.

Final resting position of G-ECAT at half-tide mark.

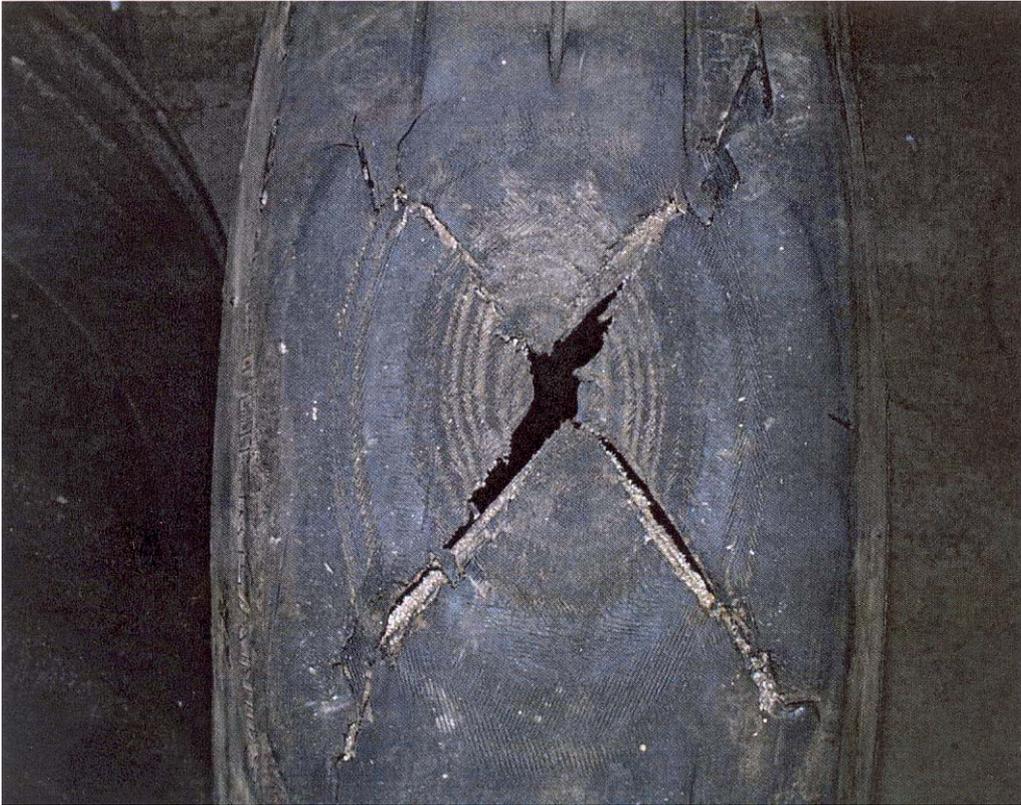
### APPENDIX E

Three main wheel tyres were found to have deflated and showed signs of rotating on their wheel rims after deflation. These were both tyres on the port side and the starboard inner tyre. The starboard outer remained inflated. All four tyres were removed for further examination. The results of this examination showed that the starboard outer type was worn down to almost its limits, and did not show any indication of skidding or aquaplaning. All the other three tyres showed a distinct skid mark, where the tyre material had been worn significantly, to such an extent that the tyre pressure caused the remaining material to suffer the classical X type of burst failure (**Appendix E**), thereby deflating the tyre. None of these three tyres showed any indication of aquaplaning.

The failure of three burst tyres is consistent with the aircraft landing with the wheels not rotating. The probable scenario is that the brakes were heavily applied either when the aircraft was airborne during a bounce, or when it had touched on with only the nose wheel in ground contact.

When the main wheels subsequently came into contact with the runway, the locked tyres were worn away quickly. As noted in 1.6.3 above, the anti-skid would not have released the brakes in such circumstances

When sufficient material was eroded, the tyres material was insufficient to resist the internal inflation pressure, and, the tyre burst at this point. This failure mode was noted on all three failed tyres. Once each tyre had burst and deflated, it rotated on its rim, thereby negating any braking affect.

The tread shows a skid mark, 90° counter-clockwise from the serial number. In the skid mark all individual tread and carcass plies show up as oval rings. In the centre of these ovals there is an 'X' break visible. Next to the skid damage there are oval wear marks visible
