Final Report by the Aircraft Accident Investigation Bureau

concerning the serious incident

to the Gulfstream IV aircraft, A6-HHH

on 15 August 2003

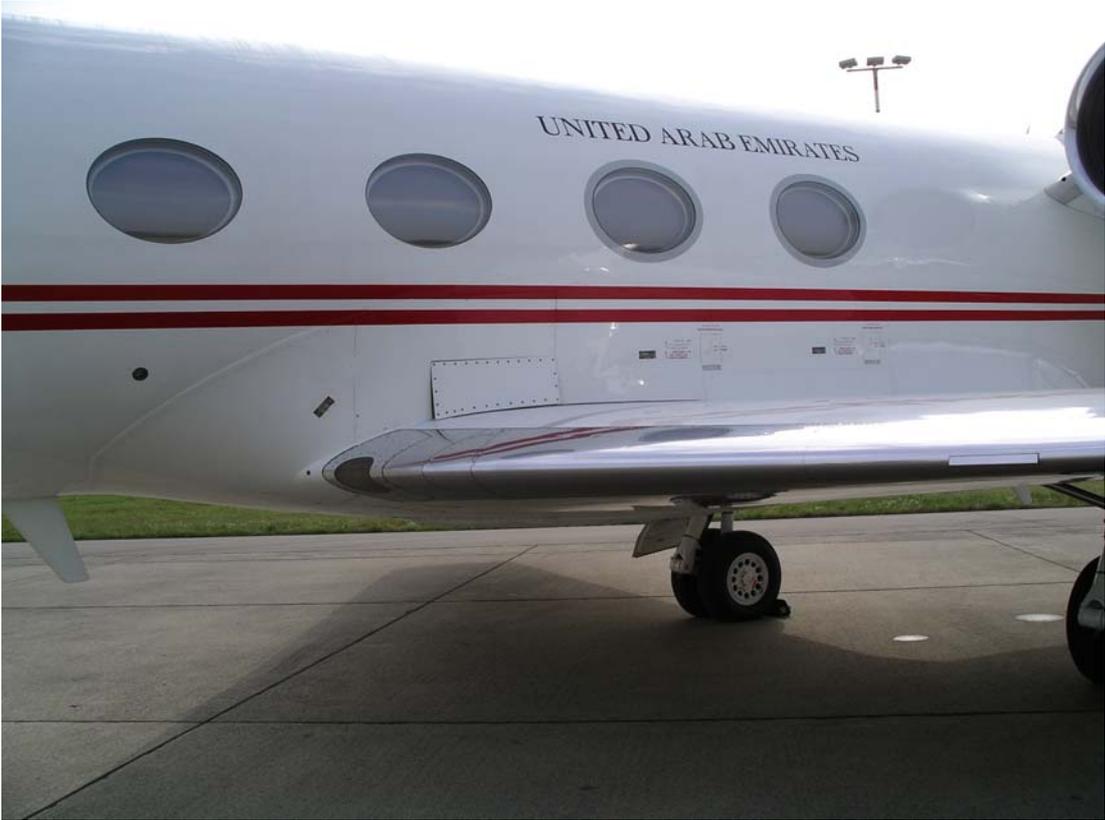
Picture 1

In Zurich, access was gained from outside the aircraft (Picture 1) to the clamp which connects the two sections of the wing anti-ice duct from the left engine and to the left wing (Picture 2). The clamp, P/N CA-33025, made by Gamah, had broken at the hinge (Picture 6) and was replaced by the mechanic accompanying the aircraft. The defective clamp was handed over to the AAIB for closer analysis.

- After the landing, it was established that on the left side of the aircraft, in the area of the wing root, a clamp (Gamah P/N CA-33025) had broken (Pictures 1, 2 and 6).

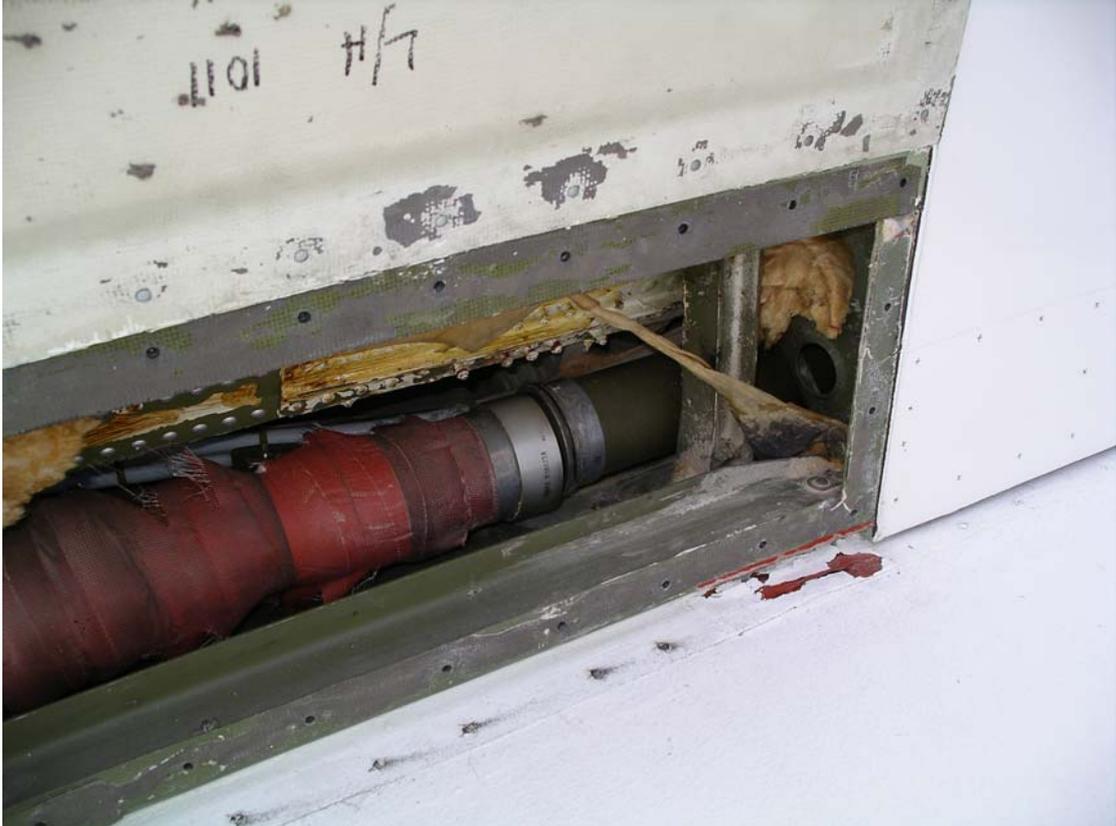
Picture 2

- A visual check, given restricted access, in the area of the opened duct well, indicated no obvious damage, apart from slight paint damage. In particular, the insulation blankets were not damaged by the escaping hot air (Pictures 2 and 3).

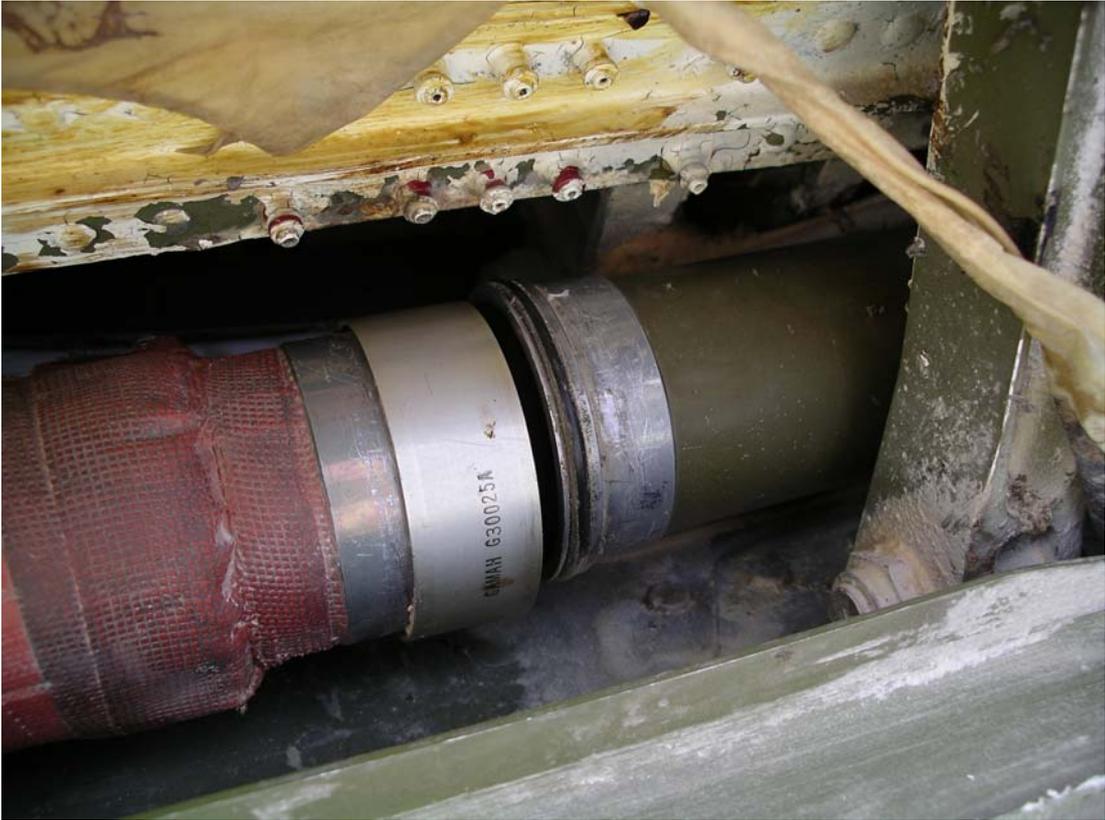
Picture 3

- As a result of this clamp breaking, the two sections of the wing anti-ice duct, which carry hot bleed air from the left engine compressor to the leading edge of the left wing, became separated (Picture 3).

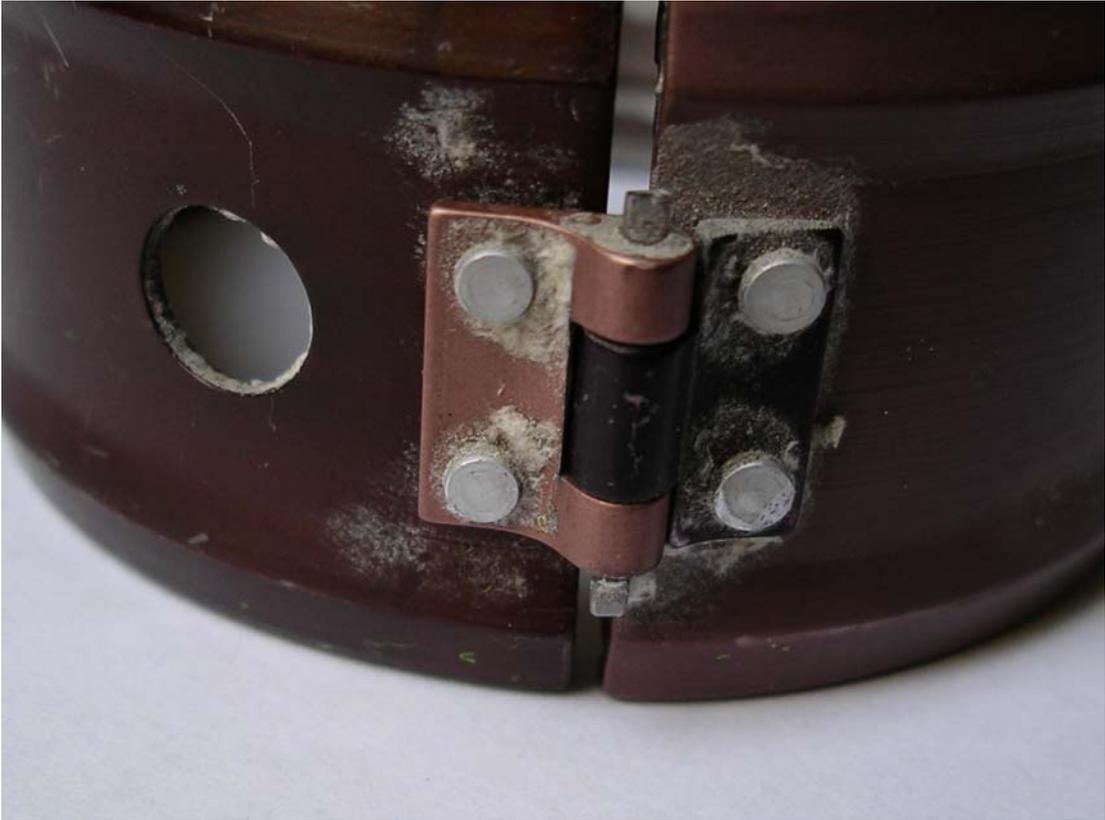
Picture 5

The clamp (Gamah P/N CA-33025) was subjected to exhaustive testing. In particular, a microscopic examination was carried out with the objective of determining the reason for the failure of the two rivets (Pictures 5 and 6). The following summary is taken from the corresponding test report:

"By means of tests on two broken aluminium rivets, it is apparent that both rivets failed primarily as a result of intercrystalline corrosion. Stress lines present on one fracture surface (rivet 1b) permit the conclusion that a further mechanism, fatigue fracture, is also involved, in addition to the damage due to corrosion. However, this can be assessed as consequential damage due to notches caused by corrosion. The metallography revealed the existence of a uniform, fine-grained matrix. The static forces acting on the rivets may be classified as low, as the residual force fracture surface elements are very small.

Knowledge of the rivet alloy used is essential in order to adequately clarify and analyse the cause of the damage and prevent it in future. From measurements using EDX, it can be assumed that the rivets were manufactured from self-hardening AlMg5. AlMg materials (Mg content >3%) have a tendency to suffer intercrystalline corrosion if a defect or unfavourable matrix condition is established. This may occur as a result of incorrect heat treatment during production, or at high temperatures during operation. For example, if the cold-worked material contains oversaturated dissolved magnesium, at temperatures of 100 to 200°C this precipitates out within a relatively short time as Al₈Mg₅ (β phase) at the grain boundaries. Since this inter-metallic bond is more reactive than the matrix, it will be favourably attacked under corrosive conditions, when the precipitates along the grain boundaries form a cohesive edge.

In the present case, the onset of the matrix state conducive to corrosion presumably occurred during operation, due to high temperatures. As a result of unfavourable ambient conditions, such as condensation, for example, corrosion progressed along the grain boundaries. It is therefore recommended that the rivets be monitored within the periodic maintenance framework."
