AAIU Report No. 2001-006

Name of Operator:	World Airways
Aircraft Type and Registration:	MD-11, N-272 WA
No. and Type of Engines:	Three, P&W PW 4462
Aircraft Serial Number:	48437
Year of Manufacture:	1993
Date and Time (UTC):	18 September 1999, 0524 hours
Location:	Shannon Airport, Co. Clare
Type of Flight:	Public Transport - Passenger
Persons on Board:	Crew - 14 Passengers - 317
Injuries:	Crew - Nil Passengers - Nil
Nature of Damage:	Minor Damage to Right Main Wheel Tyres
Commanders Licence:	Airline Transport Pilot (FAA)
Commanders Age:	52 years
Commanders Flying Experience:	8307 hours (incl 2672 hours as Captain on type) Last 90 days - 150 hours Last 28 days - 78 hours Last 24 hours - 5.3 hours
Information Source	ATC Watch Manager, Shannon Airport. AAIU Field Investigation.

VISUAL REPRESENTATION OF LANDING OF MD-11 N-272WA ON RUNWAY 24/06 AT SHANNON 18 SEPT 1999

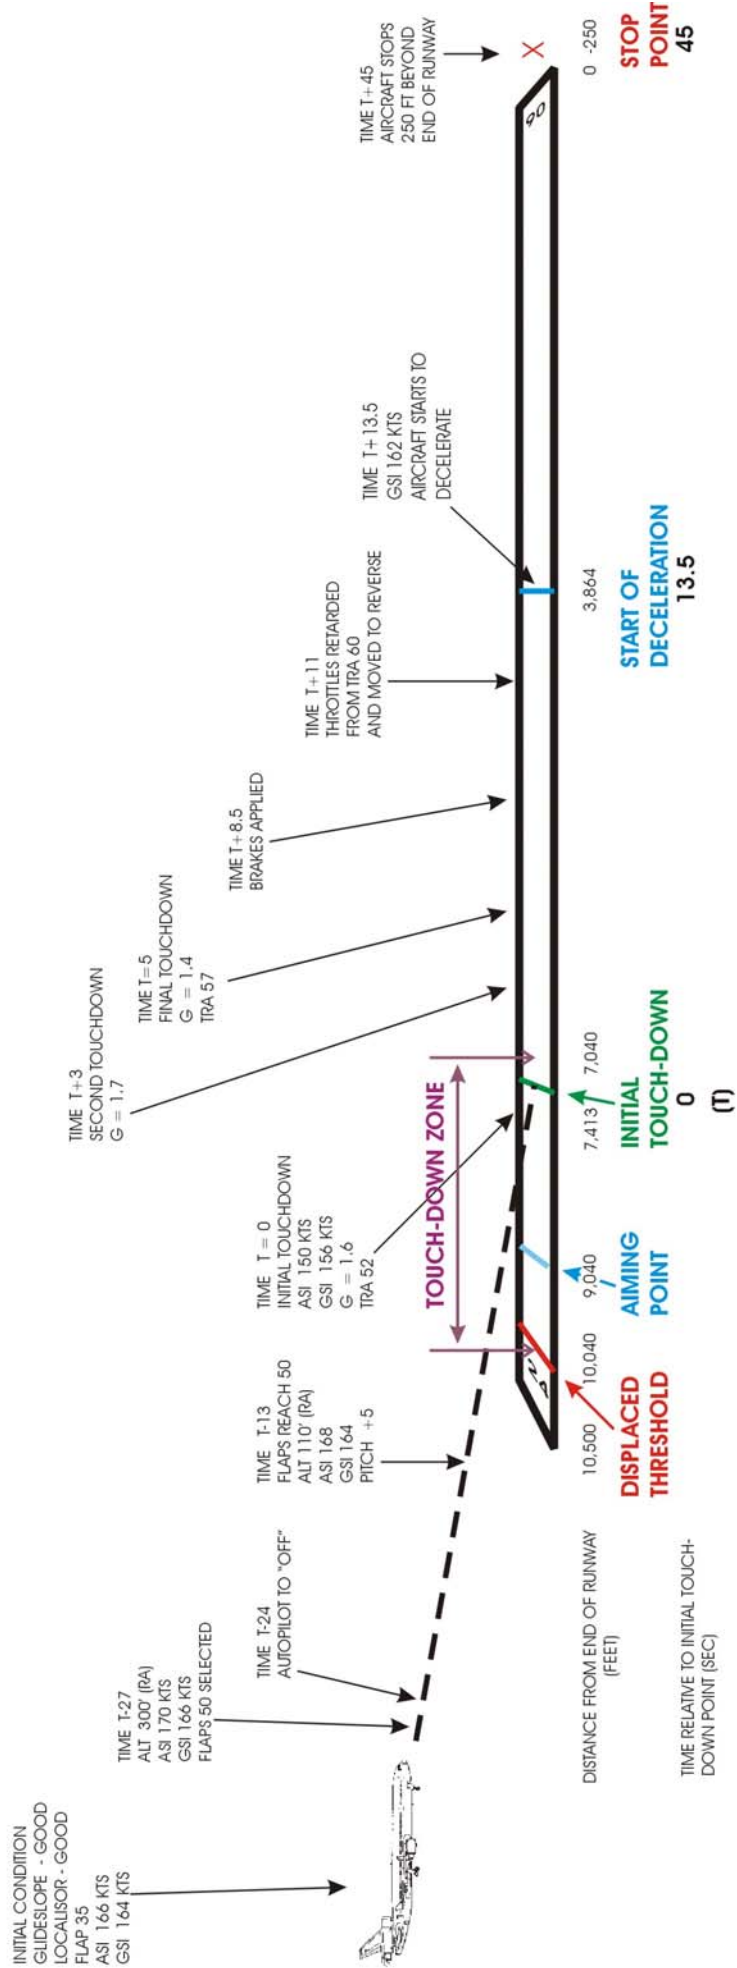
- a. the late selection of 50° flap,
- b. the threshold airspeed of 162 kt
- c. touchdown 1,600 ft past the normal 1000 ft touch down point
- d. application of power during the initial touchdown and landing roll; and
- e. the non-deployment of the ground spoilers which, in turn, precluded the use of the autobrakes.

- 3.13** The automatic ground spoilers system (AGS) which was armed during the approach did not deploy during the landing. This was caused by the advancement of the throttles during the touch down phase.
