*Serious incident on  
23 November 1997  
on approach to Orly (94)  
to the McDonnell Douglas MD83  
registered F-GRMC  
operated by AOM Minerve S.A*

**REPORT**  
**Translation**  
**f-mc971123a**

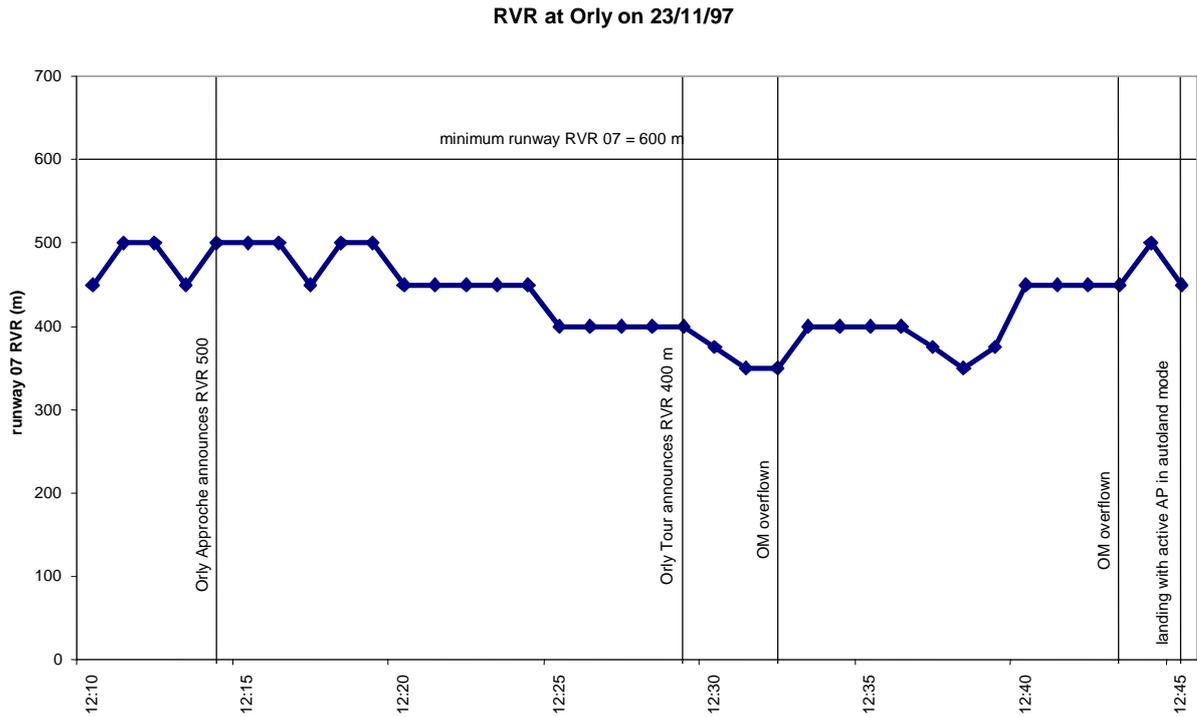
Figure 3

The runway 07 RVR figures are shown in the chart below. The crew's operational minima, overflight time at the Outer Marker and landing time and the times when ATC communicated the RVR figures are also shown.

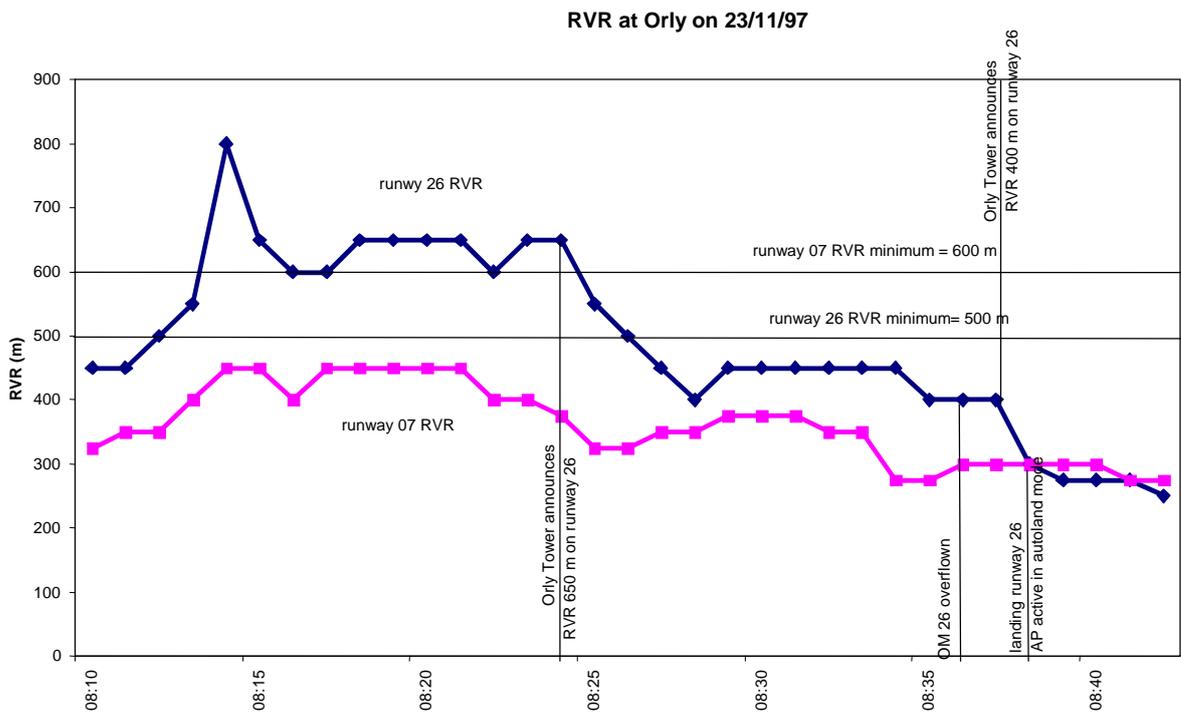
Figure 4

The RVR's recorded at Orly at the time of the morning Toulon-Orly flight are shown in the following chart. The crew's operational minima are also shown.

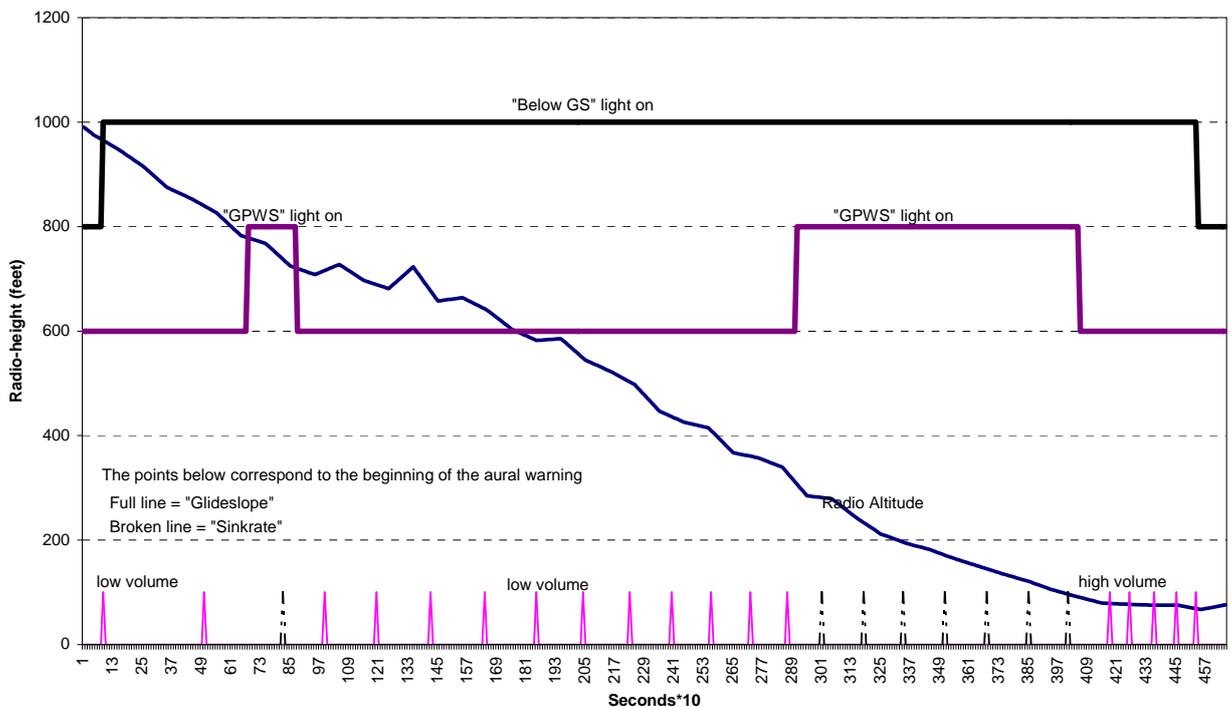
Figure 9

In May 1998 Allied Signal, at the request of the BEA, carried out a simulation of GPWS MK VII warnings using data from the flight. The results of this simulation were as follows:

The warnings which appeared are of the "Low Volume Glideslope", "Sinkrate", and "High Volume Glideslope" type. The times when the "Glideslope" and "Warning" lights came on during the simulation correspond to the respective times when the "Glideslope" and "Terrain" warnings were recorded on the QAR.

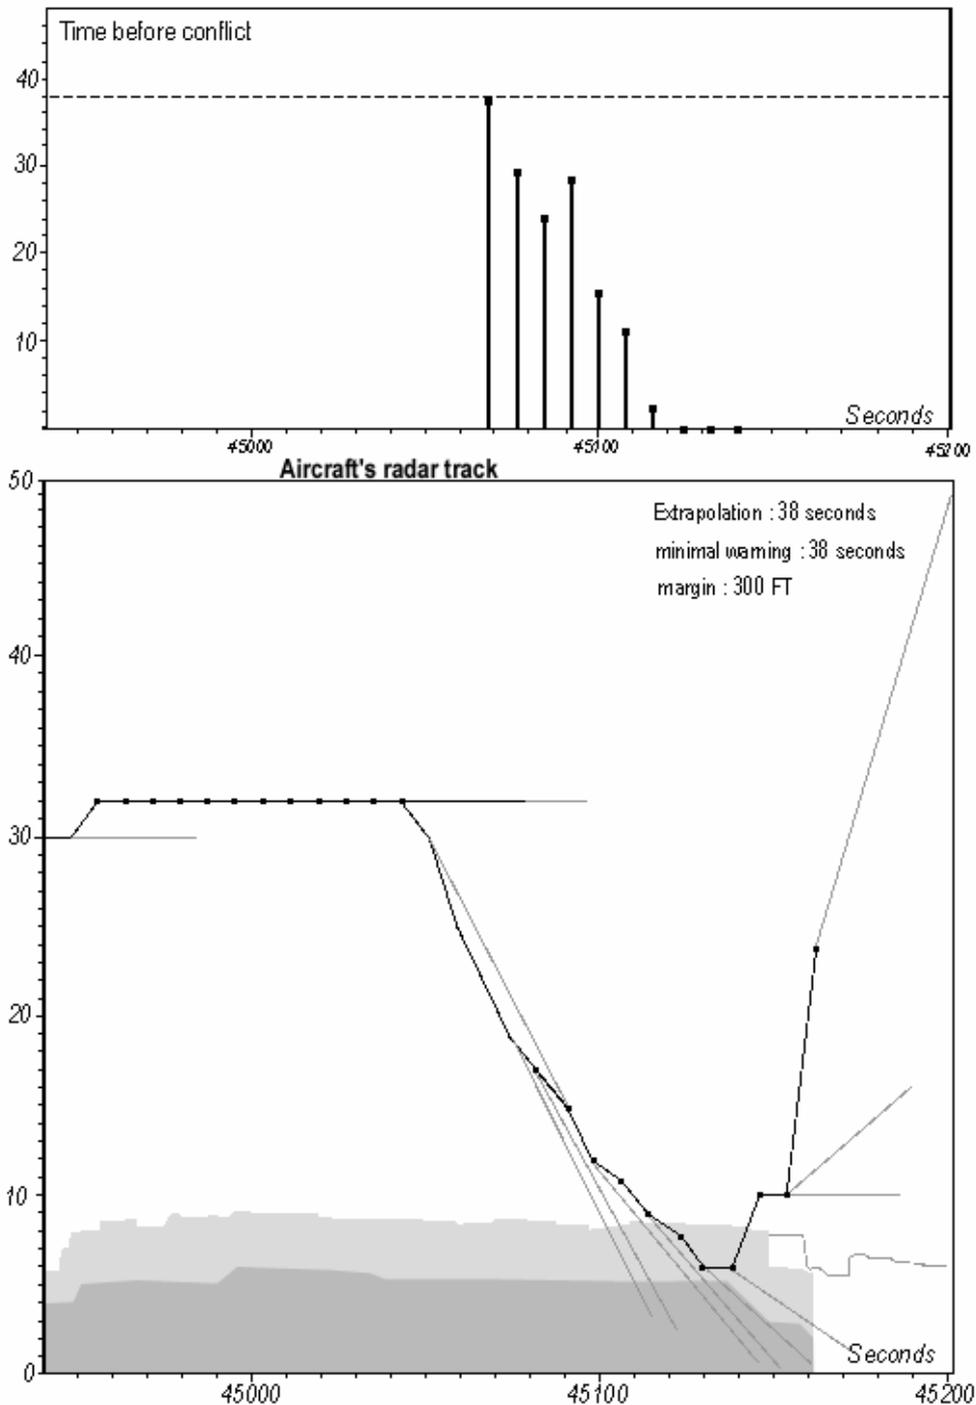
Figure 10

radar data, warns the controller in case the airplane's proximity to the ground is judged too dangerous. At the request of the BEA, the CENA (Centre d'Etude de la Navigation Aérienne) performed a simulation of the MSAW functions based on the Rheims radar recording. Parameters identical to those used at Lyon Satolas were used since this system is not installed at Orly. The vertical speed had to be estimated, since it was not available on the radar recordings.

In the simulation report, the CENA concluded: "Supposing a correct Vz STR (accurate estimate of the vertical speed) the MSAW warning could have been transmitted to the controller at 12 h 31 min 24 s. Allowing time for the controller's

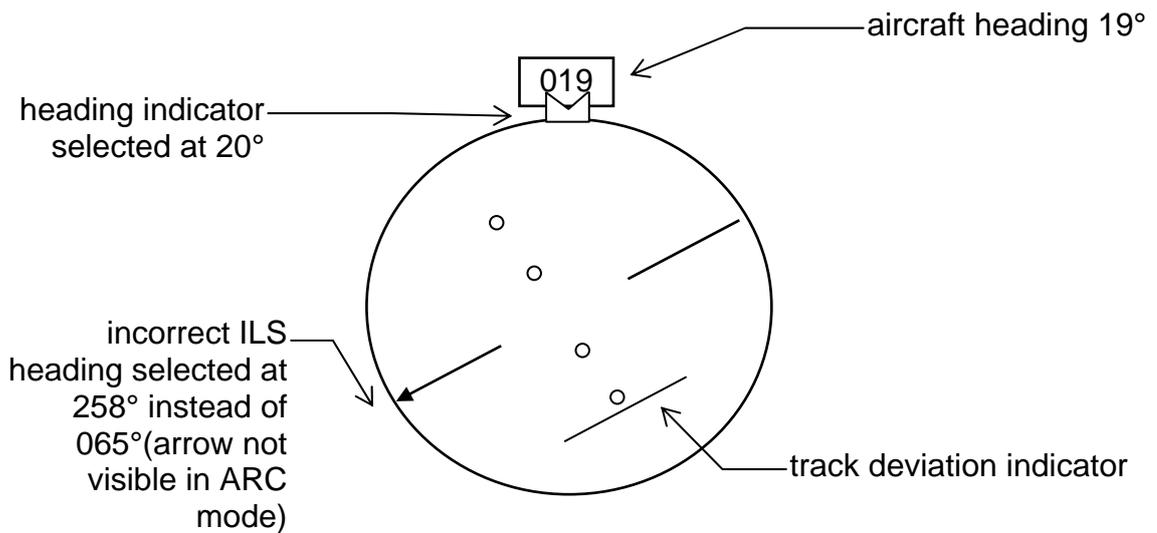
At 12 h 29 min 36s, intercepting the runway 07 ILS, the runway line-up deviation indicator began to move. A simplified representation of the Captain's HSI would show (the HSI is shown throughout in "ROSE" mode for more legibility):

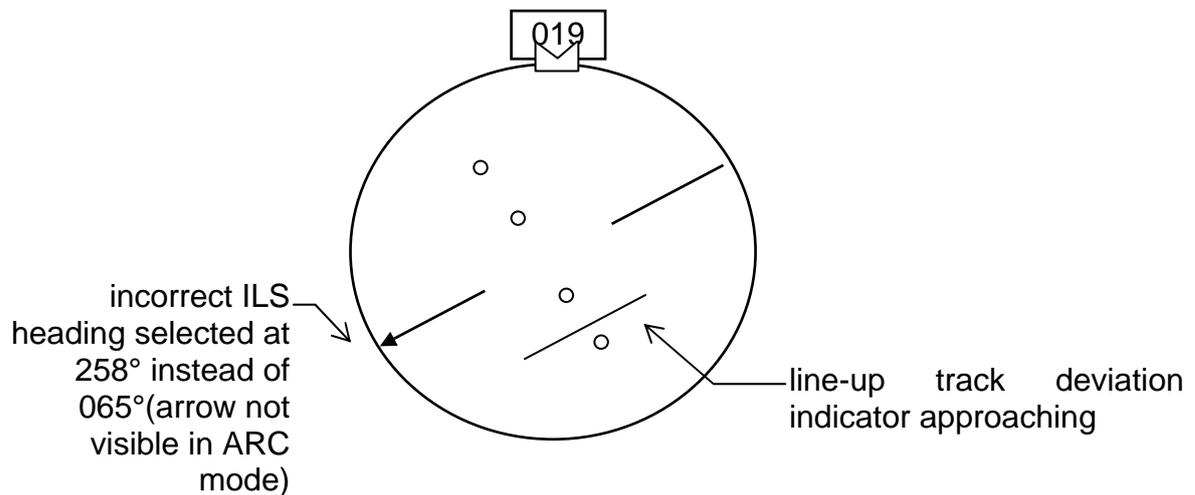
At 12 h 29 min 43 s, the LOC capture mode was displayed on the FMA. At that moment, a simplified representation of the Captain's HSI would show:

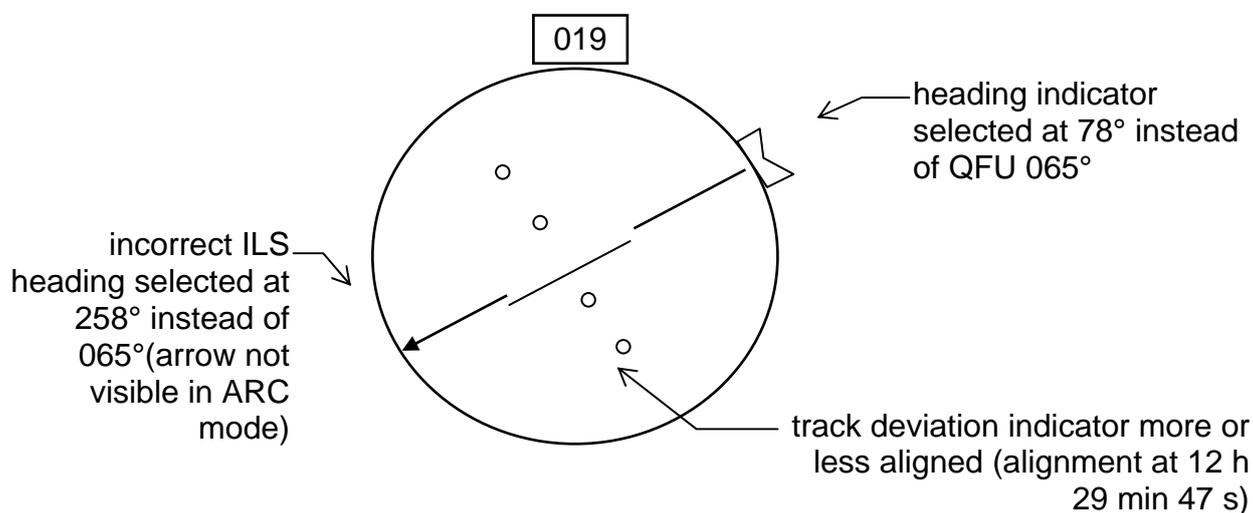
The Captain believed he was bringing the heading indicator up in line with the head of the ILS indicator arrow, but in fact he was he was bringing it to the tail of the ILS. He then noticed that the heading indicated 78° whereas he expected the QFU of runway 07. He tried to understand the difference between the expected heading and the displayed heading, which increased his workload. From this moment on, he was working alone. The co-pilot, who was no longer informed of the situation, could no longer understand the Captain's actions. A simplified representation of the Captain's HSI would show:

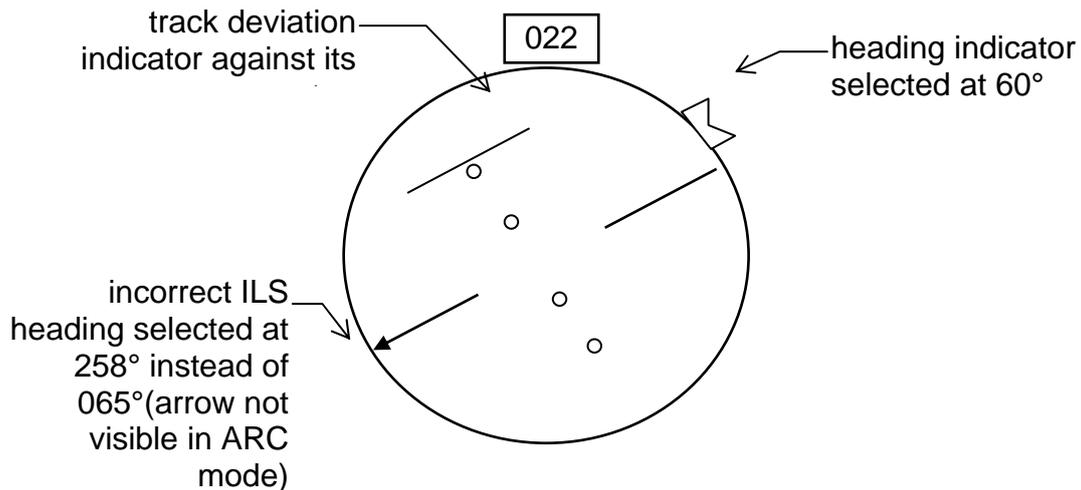
At 12 h 29 min 57 s, the track deviation indicator reached its stop. Two seconds later, the Captain selected a heading of 60° on the DFGS, probably to return

towards the localizer track which he believed to be to the left, with a heading close to the approach track. In fact, he still had not realized that the tip of the ILS heading selection arrow was pointing more or less 180° away from the ILS heading. In this configuration, the localizer track was displayed on the left on the HSI. This selection caused disarming of the "Autoland" mode, and replaced the "LOC CAPTURE" mode with "HEADING" mode. Note that if the Captain had not selected any heading, the airplane would have continued on a constant bearing without ever intercepting the localizer track. A simplified representation of the Captain's HSI would show:

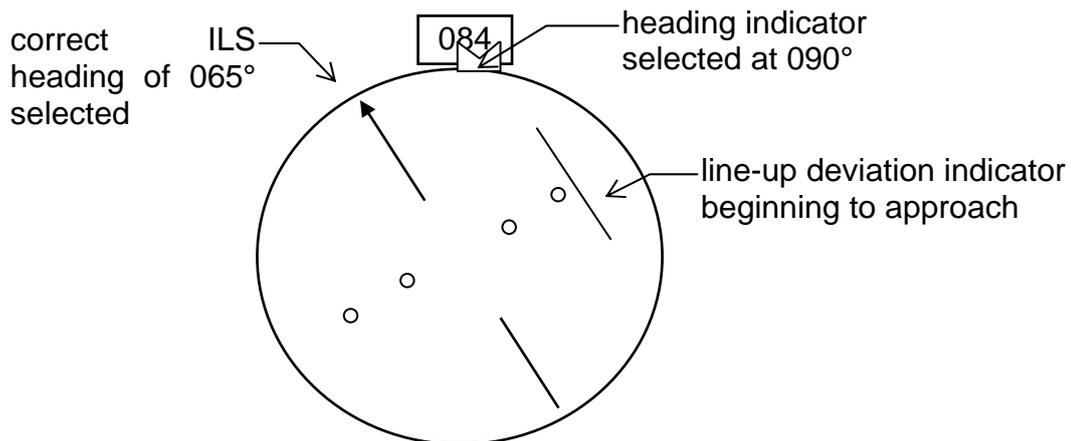
At 12 h 31 min 30 s, the airplane descended through 1,250 feet QNH and the altitude alarm triggered again and was superimposed on the GPWS alarm. It was not cancelled by the crew, and continued to sound until the airplane reached 1 250 feet QNH in climb after the go around. At 12 h 31 min 30 s, the "LOC capture" mode was displayed on the FMA and the localizer beacon indicator, until then at its stop to the right, began to move. The flight director, which was centred until that time, then indicated to the pilot the trajectory to follow to rejoin the localizer track. The Captain turned the airplane left to intercept the approach track:
