TECHNICAL REPORT

A-035/1998

Accident of aircraft Fairchild SA-227-AC "Metro III", registration number EC-FXD, in the municipal area of El Prat de Llobregat (Barcelona), on 28th July, 1998
(Issue 2)

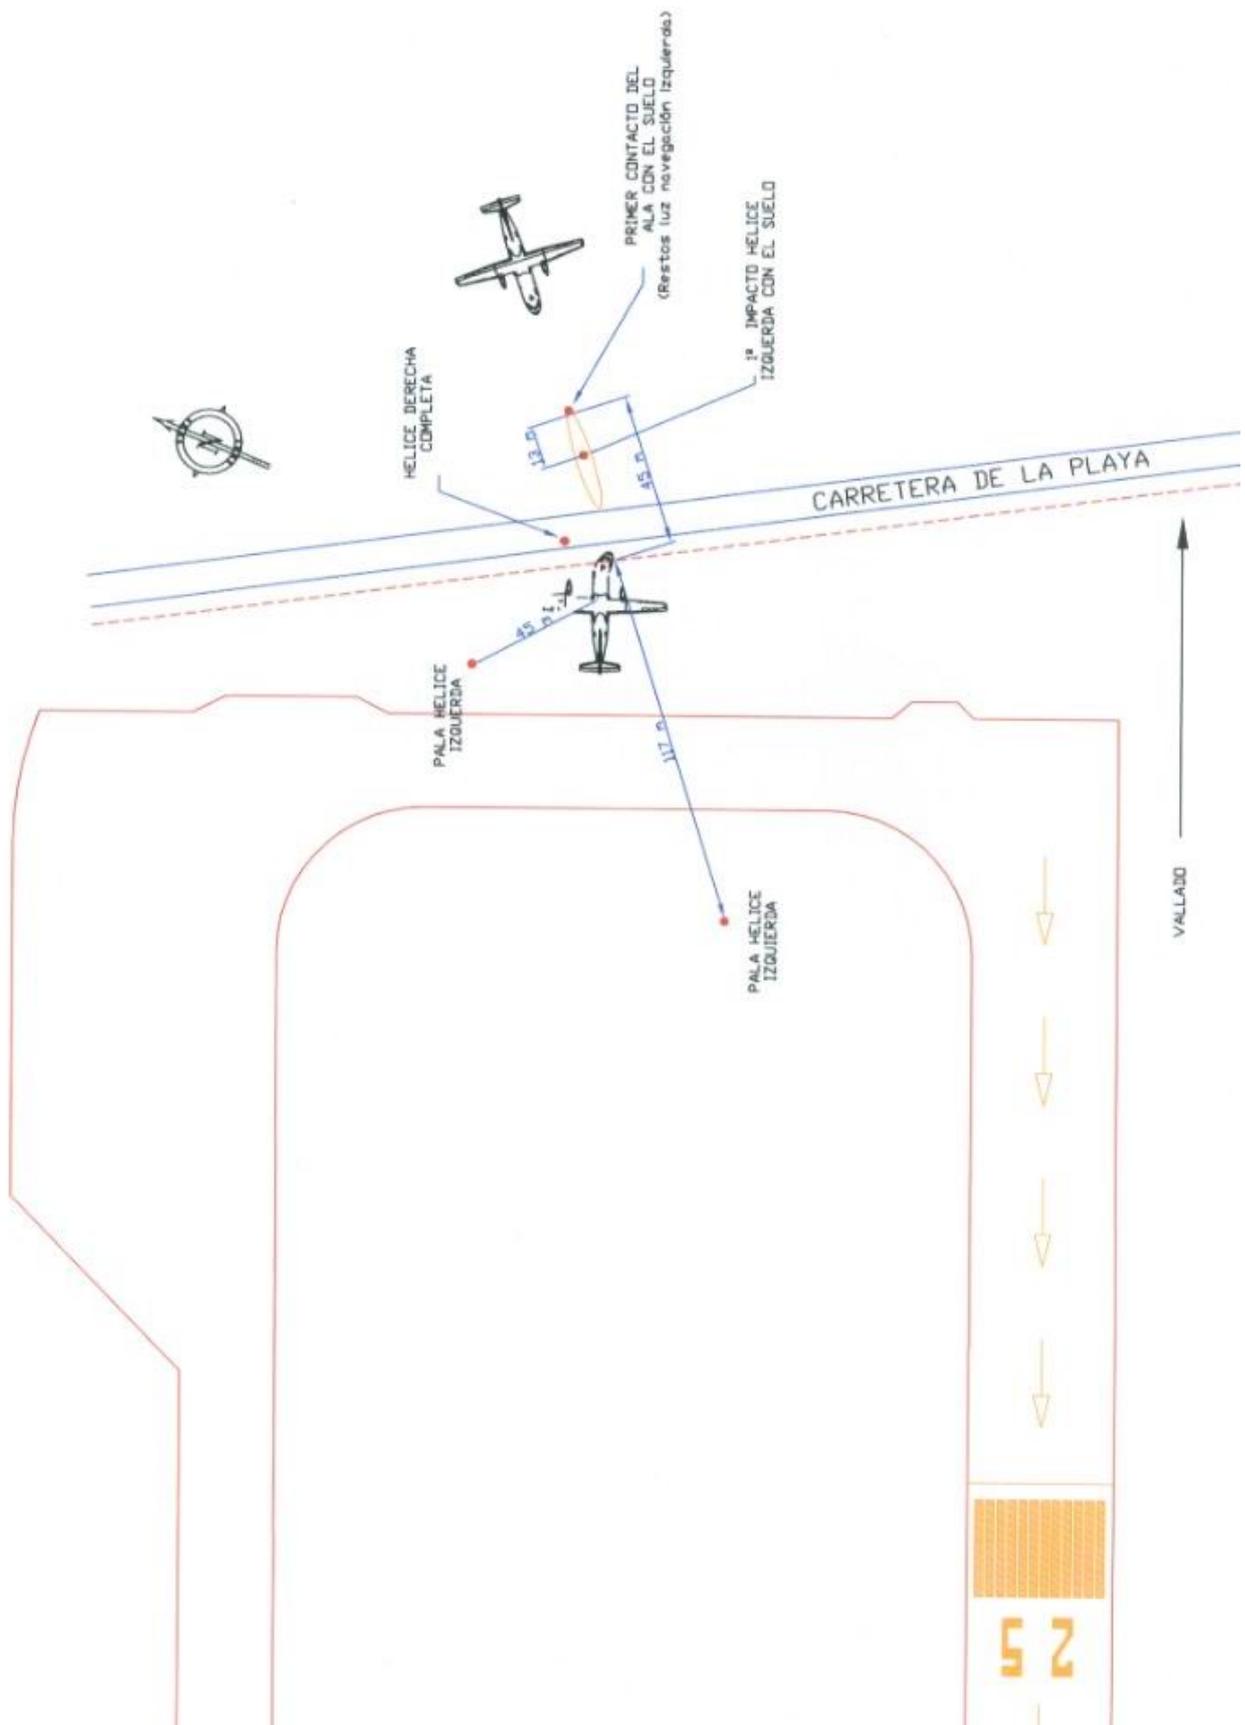
DIAGRAM OF WRECKAGE

The fuselage was caught up against the airport perimetral fence, on the inside, and with a course of some 20°, that is, about 130° to the right of the course of runway 25 (248°). The front part of the fuselage, in a length of approximately one-third of the aircraft's total length, was completely wrecked and burnt. The fuselage was rolled to the left and supported on the remains of part of the left wing, which did not come off after the first crash into the outside fence of the highway. The right wing was intact, although it had come away from the fuselage and was twisted around its longitudinal axis.

The right propeller appeared complete, with the four blades joined to the hub which, in turn, was found covered by the dome. It was close to the outside of the airport barrier, some 8 m in front and some 6 m to the left of the right engine mounting wreckage. The four blades had suffered heavy torsion and bending stresses.

The right leg of the main undercarriage appeared joined to its housing in the right nacelle and in what appeared to be an extended and locked position. The left leg had come loose from its fastening to the left half-wing and was resting some 3 m behind it. The nose landing gear was completely destroyed and burnt.

There were signs of a first contact with the ground at some 45 m from where the fuselage was found, on the other side of the highway, where remains of the left navigation light were found. Then, at some 13 m, there were signs of what appeared to be the first impact of the left propeller. The aircraft continued to go forward, dragging the left wing along the ground, where there were marks including signs of fire right from that first moment. In its path the aircraft broke a section some 30 m wide of the outside barrier of the highway, probably crossed it in a level position, until it broke the airport enclosing barrier and concrete wall and turned round on itself to end up in the position indicated above, facing the highway.

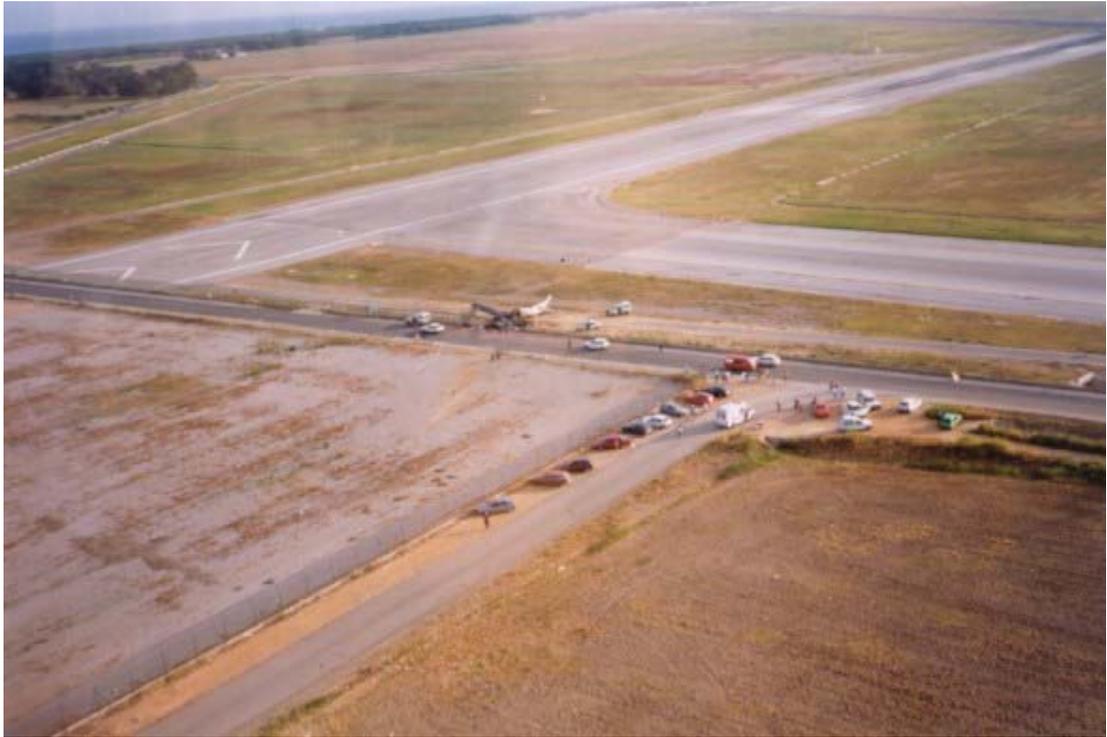
Photo 1.- Aerial view of the accident from the right

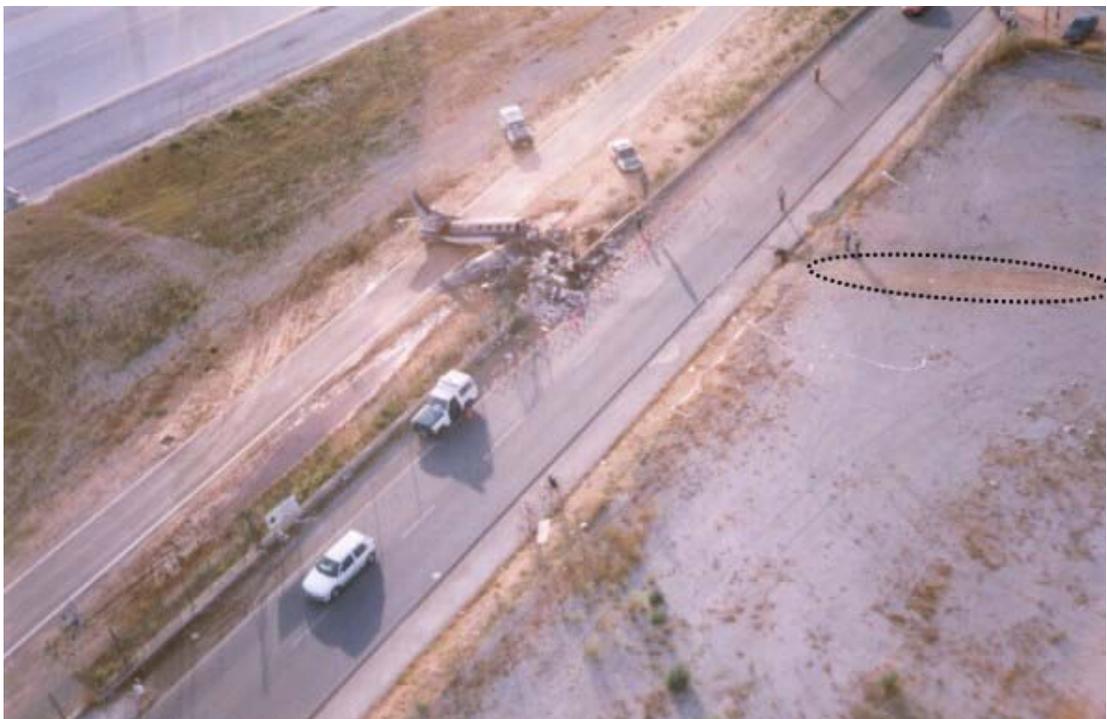
Photo 2. Aerial view from the left

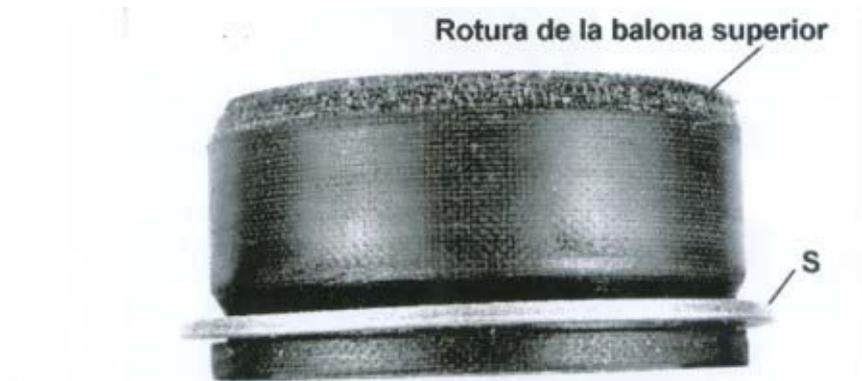
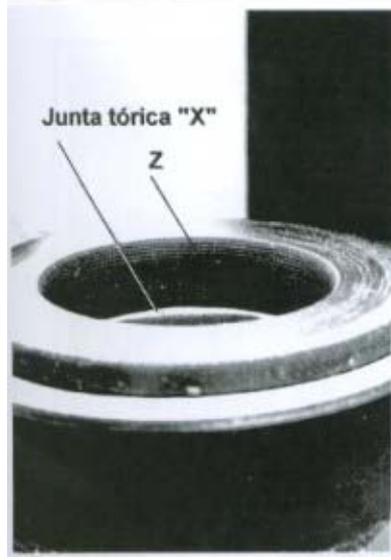
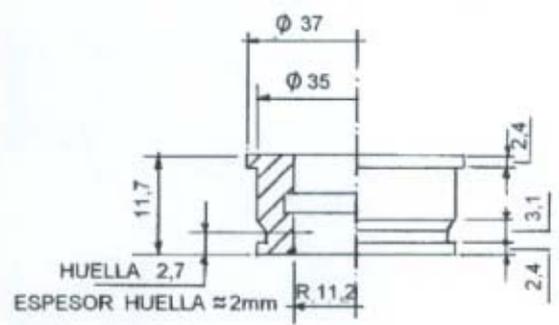
Figure 4. Photo and sketch of bushing B

Consequently, the **primary failure** of the mechanical device of the pitch control system located inside the propeller was the seizing between the connection rod of the pitch varying mechanism's piston and that rod's guiding bushing, with the direct consequence of the shearing of the bushing's upper flange and the displacement of the bushing from its housing in the hub cap. This failure occurred in a phase of the in-flight feathering, voluntary or involuntary, and can be considered as the primary failure of the entire system if there were no other previous failures of the pitch control system that could have produced the movement of the propeller towards feather in an unintentional way.

The determining factors of the incorrect behaviour of sliding between the rod and the bushing could be mechanical in origin (basically inadequate play or tolerances) or defective lubrication. In order to evaluate the first type factors, it is needed the verification of the involved elements and its comparison with the technical data of the corresponding documentation.
