Missed Assessment

Tired pilots neglected to perform a required review before landing.

This article is based on NTSB Accident Report NTSB/AAR-08/02: *Runway Overrun During Landing; Pinnacle Airlines Flight 4712; Bombardier/Canadair Regional Jet CL600-2B19, N8905F; Traverse City, Michigan; April 12, 2007.*

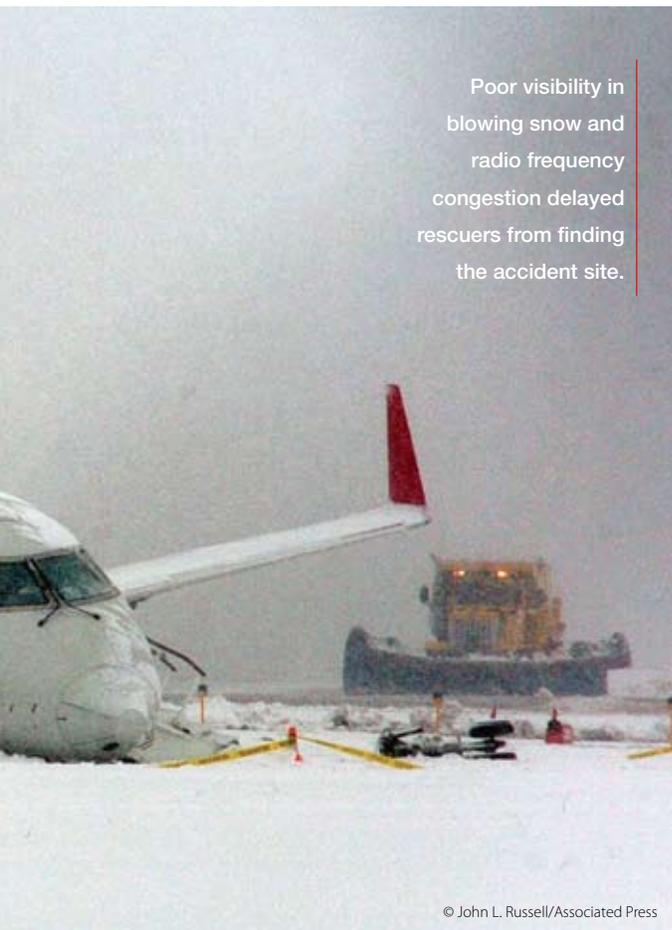
Poor visibility in blowing snow and radio frequency congestion delayed rescuers from finding the accident site.
