Noncompliance With Instrument Approach Procedures Cited in King Air CFIT Accident in Australia

The report said that dark night conditions during the emergency medical services positioning flight also were a significant factor in the fatal controlled-flight-into-terrain accident.

—
FSF Editorial Staff

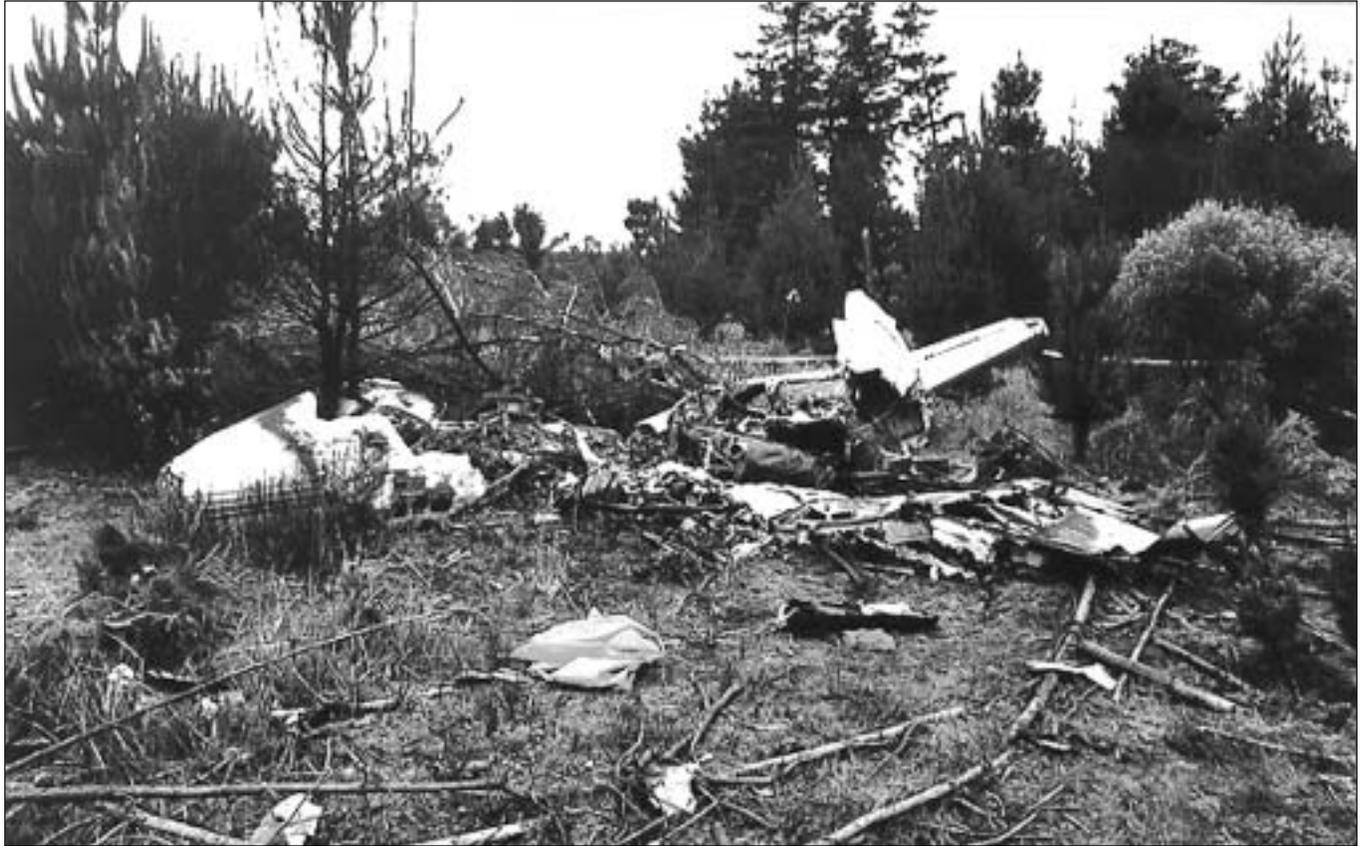
Wreckage of the accident airplane was found right of the Runway 18 extended centerline, “with a deviation to the right of about five [degrees] to 10 degrees,” the report said. The airplane struck the ground in a nose-low attitude, with the right wing slightly low; the landing gear had been extended, and the flaps had been extended to the approach configuration. Because of impact damage and fire damage, no information was obtained from cockpit instruments or flight control positions.

The report said that damage to the trees in the approach path indicated that the airplane’s approach angle had been about 10 [degrees] to 13 degrees.

The Raytheon Beech Super King Air 200C struck the ground 3.1 nautical miles (5.7 kilometers) from Runway 18 at the Mount Gambier airport. (Source: Australian Transport Safety Bureau)
