Improper Loading of Cargo Causes Loss of Aircraft Control on Approach

The Fokker F27 pitched nose-up when the flight crew extended full flaps on final approach. The crew did not regain control, and the aircraft stalled and struck the ground. The accident report said that the aircraft's center of gravity was "significantly aft" of the approved limit.

At 1706 local time Jan. 12, 1999, a Fokker F27-600 operated on a cargo flight by Channel Express struck the ground after the flight crew lost control of the aircraft on approach to Guernsey Airport, Channel Islands, United Kingdom. Both pilots were killed, and the aircraft was destroyed.

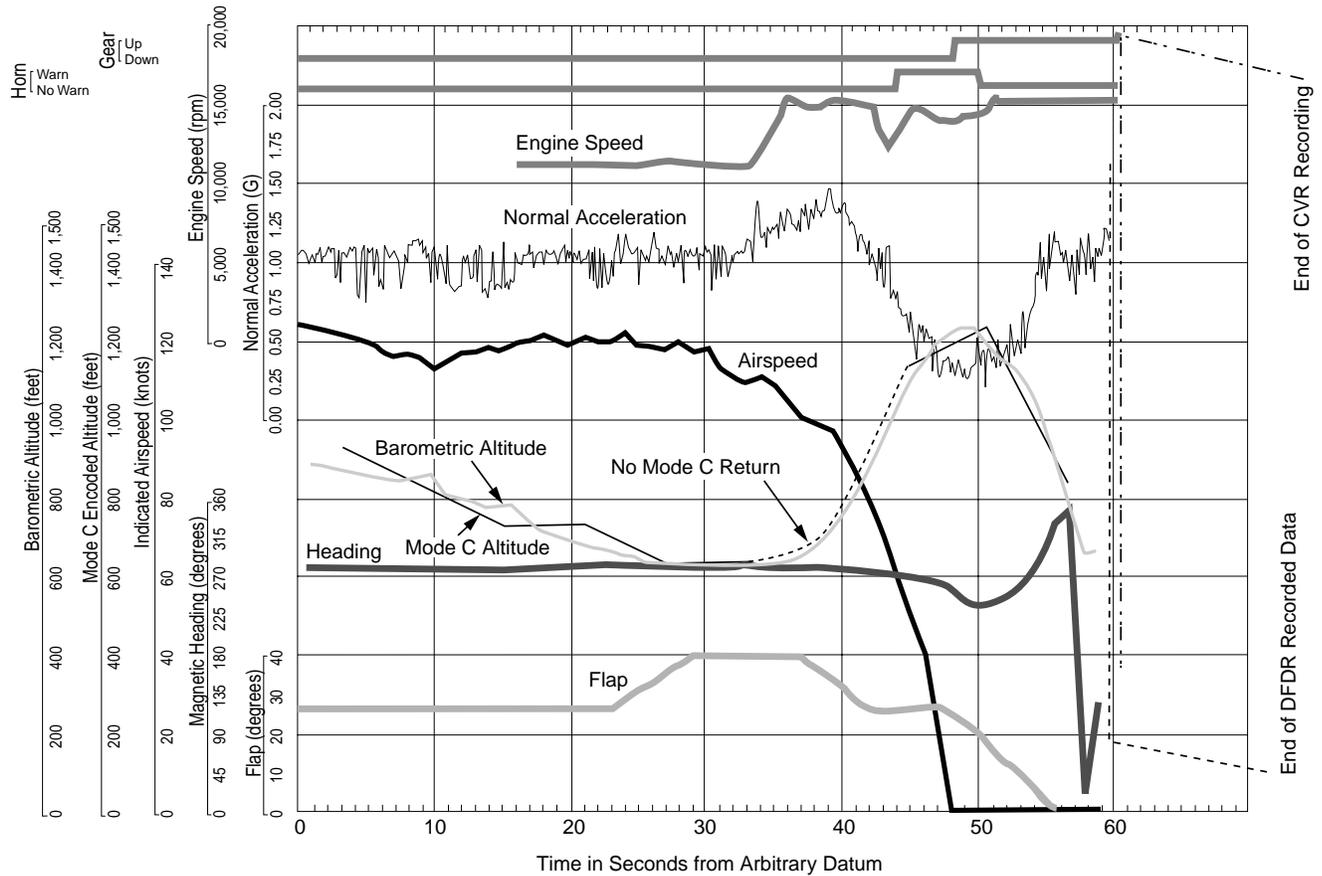
Figure 1 shows aircraft parameters correlated from the aircraft’s digital flight data recorder (DFDR) and cockpit voice recorder (CVR) for the last 60 seconds of the flight.

The aircraft was at 650 feet (approximately 300 feet above ground level) when the commander said, “OK, the decision is to land. Speed [is] below one four four [knots]. Flaps forty.”

The first officer acknowledged the instruction and said “running.” About five seconds later, the first officer said, “Flaps forty, gear and clearance you have — oops.”

“The commander then said, in an anxious tone of voice, ‘OK, flaps twenty-six,’ and the engines could be heard accelerating on the cockpit voice recording,” the report said.

The commander applied full engine power. Airspeed decreased below 97 knots as the aircraft began to climb.

“Normal acceleration reached a peak of 1.5 G,” the report said. “The aircraft continued to climb [and] reduce airspeed, and the normal acceleration readings started to decrease. The aircraft also started to turn to the left.

“As [the aircraft] climbed through 1,000 feet with an airspeed of 70 knots, engine power was reduced. One and a half seconds later, at approximately 55 knots and 1,100 feet, a continuous warning horn was heard in the cockpit.”

The report said that DFDR data and CVR data show that the warning horn sounded because airspeed was below 55 knots, the right power lever was below 14,000 rpm and propeller ground-fine pitch was not activated.

“Over the next four seconds, the aircraft climbed to a maximum altitude of 1,230 feet and airspeed decayed to zero; normal acceleration reduced to a minimum of 0.3 G, and the aircraft had turned left to 236 degrees,” said the report.

Correlated Flight Data Recorder Data and Cockpit Voice Recorder Data, Fokker F27-600, Near Guernsey Airport, Channel Islands, U.K., Jan. 12, 1999
