Engine-intake Icing Sets Stage for Ditching of Shorts 360 During Cargo Flight

Snow likely entered unprotected engine air intakes when the twin-turboprop airplane was parked overnight facing into strong surface winds. Intake-airflow disruption resulting from the crew's selection of the intake anti-icing vanes during departure caused nearly simultaneous flameouts of both engines.

[FSF editorial note: This article, except where specifically noted, is based on the U.K. Air Accidents Investigation Branch report no. 2/2003 (EW/C2001/2/6): *Shorts SD3-60, G-BNMT, near Edinburgh Airport on 27 February 2001*. The 91-page report contains illustrations and appendixes.]

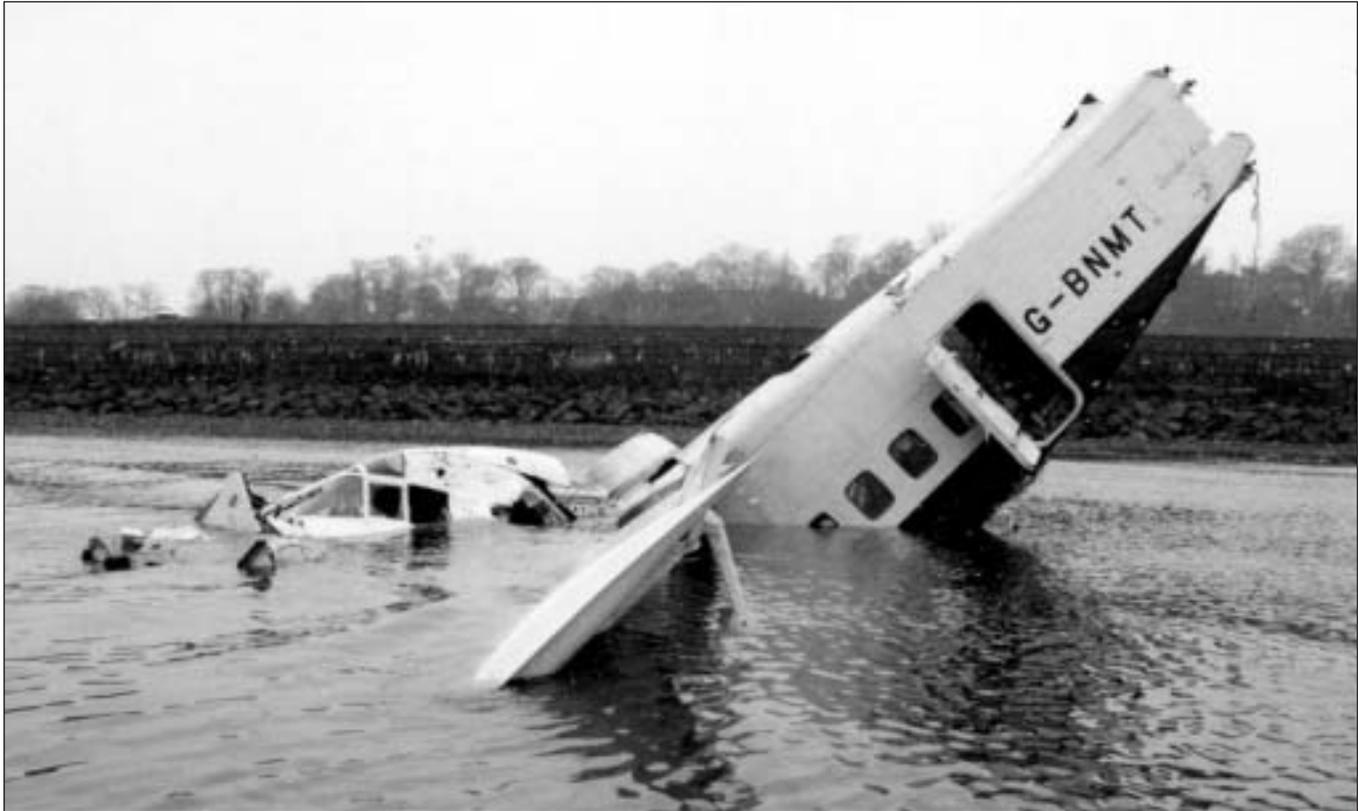
When investigators arrived at the accident site, the tide had receded and the airplane was only partly submerged in seawater.
(Photo: U.K. Air Accidents Investigation Branch)

“It came to rest on the sea bottom in a nose-down attitude with the forward section of the fuselage submerged, 65 meters [213 feet] offshore, in a water depth of about six meters [20 feet],” the report said.
