Final Accident Report

Accident involving Sudan Airways Airbus 310

Registration ST-ATN

At Khartoum Airport

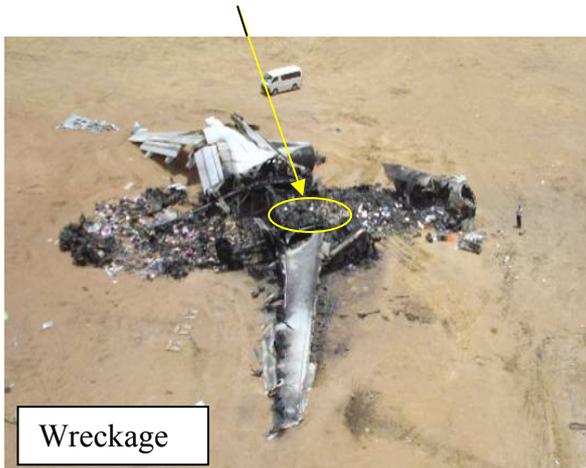
The main part of the fuselage was severely burnt. Wreckage examination showed that:

- The bottom and top skins of the wing box structure fractured at the main right gear attachment area. This assembly rotated forward and down, with the top of the assembly (top of landing gear) in contact with the ground.
- The main fire area was between the right engine and the right wing root.

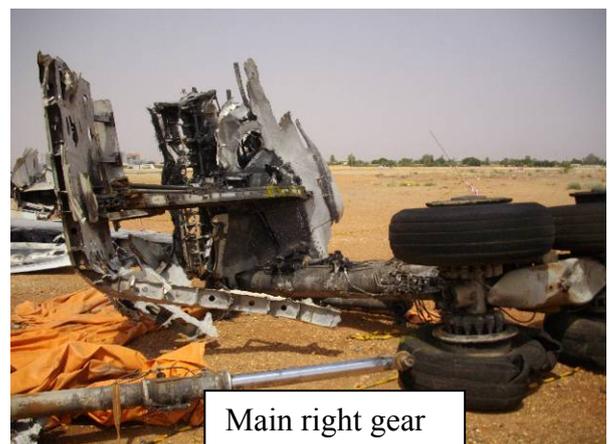
Main right gear

Investigations were done to determine the cause of the right landing gear collapse with a part of the wing still attached. The results were the following:

- The maximum loads recorded by the DFDR during the rollout were the following (refer to annex II) :
 - Vertical g: +2.36
 - Longitudinal g: +0.78
 - Lateral g: -0.67
- According to certification requirements, structure is designed to resist to combined accelerations values up to 9 g.
- The structure analysis allowed confirming that the rupture was not caused by fatigue.
- On site investigation and Captain interview confirm that during the overrun, the aircraft destroyed some lights and antennae. Some parts were ingested by engine 2. Since the thrust reverser was deployed, these parts may have been thrown to the right wing.
- According to the Captain, the aircraft was on its three gears when he left the aircraft. Consequently the right landing gear did not collapse when the aircraft stopped, but later on.

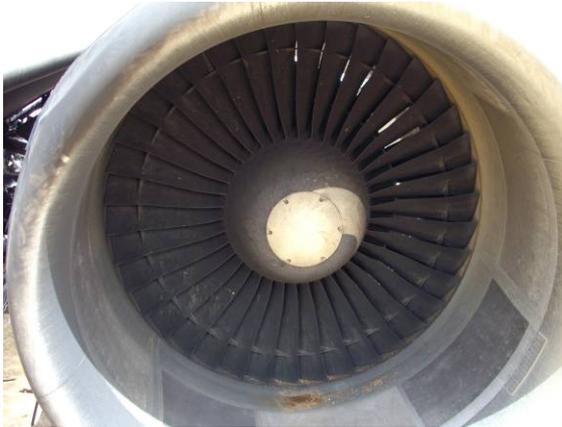
Engine 1 (LH)

Engine 1 thrust reverser was inspected to be stowed and de-activated.
 Engine 2 thrust reverser was inspected to be fully deployed.

Engine 1 did not show evidences of foreign objects ingestion.
Engine 2 fan blades condition was consistent with foreign object ingestion.

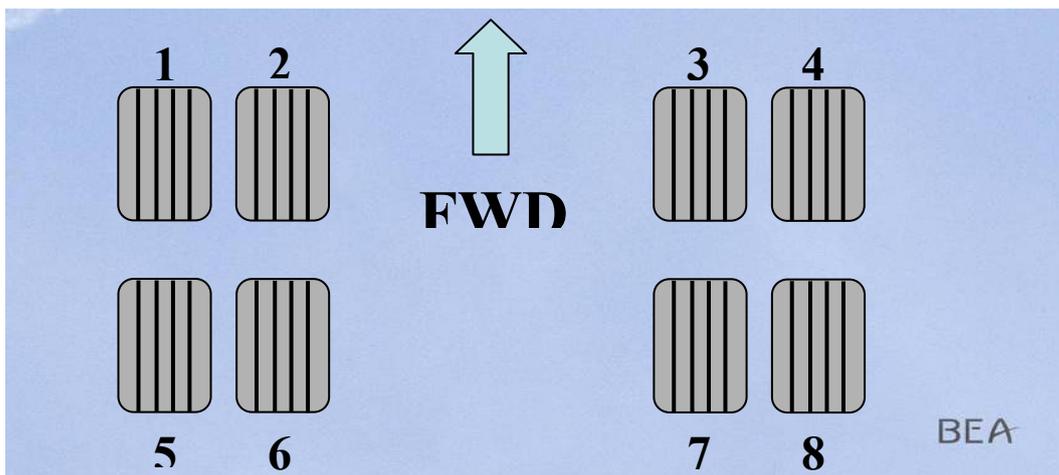
All tires including the Nose Landing gear ones were found installed on the wheels.

All tires of the two Main Landing Gears showed evidence of braking.

- “8 tires show flat spot on the tread. 7 of 8 tires have burst, only the tire #1 (LH MLG – left front tire) did not burst.
- The flat spot damages are the consequences of a locking of the wheels. So, the 8 wheels of the main landing gears were locked.
- There was no evidence of hydroplaning seen on the tires. In fact, in case of hydroplaning, the damages of the tires are typical of a tread rubber reversion. That kind of marks was not seen on the tires.
- The rim of the wheels do not show flat wear marks. That indicates the rim did not scrap on the runway.
- The LH MLG marks seen close to the runway threshold and to the end of the stabilized pavement (cp Airbus factual report) indicate that the tires of the LH MLG were not burst.”

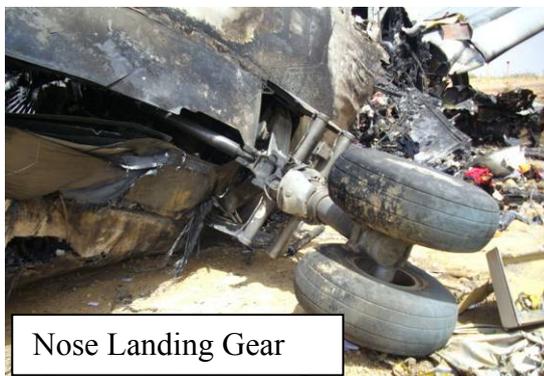
Nose Landing Gear did not collapse and was found few degrees turned to the right. Nose landing Gear down-locking indicator was found in down-locked position.

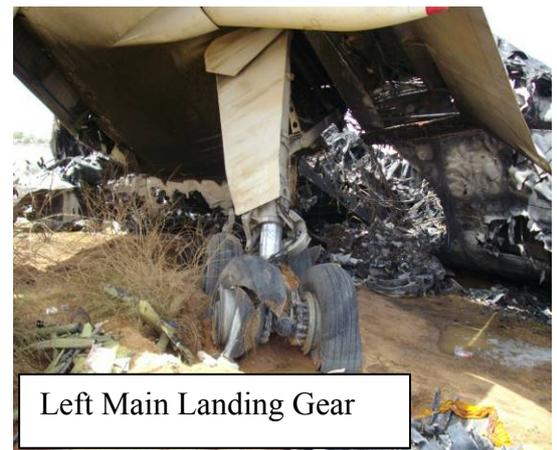
Left main landing gear

The front of the bogie was stuck on the ground. The bogie axle was aligned with the runway direction but not with the aircraft direction.

The torque link was broken. This indicated that aircraft pivoted around the left main landing gear when it stopped.

Shock absorber extension was measured (380 mm), indicating that it was not deflated.

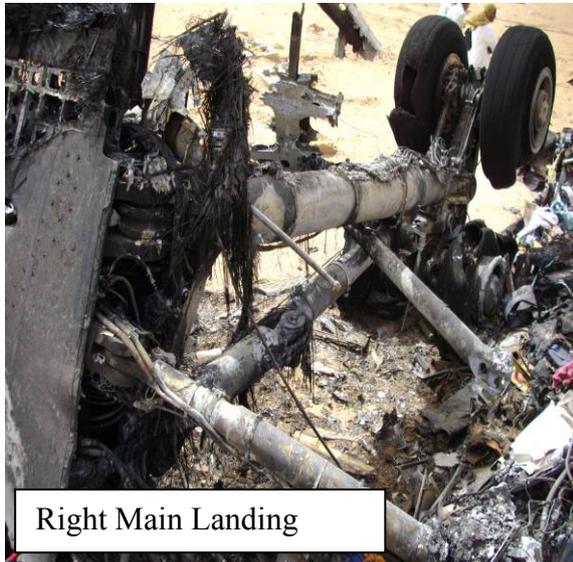
Right main landing gear

Main right undercarriage was attached to the wing box structure pieces.

The right brace strut and the brace strut actuating cylinder were found partially melt.

The cross brace was still attached to the Rib 5 but found separated from the structure area on the other side (brace strut side). The retraction actuator was found attached on both sides.

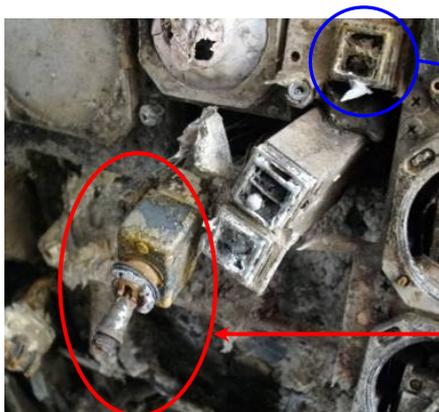
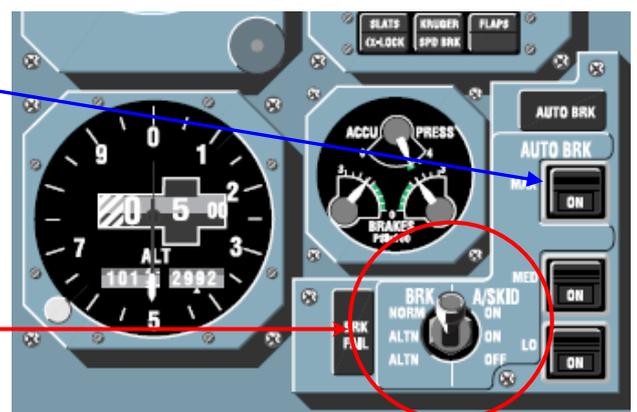
The “BRK A/SKID” lever (FIN 96GG) was found hanging from the 401VU panel, in the position indicated on the below picture. This position was consistent with the switch being set to “ALTN OFF” (Alternate braking / Anti skid off)

The 3 push buttons of AUTO BRK selection were severely damaged by fire.

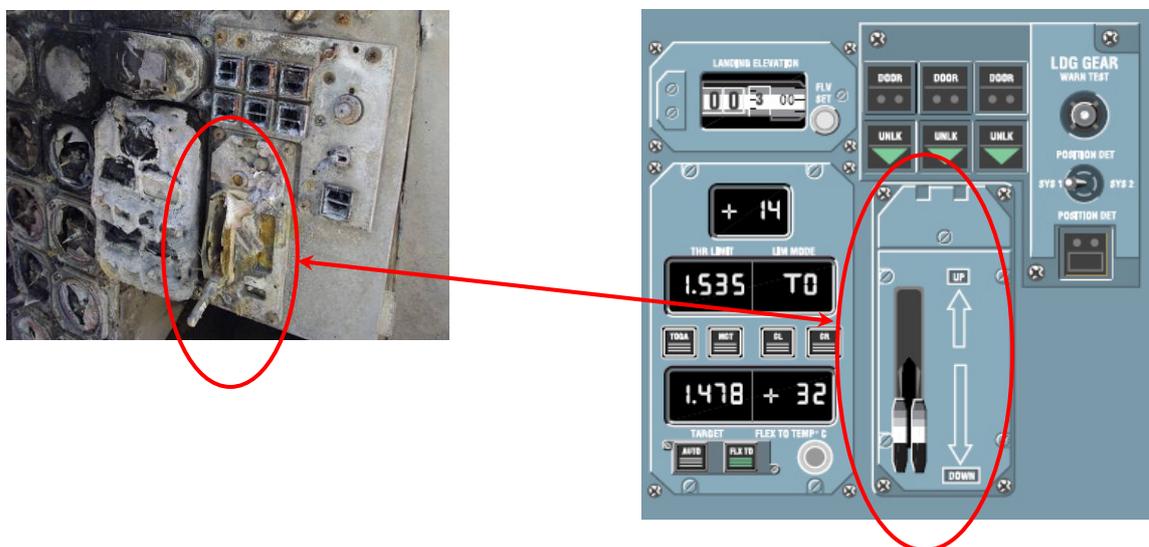
The Landing gear control handle was found in DOWN position:

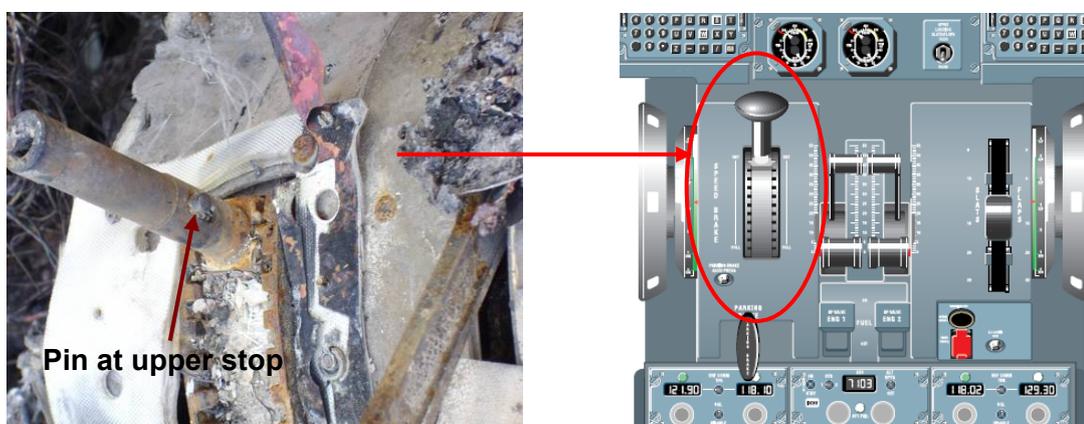
The speed brake/ground spoilers control lever, located at central pedestal, was damaged by fire, but the position of the pin at upper stop of its groove indicated that lever was in ARMED position.

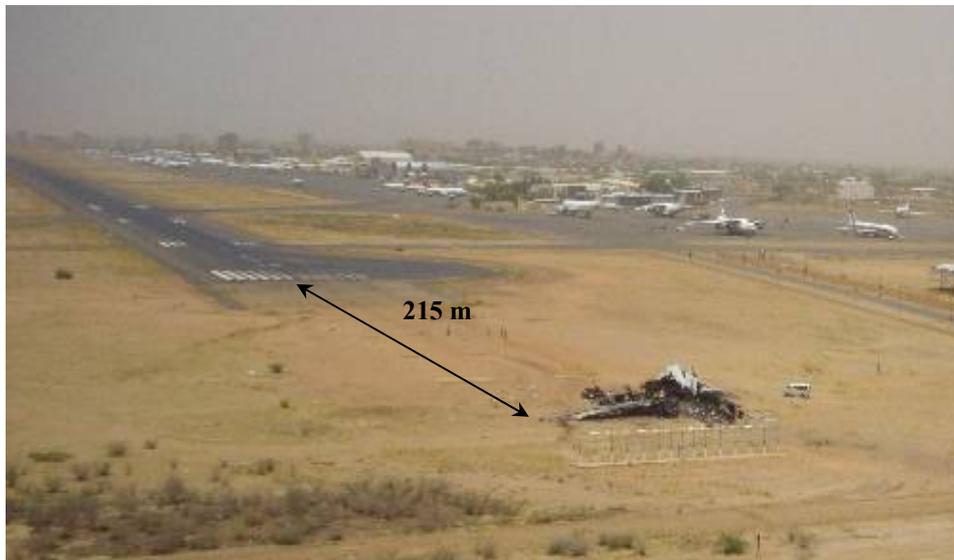
- Middle and forward aircraft sections, that included wings, engines, and cockpit, were located at about 215 meters from the end of runway 36, on hard ground.

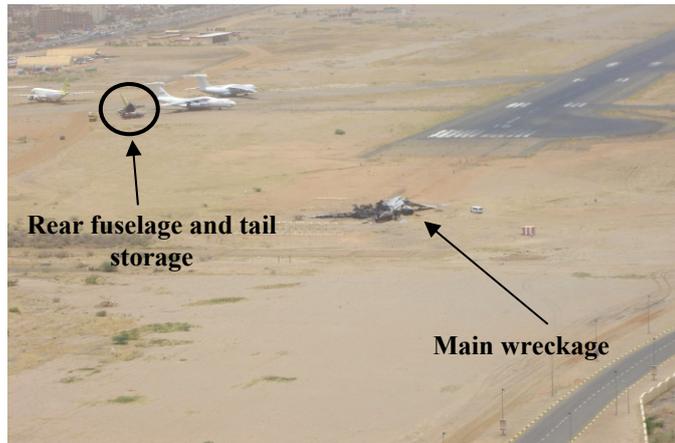
- Rear section of the aircraft structure was transported to an aircraft parking area aside of the runway. This rear section included the rear fuselage, fin and rudder, horizontal stabilizer and elevators, Auxiliary Power Unit (APU).

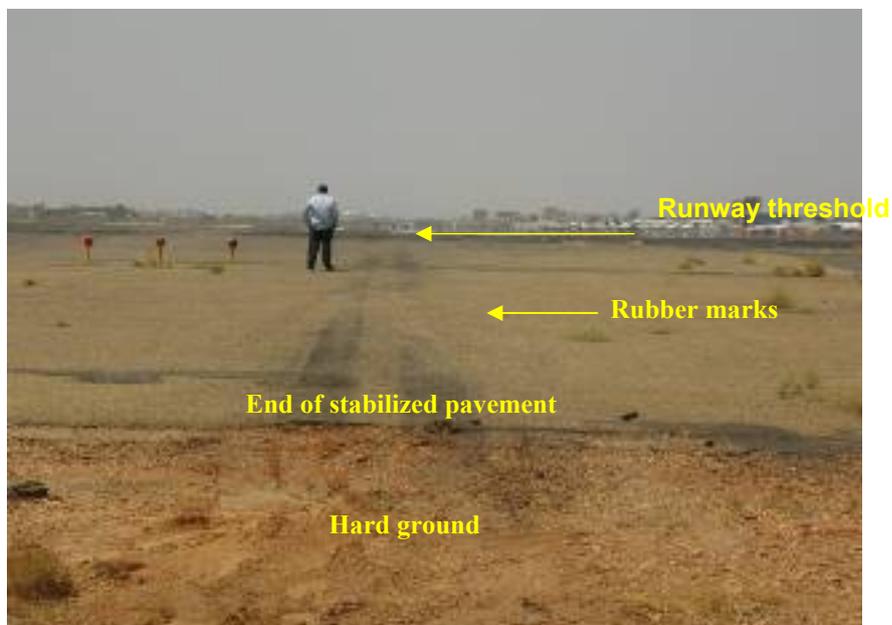
- Runway 36 ended into a stabilized pavement before changing to hard ground. In the continuation of runway 36 there were 6 series of lights, used for landing on runway 18, and a row of antennae. Rubber marks were observed on the end of the runway and the stabilized pavement.

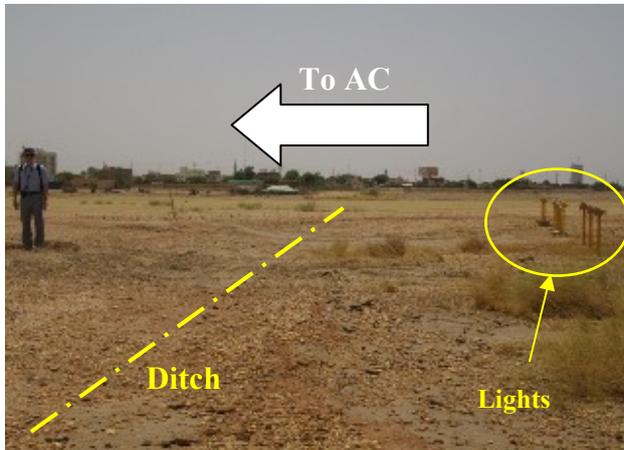
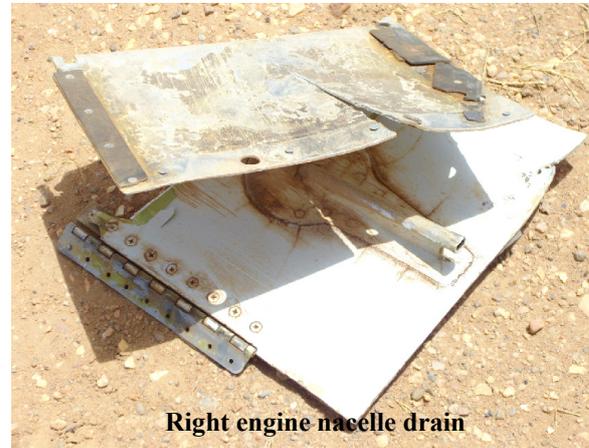
- There was a ditch (between the 3rd and 4th series of lights) which dimension was about 0.9 meters width and 0.5 meter deep. There were no traces of aircraft impact with the ground in the overrun area. However,

the drain of the right engine nacelle showing scarring marks was found after the ditch at about 110 meters from the runway threshold, possibly suggesting a contact of the nacelle with the ground.

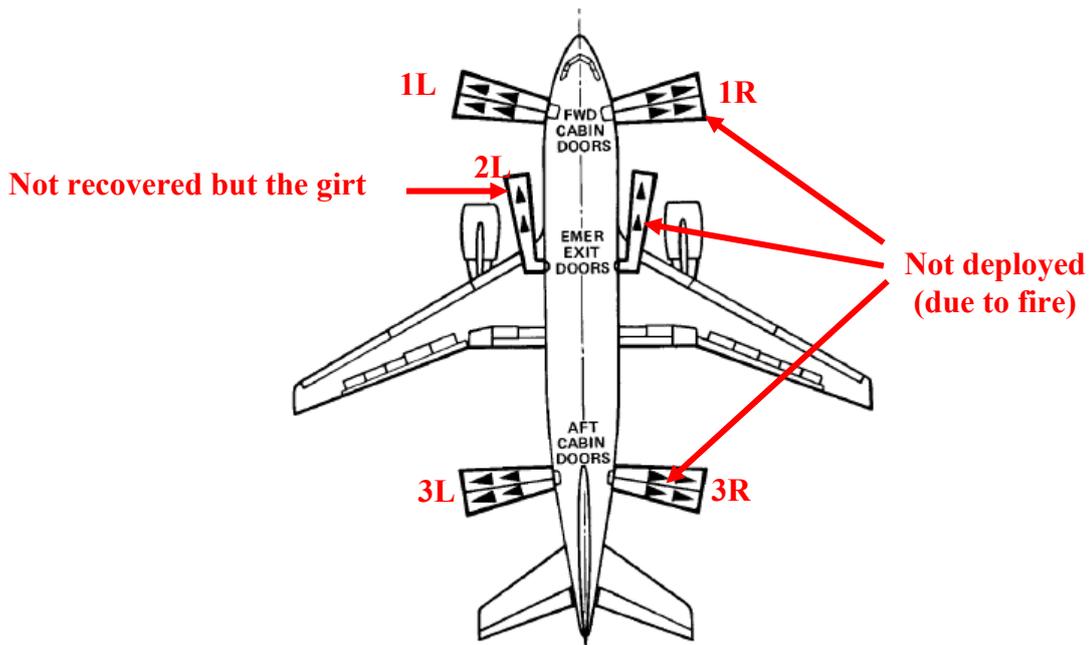
- The three left doors (1L, 2L, 3L) were opened, slides 1L and 3L were deployed and deflated, girt of slide 2L was attached to the door.
- According to the Captain interview, doors 1R, 2R and 3R were not used due to fire on right side.
 - Door 1R: it was not possible to extract it from the wreckage or to determine the condition of its mechanism. Its slide was found not deployed.

- Door 2R: neither the door nor the slide was recovered.
- Door 3R: it was found opened, with its slide in place not deployed.
