**Hard landing, inappropriate stopover maintenance procedure,
take-off with a substantially damaged aeroplane**

Aircraft	Airbus A330-211 registered F-GZCB
Date and time	13 April 2011 at 18 h 25 ⁽¹⁾
Operator	Air France
Place	Caracas-Maiquetía Simón Bolívar Airport (Venezuela)
Type of flight	Scheduled international public transport of passengers
Persons on board	Captain (PF), copilot (PNF), copilot (relief), 10 cabin crew, 202 passengers
Consequences and damage	Aeroplane substantially damaged

This is a courtesy translation by the BEA of the Final Report on the Safety Investigation. As accurate as the translation may be, the original text in French is the work of reference.

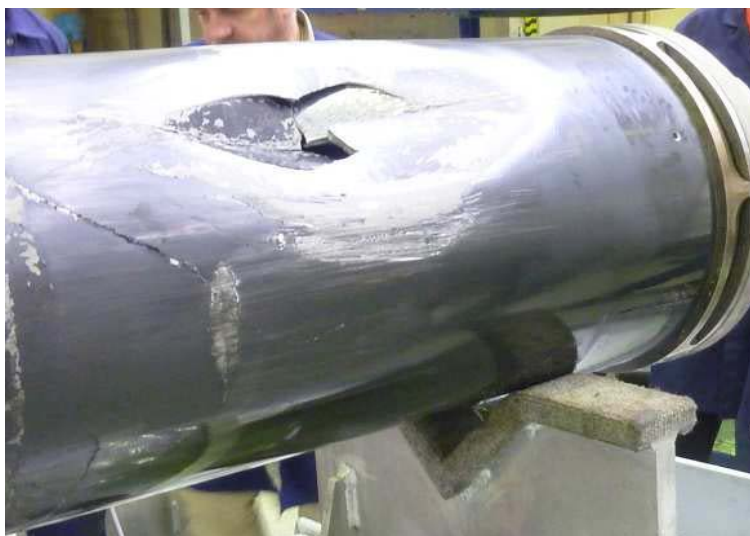
The landing gear was examined in two stages. The first examination carried out in an approved workshop enabled the absence of hydraulic fluid to be noted as well as internal fractures on the body of the fixed unit (Upper Piston). Further examinations, including in particular the characterisation of the fractures, were carried out at the manufacturer's. The examinations showed that the fractures were the result of abnormally high stress.

The incipient failure did not show any pre-weakening. Its characteristic fracture surfaces indicated that it was sudden. However the presence of an end mark was noted about twenty centimetres from the source of the fracture, indicating the development and propagation of the crack in two stages.

This mark corresponded to the end of the cracking during the immobilisation of the aeroplane on the tarmac, on arrival of the flight from Paris.

The final fracture was a result of deterioration of the landing gear which may have occurred either during taxiing to take-off on the return flight or during landing of the same flight.

The violent impact of the landing gear during the hard landing caused an excessive local increase in the damping hydraulic pressure in the lower part of the mechanism leading to constraints greater than the materials' resistance. There was excessive compression of the static piston, subsequently limiting its movement. This damage prevented the full operation of the landing gear retraction sequence.
