**SERIOUS INCIDENT**

<b>Aircraft Type and Registration:</b>	Airbus A330-343, G-VKSS
<b>No &amp; Type of Engines:</b>	2 Rolls-Royce RB211 Trent 772B-60 turbofan engines
<b>Year of Manufacture:</b>	2011 (Serial no: 1201)
<b>Date &amp; Time (UTC):</b>	19 January 2013 at 2333 hrs
<b>Location:</b>	On departure from Orlando International Airport, USA
<b>Type of Flight:</b>	Commercial Air Transport (Passenger)
<b>Persons on Board:</b>	Crew - 14                      Passengers - 311
<b>Injuries:</b>	Crew - None                      Passengers - None
<b>Nature of Damage:</b>	Damage to both engines, leading edges and radome
<b>Commander's Licence:</b>	Airline Transport Pilot's Licence
<b>Commander's Age:</b>	48 years
<b>Commander's Flying Experience:</b>	13,850 hours (of which 128 were on type) Last 90 days - 135 hours Last 28 days - 75 hours
<b>Information Source:</b>	AAIB Field Investigation

**Synopsis**

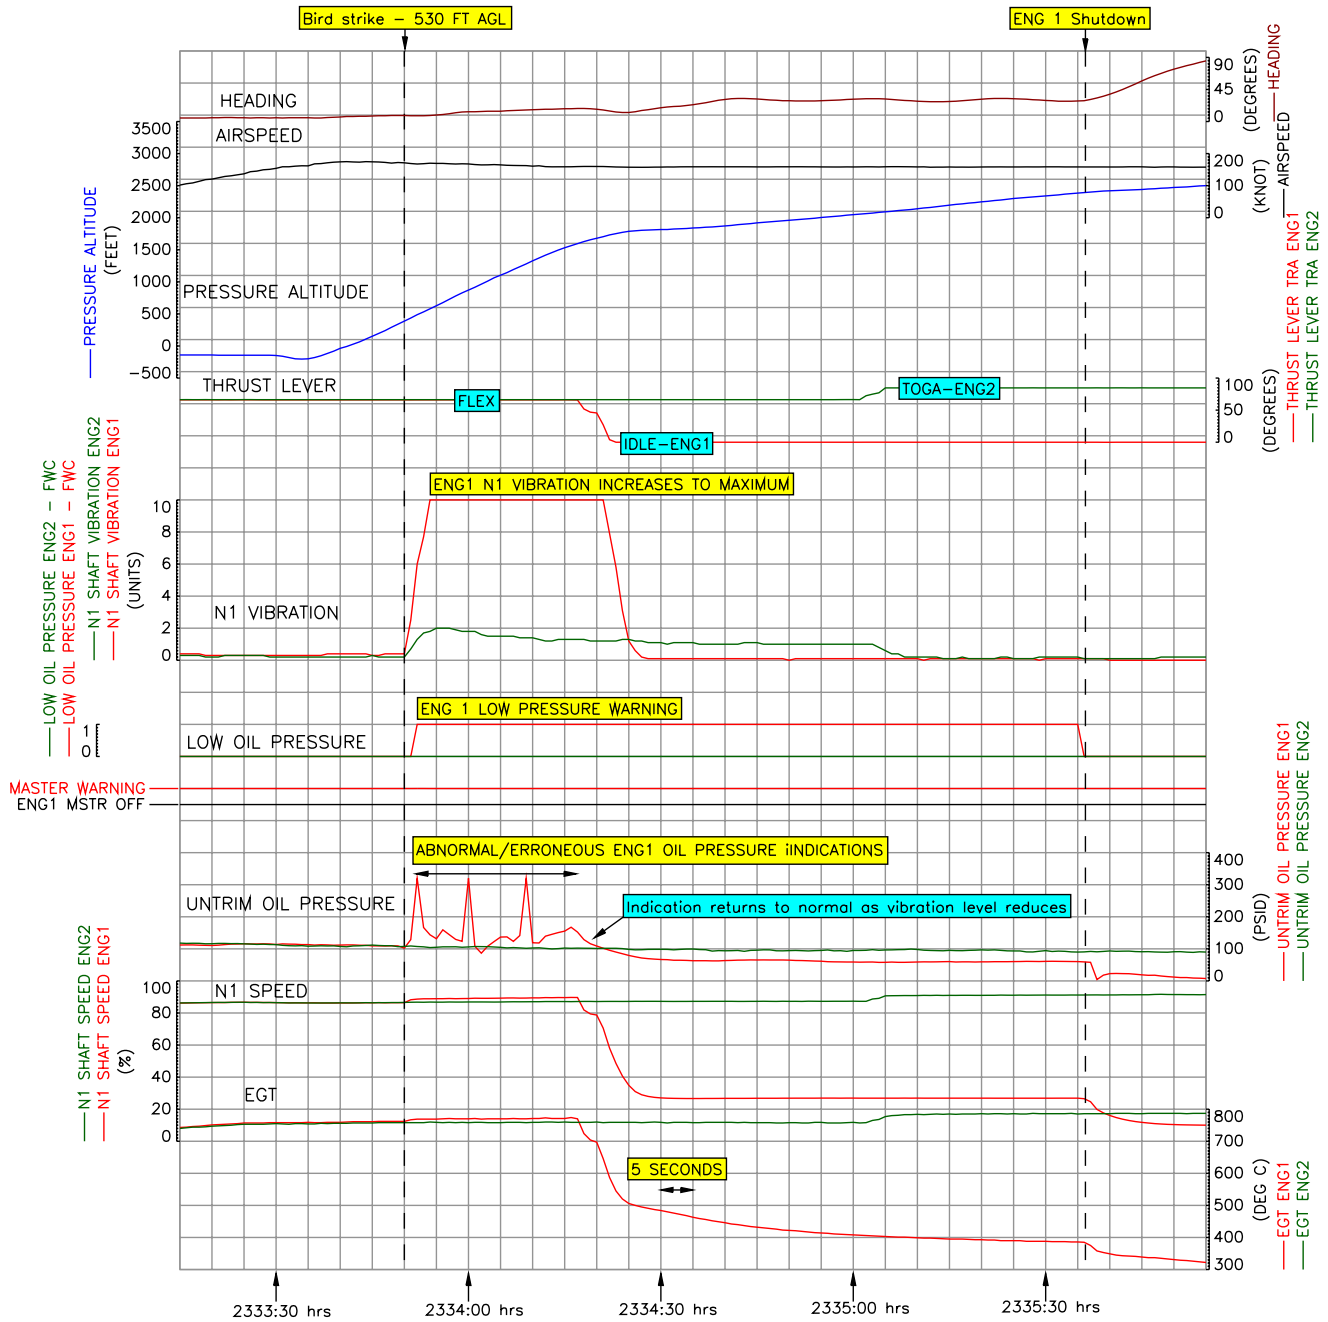
**Figure 2**  
Data recorded between takeoff and engine shutdown

untrim<sup>4</sup> oil pressure from the Engine Interface and Vibration Monitoring Unit (EIVMU) and engine  $N_1$  shaft vibration for each engine. Figure 2 illustrates salient parameters during the period between takeoff and engine shutdown.

The aircraft took off from Orlando International Airport Runway 35L at 2333 hrs (1833 hrs local). The takeoff roll was uneventful, but at a height of approximately 530 ft during the climb out, there was a loud bang, which was almost immediately followed by the activation of the master warning and ENG 1 FAIL and ENG 1 LO PR captions being displayed on the ECAM. The left engine  $N_1$  shaft vibration increased

from 0.4 to 10 units<sup>5</sup>, which is the maximum range of the parameter, EGT increased by 10°C to 771°C and all three engine shaft speeds,  $N_1$ ,  $N_2$  and  $N_3$ , increased slightly and a series of rapid and erroneous fluctuations in the left engine untrim oil pressure were also recorded. The right engine  $N_1$  shaft vibration also increased from 0.2 to 1.8 units at this time.

Almost immediately, the commander (PNF) confirmed the ECAM indications and the left engine thrust lever was retarded to the idle position. He declared a “PAN” to ATC which was then upgraded to a “MAYDAY”. As the left engine speed reduced, the  $N_1$  shaft vibration level also reduced to 0.1 units and the untrim oil pressure normalised. The PF increased the right engine thrust to the TOGA position, before the shutdown procedure for the left engine was completed. The total time from initial warning to shutdown was 1 minute 46 seconds.
