ATSB TRANSPORT SAFETY REPORT
Aviation Occurrence Investigation
AO-2009-027
Final

In-flight fire
427 km south-west of Guam
10 June 2009
Airbus A330-202
VH-EBF

In-flight fire – 427 km south-west of Guam – 10 June 2009 – Airbus A330-202 – VH-EBF

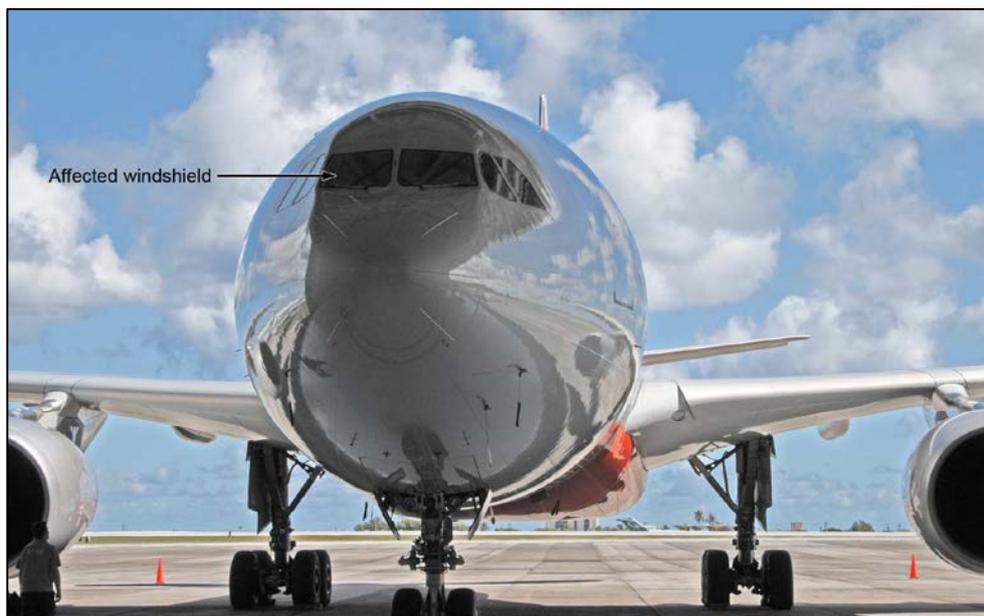
Figure 1: VH-EBF undergoing repair at Guam showing the location of the right windshield

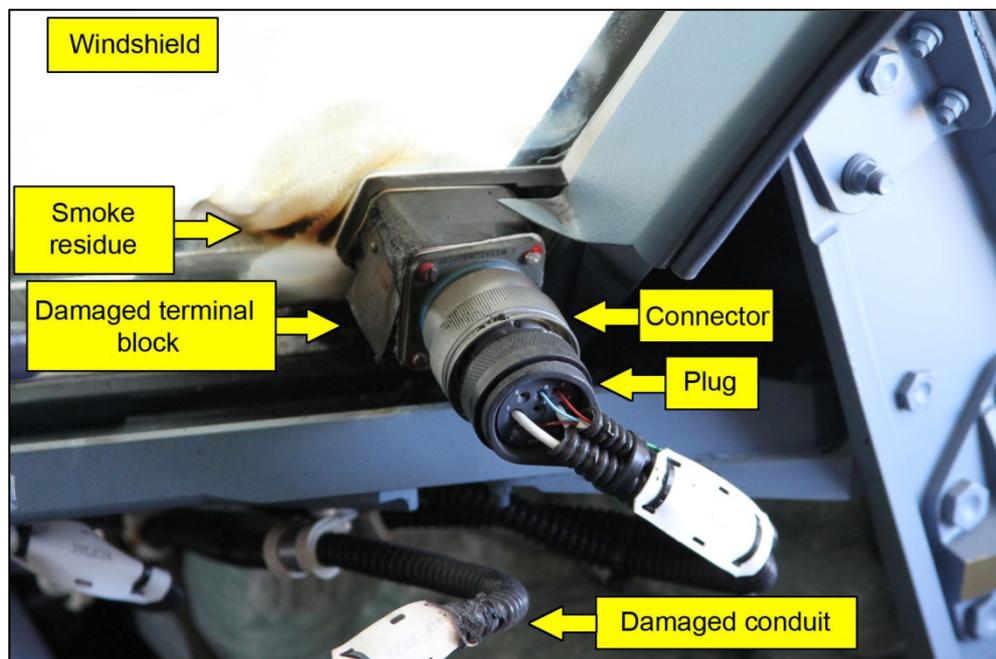
The damaged right windshield¹⁰ was produced by Saint-Gobain Sully, France, in February 2007, and had been installed during construction of the aircraft. Inspection in Guam showed severe burning and melting of the right side windshield terminal block housing and minor heat damage to the glare shield and wire conduit around nearby loudspeaker wiring (Figures 3 and 4). The electrical plug from the window heat computer was firmly secured to the windshield connector and was undamaged. There was no evidence of loose fitting between the connector and the terminal block.

Figure 3: Windshield heat electrical connector and terminal block housing (in situ)

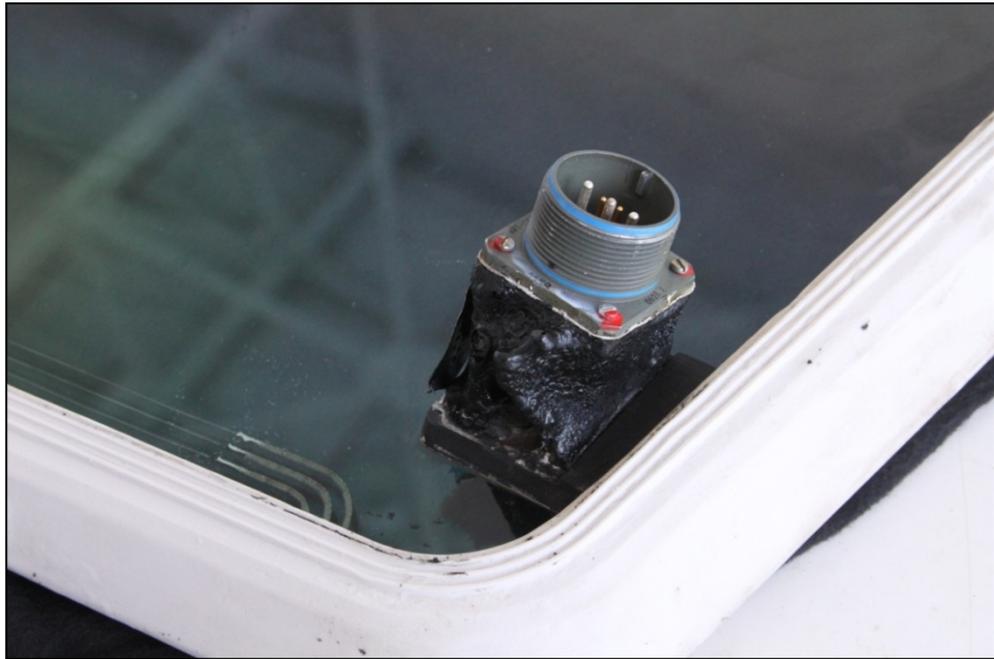
Figure 4: Close-up view of the melted terminal block

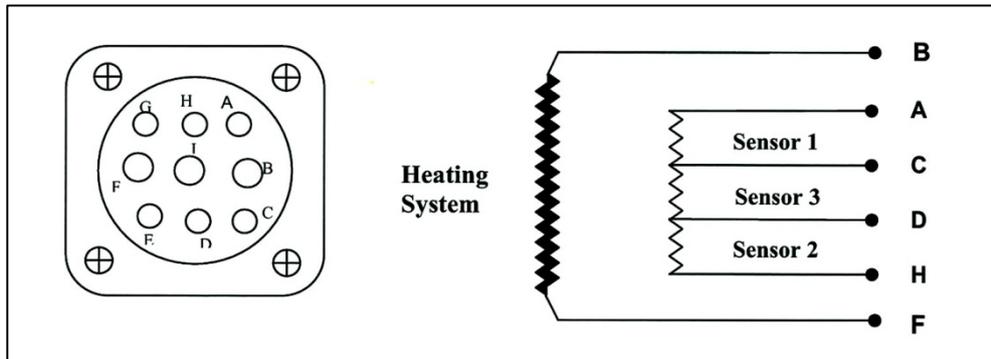
Figure 5: Terminal block connector pin layout; pins B and F supplied power to the inter-laminate heating film and pins A, C, D and H were connected to the temperature sensors

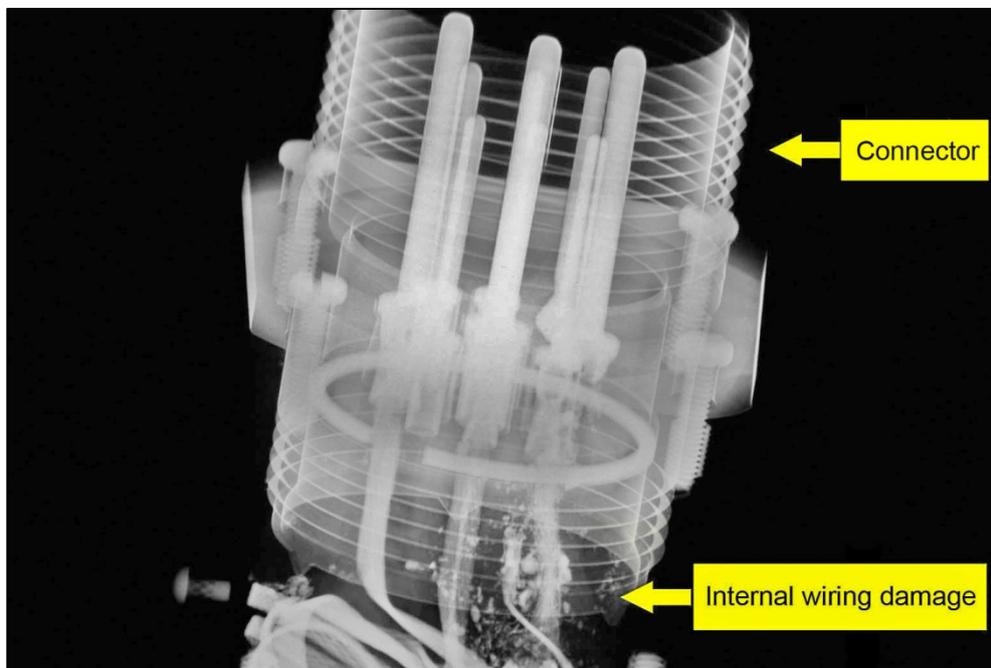
After the windshield from VH-EBF had been removed from the airframe and prior to any disassembly taking place, the terminal block was inspected by the ATSB using radiographic techniques. The x-ray inspections permitted an understanding of how the wires were organised inside the terminal block, with one of the braided wires showing severe localised damage. A schematic diagram of the terminal block and the pin connections is shown at Figure 5, with a radiograph showing the wiring damage at Figure 6.

Figure 6: Radiograph showing disruption to the internal wiring within the terminal block

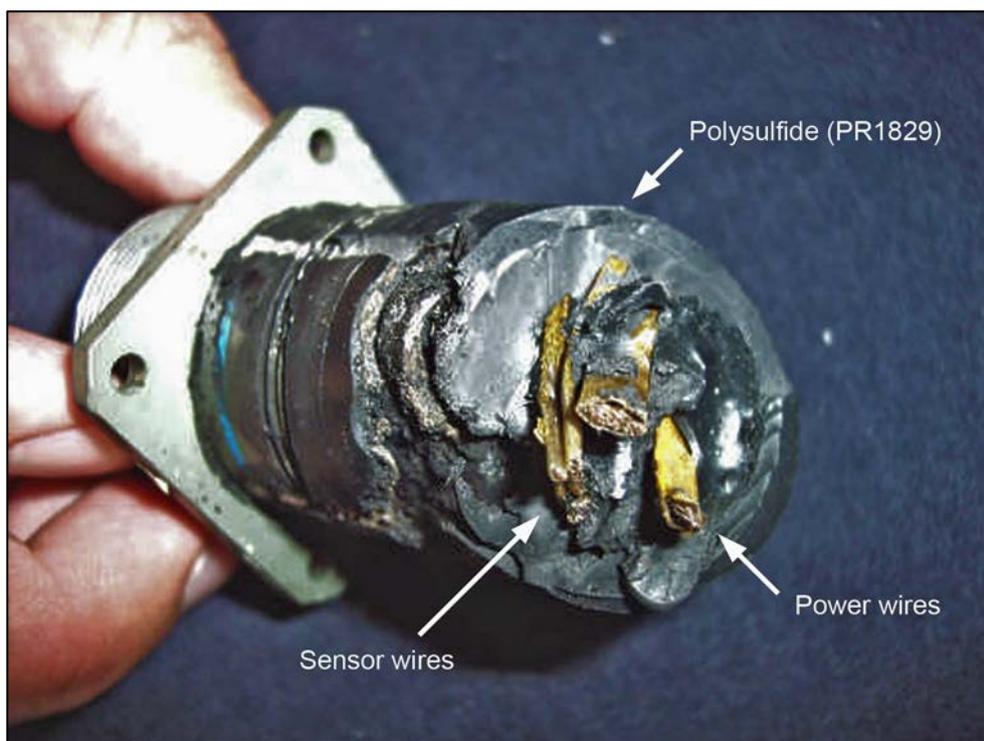
- In order to visually examine the physical condition of the power and sensor wiring, the terminal block was dismantled from its windshield mounted position and then destructively sectioned. That action showed that a plug of polysulfide sealant (PR1829) had been used to encase the wiring within the terminal block (Figure 7). The sectioning also showed that the silicone insulator surrounding the braided power wires (pin B) had partially burnt away from the effects of electrical arcing (Figure 8).
- The polysulfide sealant was removed from around the wire bundle to expose the general condition of the wires. Contact pin B that formed part of

- The aircraft manufacturer indicated that a polysulfide sealant (PR1829)¹⁶ had been used to fill the terminal block for windshields manufactured between January 2007 and October 2008. For those windshields (1,500 in total), the terminal block cavity was filled with sealant prior to final assembly. The sealant's purpose was to prevent moisture and condensate from entering the terminal block. Of the windshields that had sustained an electrical failure (19 in total), it was indicated that all had been manufactured with a filling of PR1829 sealant.

Figure 7: Partially dismantled windshield terminal block from VH-EBF with wiring shown encased in polysulfide sealant

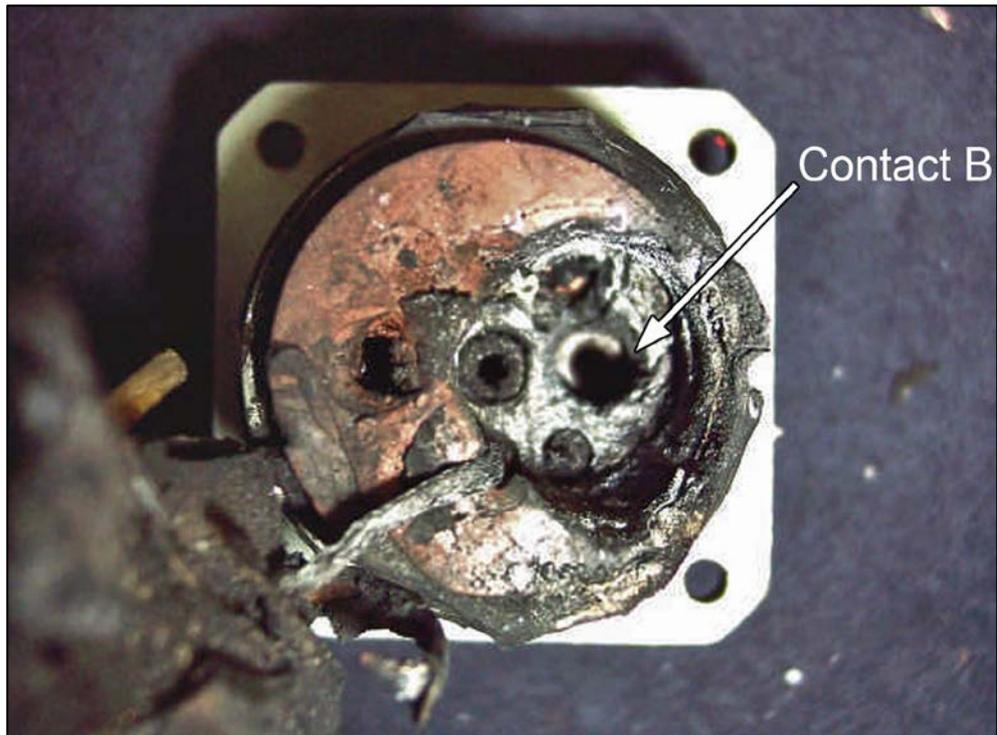
Figure 8: Partially dismantled windshield terminal block from VH-EBF showing concentrated burning of the silicone insulator that surrounded contact pin B

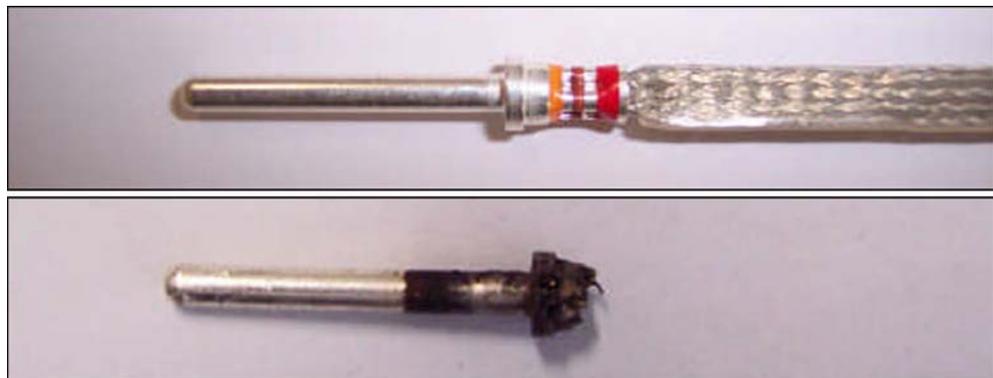
the electrical power circuit was revealed to have fragmented in a way consistent with extreme overheating damage (Figure 9).

Figure 9: Comparison of electrical terminal block connector pins: burnt pin B from VH-EBF (lower) and that from an exemplar unit (upper)

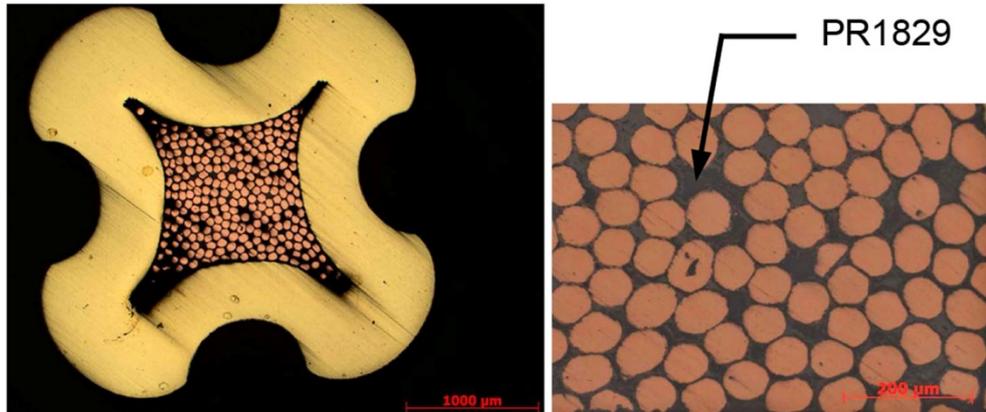
A transverse metallographic cross-section of the crimped region from a connector pin is shown at Figure 10. As noted in the extract¹⁹ below, while the connector pin and braided copper wires had been crimped, sufficient residual space remained after that process to allow PR1829 to migrate into the voids between the wire strands.

Figure 10: Metallographic cross-section through a connector pin displaying only partial compaction of the copper wire strands and migration of PR1829 sealant between the wires

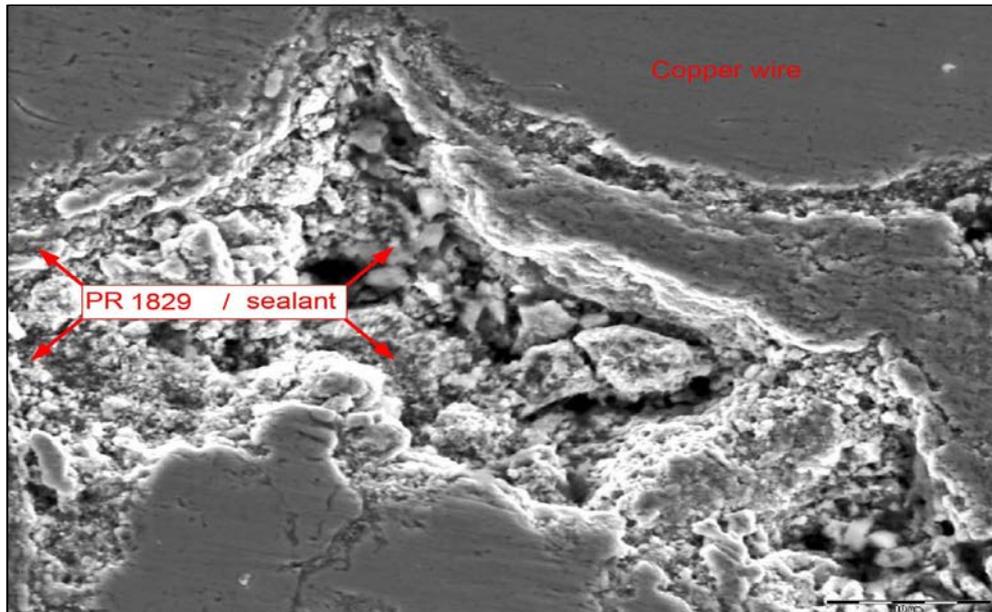
Figure 11: Scanning electron image showing the presence of PR1829 sealant between the individual copper wires of the braid

In the case of the connector pins examined by EADS, polysulfide sealant (PR1829) had migrated between the individual wire strands within the crimped power wire connector pins. PR1829 had been used on a batch of around 1,500 windshields to prevent moisture ingress into the terminal block. The crimped region within the connector pins should normally be devoid of PR1829 sealant – particularly between the conducting wires.

In May 2010, the aircraft manufacturer issued a service bulletin (SB) A330-56-3009 that implemented a windshield recall, removal and replacement program. The program applied to a batch of approximately 1,500 windshields that had been manufactured between January 2007 and October 2008 where PR1829 polysulfide sealant had been used as a filling agent within the terminal block. The SB recommended a visual inspection of the left and right windshields to determine whether they were part of the batch containing PR1829 sealant. If identified, Airbus recommended that the affected windshields be replaced within 900 flight hours. Airbus reported to the ATSB that the airlines which had been initially affected by in-flight windshield overheat events would be prioritised in the replacement program.
