Investigation Report

Type of Occurrence:	Serious incident
Date:	21 August 2008
Location:	Frankfurt/Main
Aircraft:	Transport aircraft
Manufacturer / Model:	Airbus Industry / A340-313
Injuries to Persons:	None
Damage to aircraft:	Minor damage to airplane
Other damage:	Vehicle (passenger bus) damaged
Source of information:	Investigation by BFU
State File Number:	BFU 5X015-08

At 0622¹ hrs, an Airbus A340-313 (A340) collided with a passenger bus on the apron in the area of the crossing of taxiway G and the taxi area road proceeding parallel to taxiway N of Frankfurt/Main Airport (EDDF).

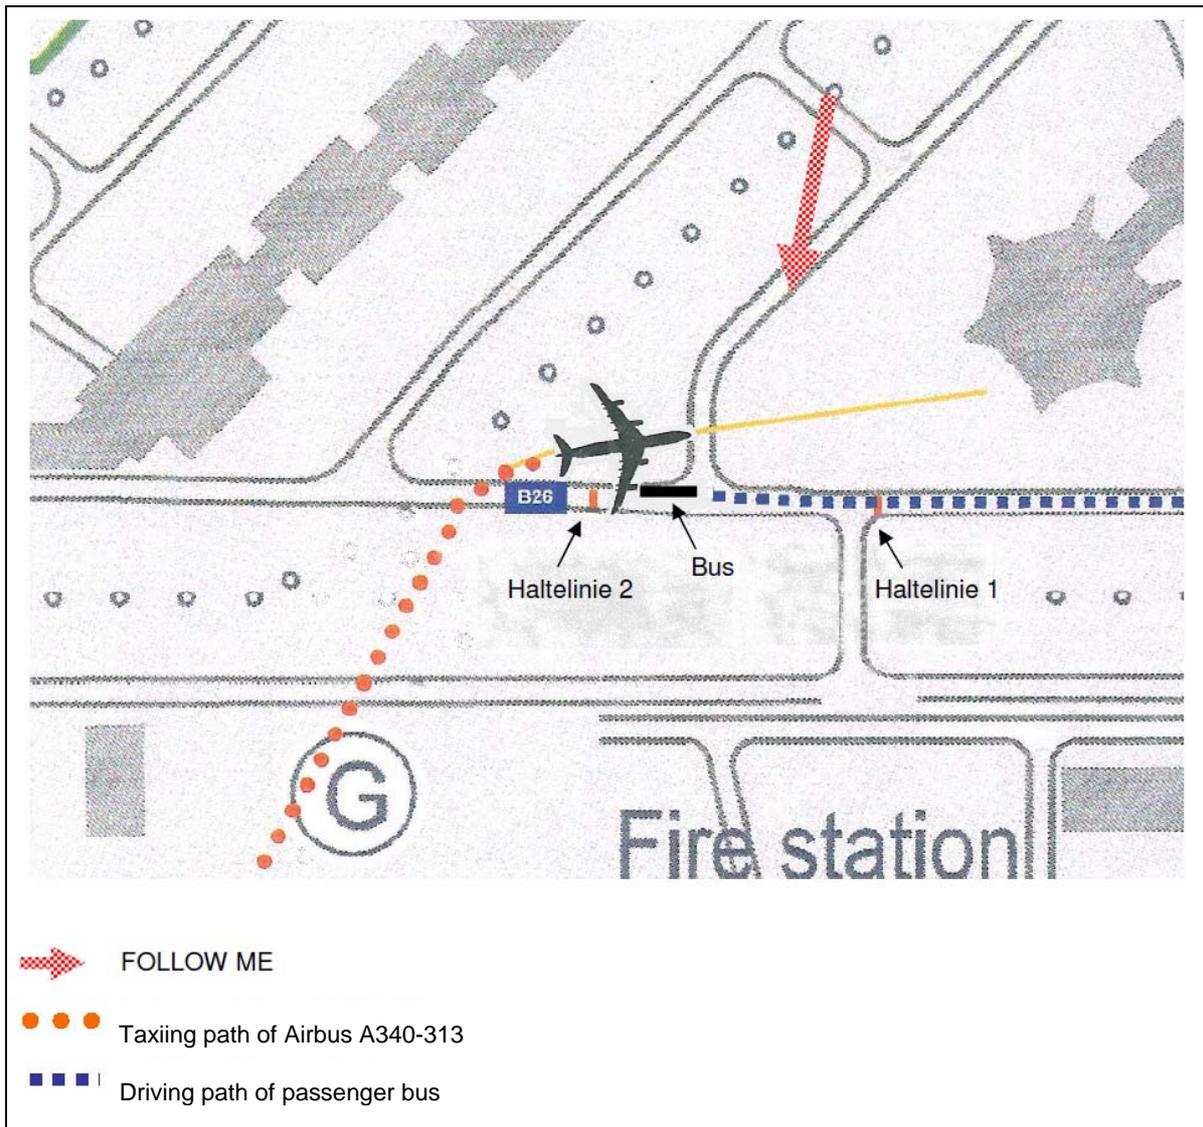
The passenger bus driver had the instruction to pick up passengers at parking position A17. He stated that he had initially seen the Airbus A340 when his bus was between two stop line markings on the taxi area road. When he stopped a few meters away from the second stop line, the Airbus A340 turned into parking position B26 and the engine of the airplane collided with the bus.

Reconstructed taxiing and driving paths

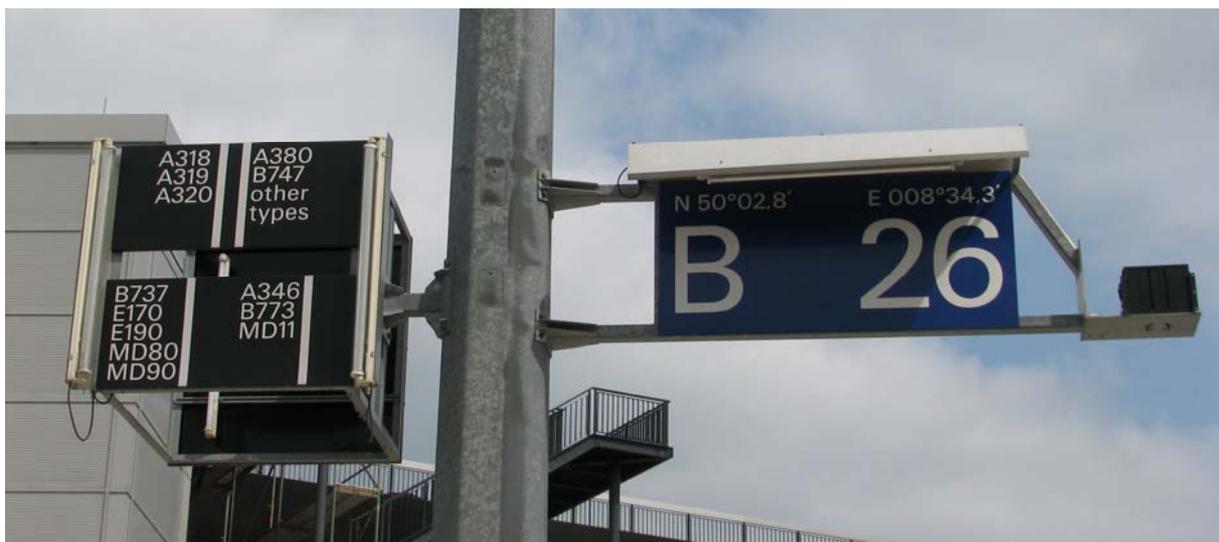
The operating status of the visual guidance system was monitored and documented in the system itself. It showed that the AGNIS/PAPA was not operating at the time of incident.

AGNIS / PAPA at parking position B26

The marshaller's statement of not having activated the AGNIS guidance system was confirmed by the operating status log of the device.

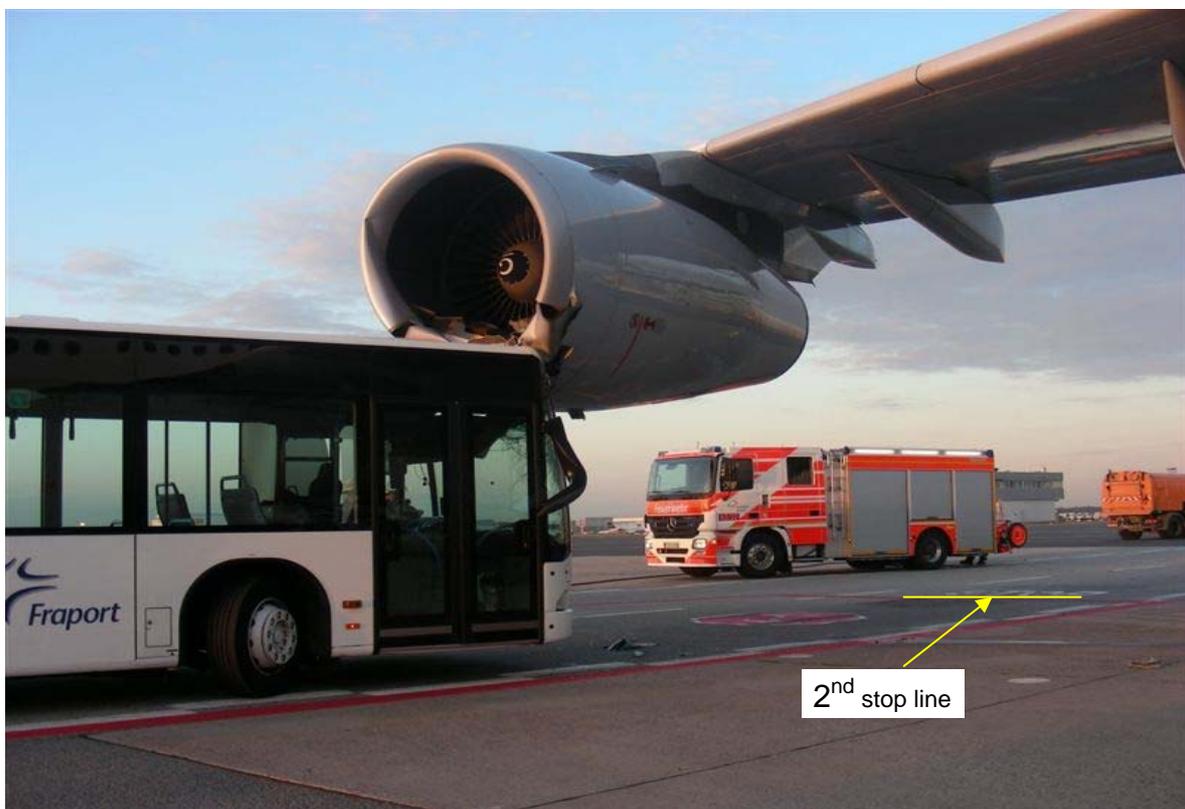
Engine No. 4 of the Airbus A340 rested with the bottom side of the engine cowling on the upper front part of the passenger bus. The airplane was on the yellow guide line for parking position B26, and the passenger bus was on the taxi area road approximately 8 m in front of the second stop line marking for vehicles.

Airplane and passenger bus on the apron

The lower part of the cowling of the airplane's engine No. 4 was compressed; parts of the damaged cowling were found in the engine. The interior of the engine was damaged. It had to be removed for further damage identification and repair.

The passenger bus's upper front carriage was deformed. The rear view mirror and cover panels were torn out of their fixings and damaged.

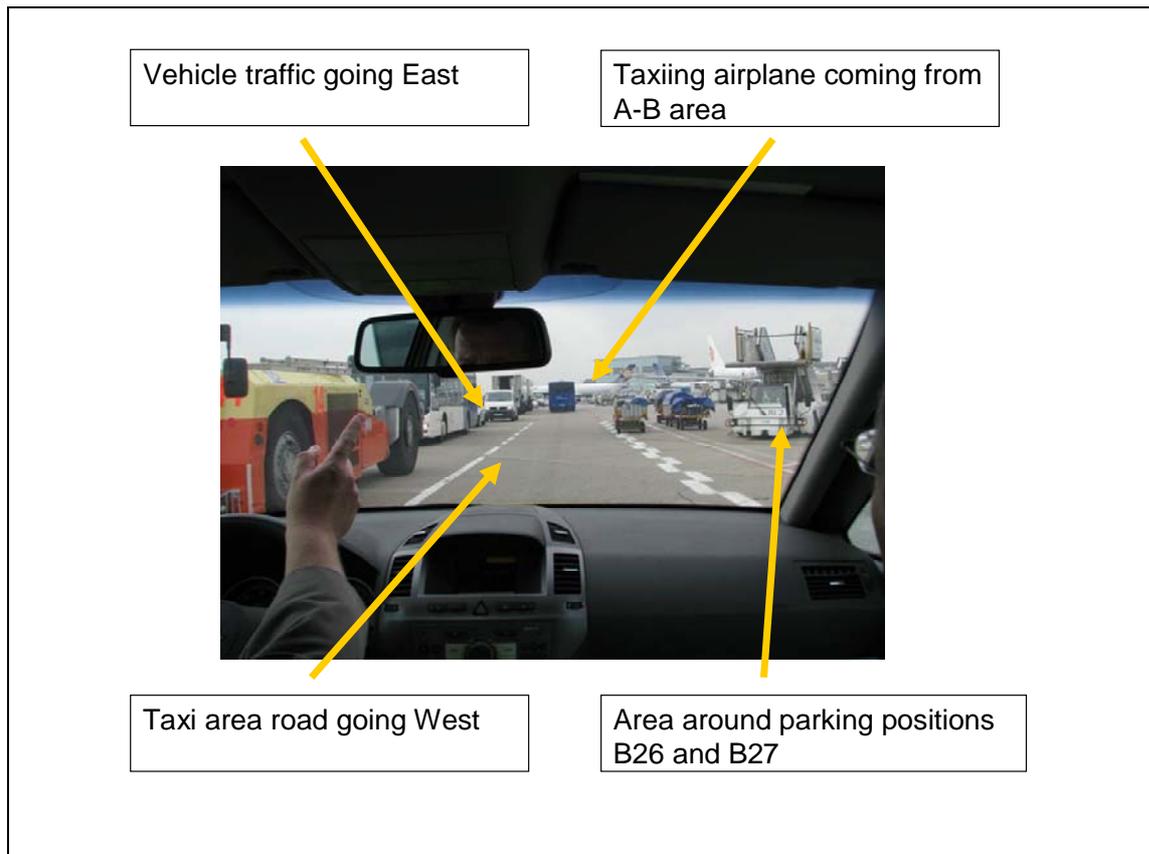
Traffic situation on the taxi area road

In the scope of the investigation an on-site inspection revealed that the traffic situation caused by taxiing aircraft and vehicles becomes confusing especially during peak periods.

Caused by the reconstructions including the modified guide lines for the docking of A380s and other wide-body aircraft, the risk situation in the crossing area of taxiway G and parking position B26 has intensified. The gate can only be reached if aircraft use the taxi area road with the outer most tips of their wings for longer than would be necessary if the taxi area road were crossed at a right angle. Another solution was not possible given the road and taxiway direction and the spatial situation.

The operator of the Frankfurt/Main Airport should ensure a spatial separation of the taxiing traffic and the vehicle traffic on the apron in the area of the crossing of taxiway G with the taxi guide line to position B26 by means of infrastructural measures (e. g. change of traffic routing).
