SERIOUS INCIDENT

Aircraft Type and Registration:	Airbus A340-313, G-VAIR
No & Type of Engines:	4 CFM56-5C4 turbofan engines
Year of Manufacture:	1997
Date & Time (UTC):	27 April 2008 at 0218 hrs
Location:	Nairobi Airport, Kenya
Type of Flight:	Commercial Air Transport (Passenger)
Persons on Board:	Crew - 14 Passengers - 108
Injuries:	Crew - None Passengers - None
Nature of Damage:	Minor scratches to left aft lower fuselage
Commander's Licence:	Airline Transport Pilot's Licence
Commander's Age:	49 years
Commander's Flying Experience:	14,250 hours (of which 9,667 were on type) Last 90 days - 108 hours Last 28 days - 41 hours
Information Source:	AAIB Field Investigation

Synopsis

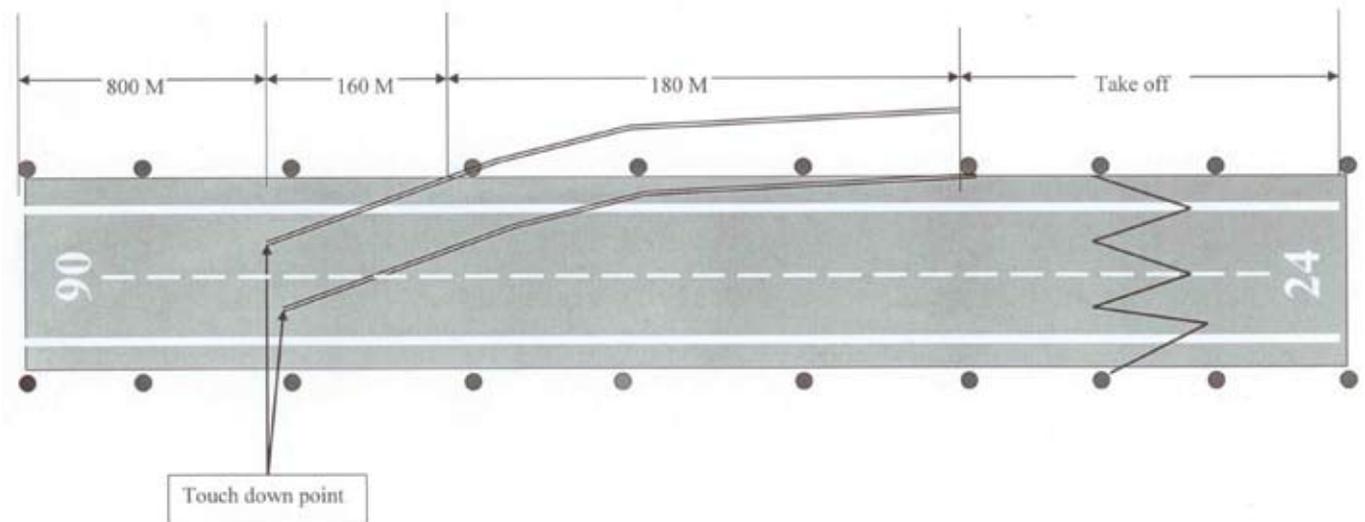
Figure 1

Having been advised of the possibility that the aircraft had run off the runway an inspection by Nairobi Airport staff confirmed the presence of a set of landing gear tracks running off to the left of the paved surface. They believed these had been made by the main gear of G-VAIR. The marks started 800 m from the threshold of Runway 06 and continued towards the edge of the runway for 160 m. From that point the marks from the left main gear passed over a runway light (which had been destroyed) before continuing off the paved surface and then curving right to run approximately parallel with the runway for 180 m. The set of marks from the right main gear did not quite leave the paved surface (stopping 5 cm from the edge of the paved shoulder) although they were off the declared runway surface. The airport staff provided a diagram depicting the ground marks and this is shown in Figure 1. Photographs of the ground marks were also taken at six hours and 14 days after the event. These are shown in Figures 2 and 3 respectively.

Diagram depicting ground marks

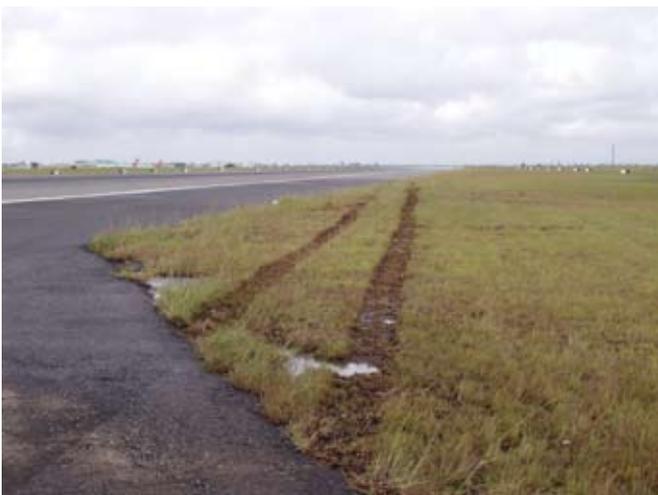
Figure 2

View towards the touchdown point

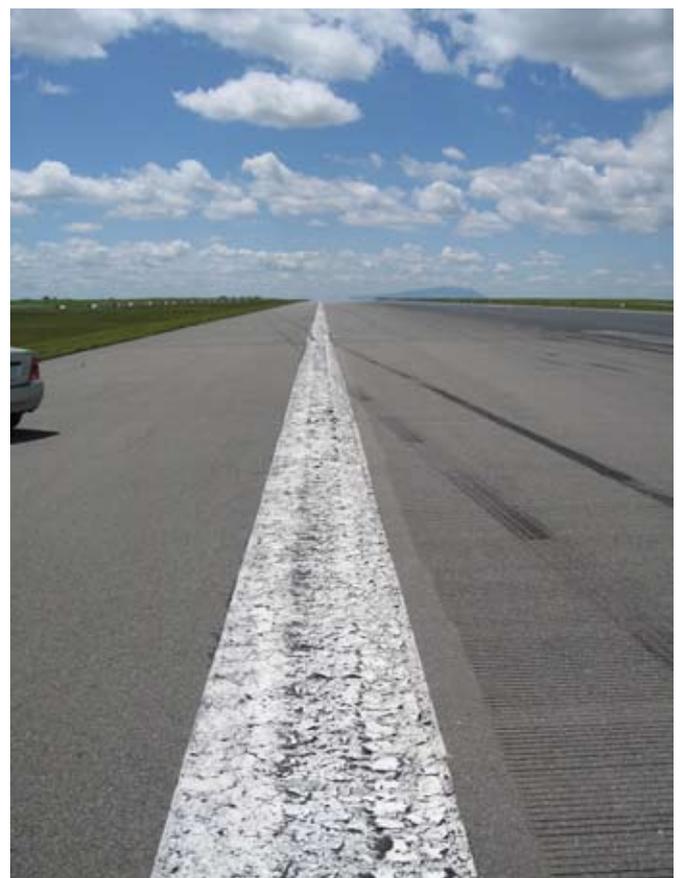
Figure 3

Left hand runway edge markings for Runway 06 with G-VAIR left main gear tyre tracks visible

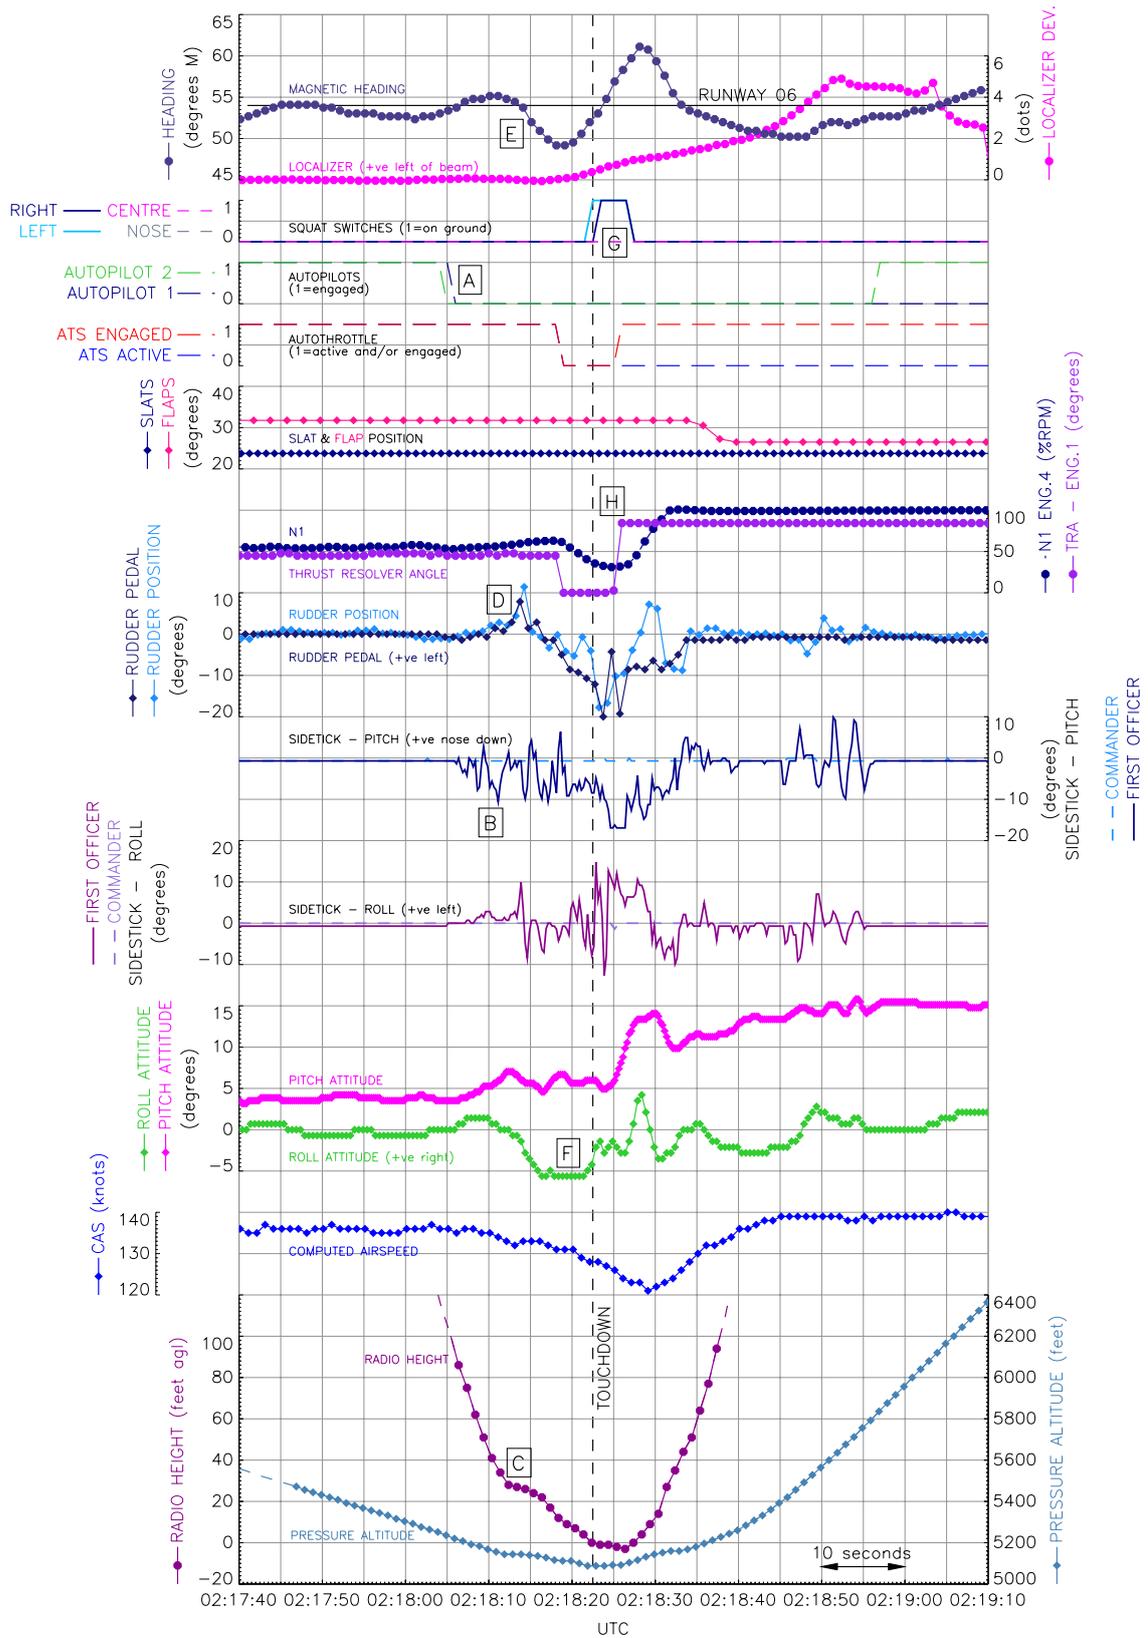
Figure 4
 Salient FDR Parameters
 (Serious Incident to G-VAIR on 27 April 2008)

The aircraft continued descending on the ILS with minor variations in heading of $\pm 2^\circ$ to the runway heading. At approximately 90 ft agl, wings level and 4° nose-up pitch attitude, both autopilots were disengaged (Point A) with multiple FO sidestick inputs and some left rudder following. The ATS remained engaged and active.

Between 40 and 50 ft agl, the PF initiated the flare by briefly pulling back on the side stick (see Point B).

This momentarily pitched the aircraft to 7° nose up, and reduced the rate of descent to about 60 feet/minute as the aircraft passed through 30 ft agl (Point C). The FO then put in a 10° left side-stick¹ input followed by an 8° right input, during which the FDR recorded an 8° left rudder pedal² input being made (Point D), causing G-VAIR to roll left and drift to the left of the runway centreline (Point E).

The PF continued to make further pitch and roll stick inputs and, as the aircraft passed through 17 ft agl, all engines were throttled back to idle, causing the ATS to drop out automatically. Right rudder inputs were also made that slowed the drift to the left; however, the aircraft remained left wing down till touchdown (Point F).

Touchdown occurred 10 seconds after the flare was initiated, still left of the runway centreline with only the main gear making contact with the ground and the left gear touching down first (Point G). The airspeed at touchdown was 128 kt, with a recorded vertical acceleration of 1.1g (not shown).

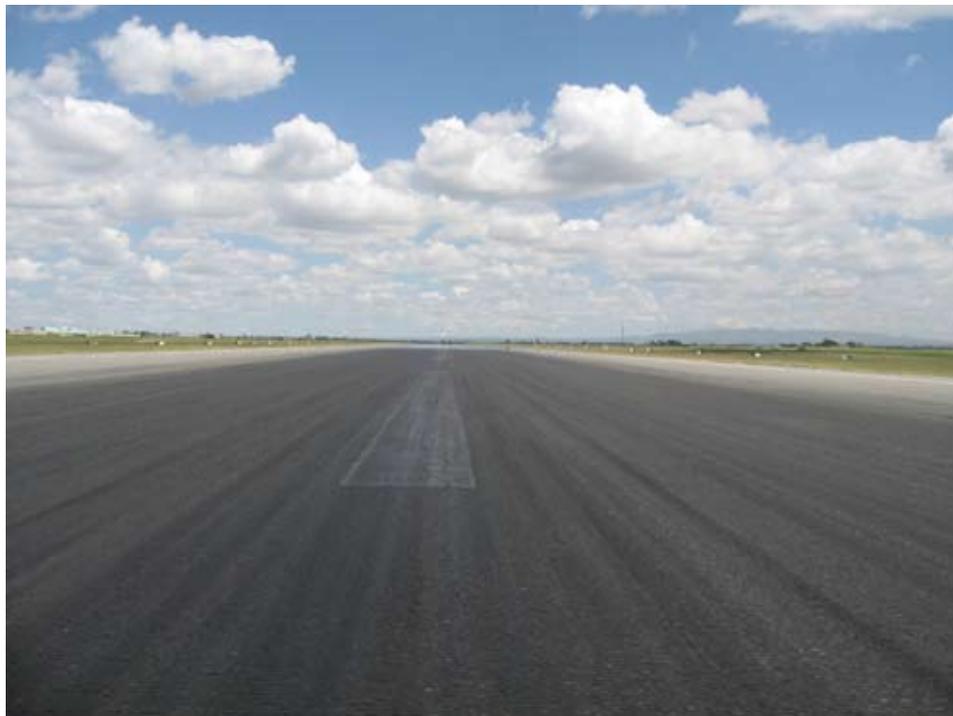
Figure 5

Runway 06 at Nairobi is declared as 4,117 m long by 45 m wide. It consists of a grooved asphalt surface with 7.5 m asphalt shoulders either side to give a total paved width of 60 m. Two weeks after the incident to G-VAIR, an AAIB Inspector, in conjunction with the Kenyan Accredited Representative, conducted a visual inspection of the runway condition. The touchdown zone area of Runway 06 appeared heavily contaminated with rubber deposits which partially obscured the runway centreline markings. A photograph of this area is shown in Figure 5.

Contamination in touchdown zone area of Runway 06

Of limited consequence to this investigation, the level of contamination seen on the surface of Runway 06 and the lack of any evidence that grip testing had been conducted was of concern. It was considered that the quantity of rubber deposition may reduce the available friction and braking action for landing aircraft on Runway 06, whilst aircraft conducting a rejected takeoff on the reciprocal runway (Runway 24) in wet conditions could suffer a significant loss of braking effectiveness. In the absence of routine grip testing it is unlikely that

Safety Recommendation 2009-073

It is recommended that the Kenya Airports Authority initiates routine testing to monitor runway friction levels at Nairobi International Airport in order to ensure compliance with the standards required by ICAO.

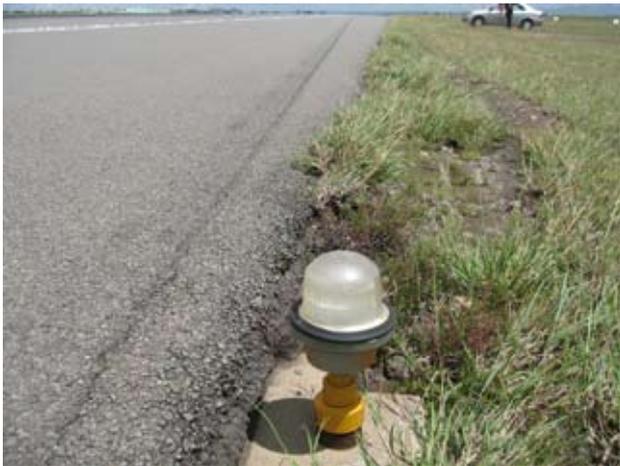
Figure 6
“Frosted” edge light

Photographs of the edge lighting were shown to an expert in runway lighting systems. He commented that, in the photograph shown in Figure 6 below, the glass on the lamp appeared "frosted" which would diffuse the light adversely affecting its output. He also commented that, in one photograph he was shown (Figure 7), the lamp appeared to be misaligned and also that he would have expected to see reference markings to the runway centre line and a unique identifier for each lamp neither of which was visible in the photographs.

Safety Recommendation 2009-070

It is recommended that the Kenya Airports Authority review their maintenance programme for runway lighting at Nairobi International Airport to ensure that runway lighting quality complies with ICAO Standards.

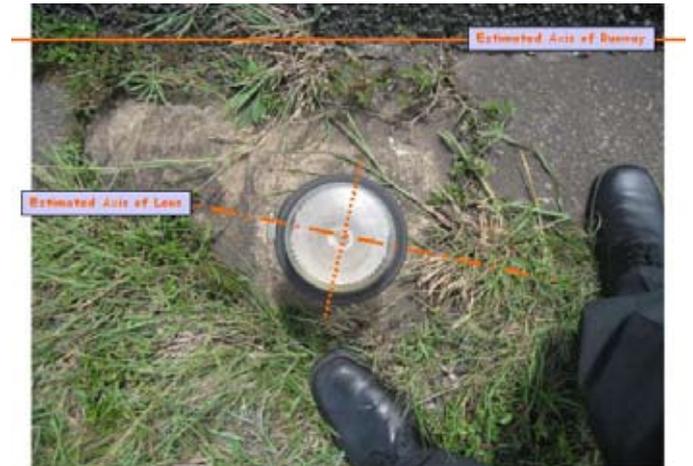
Figure 7
Example of edge light misalignment

The runway lighting was observed by an AAIB inspector during a night arrival two weeks after the incident. During a good-visibility arrival, turning from base leg to final, the runway lighting had a ragged appearance. A UK CAA expert from Aerodrome Standards was of the opinion that this ragged appearance may have been caused by the rotational alignment of individual lights not being uniform.

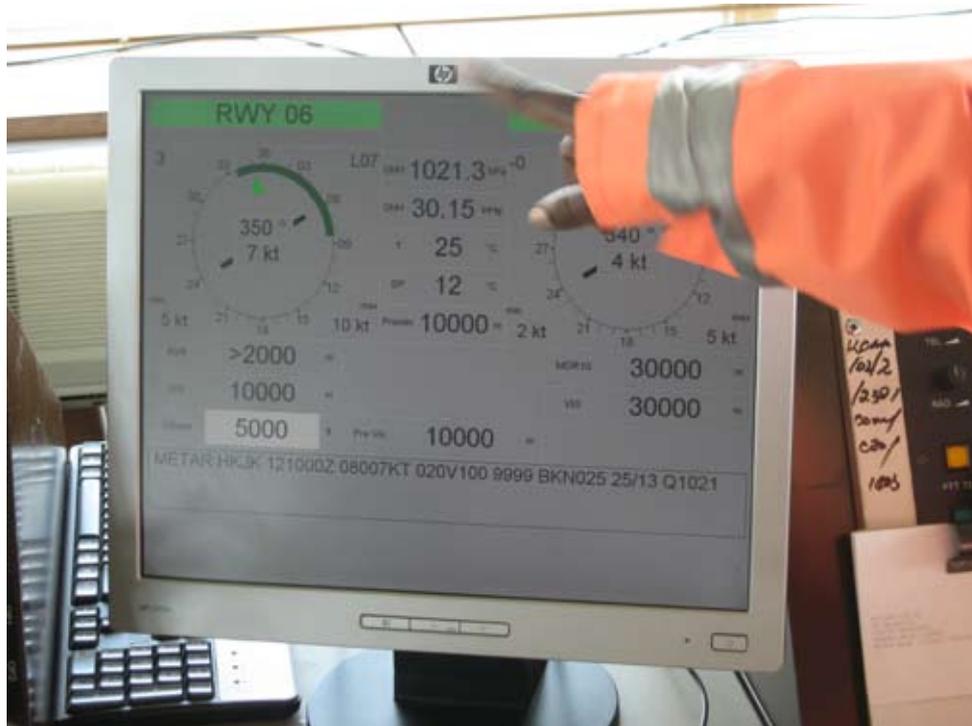
Figure 8
AWOS display in the tower

An Automated Weather Observation System (AWOS) was installed at Nairobi. This system was certified as operational by the manufacturer and accepted into service on 31 October 2006. In addition to sending data to the meteorological office on the airfield it had the capability to provide instantaneous Runway Visual Range (RVR) to the ATC tower as well as other weather information. The display for this system was positioned next to the tower controller's communications desk, as shown in Figure 8.

limited as, due to the absence of appropriate training on the AWOS, information from that system was not passed to flight crews and pilot-assessed visibility from several minutes earlier was routinely relayed instead. Therefore the following Safety Recommendation is made:

Safety Recommendation 2009-069

It is recommended that the Air Traffic Controllers at Nairobi International Airport are provided with appropriate training in the use of the Runway Visual Range measuring equipment which is a function of the Automated Weather Observation System installed at the airport.
