NATIONAL TRANSPORTATION SAFETY BOARD

Interim Factual Report

NTSB Case Number: DCA13IA037
Location: Boston, Massachusetts
Date: January 7, 2013
Aircraft/Operator: Boeing 787-8, JA829J, Japan Airlines

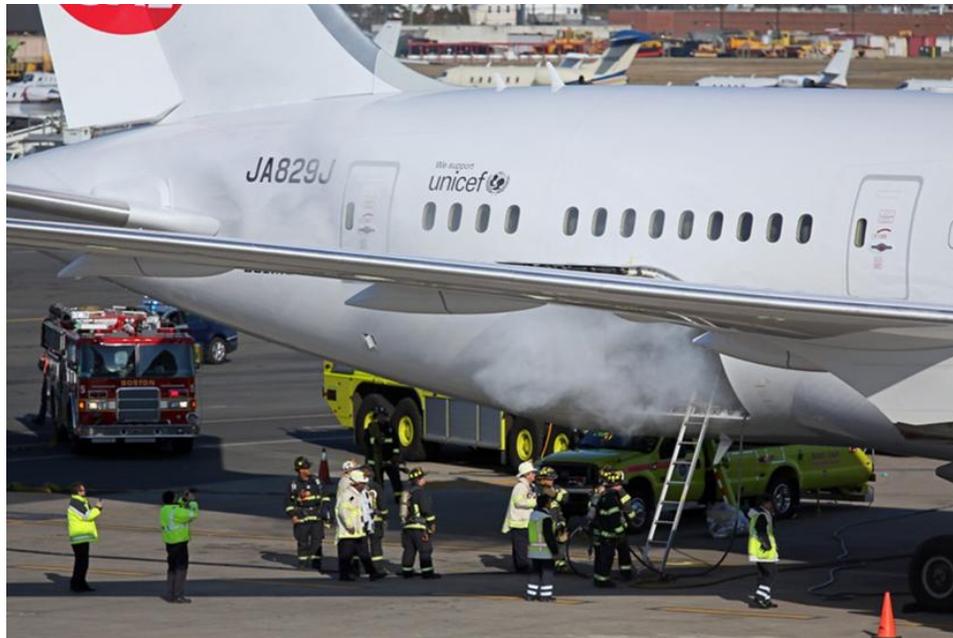
The JAL mechanic advised ARFF personnel that the fire was in the aft E/E bay and led a firefighter to the aft E/E bay door. The firefighter reported that, after entering the compartment, “a white glow about the size of a softball” could be seen on a hand-held thermal imaging camera¹⁸ and that he applied “a shot” of Halotron (a clean fire-extinguishing agent)¹⁹ to try to knock down the fire.²⁰ The thermal imaging camera showed that the white glow was still present but was less than before. The airport security camera video showed smoke coming out of the airplane, as shown in figure 1, at 1040:26.

Figure 1. Smoke emanating from the aft electronic equipment bay.

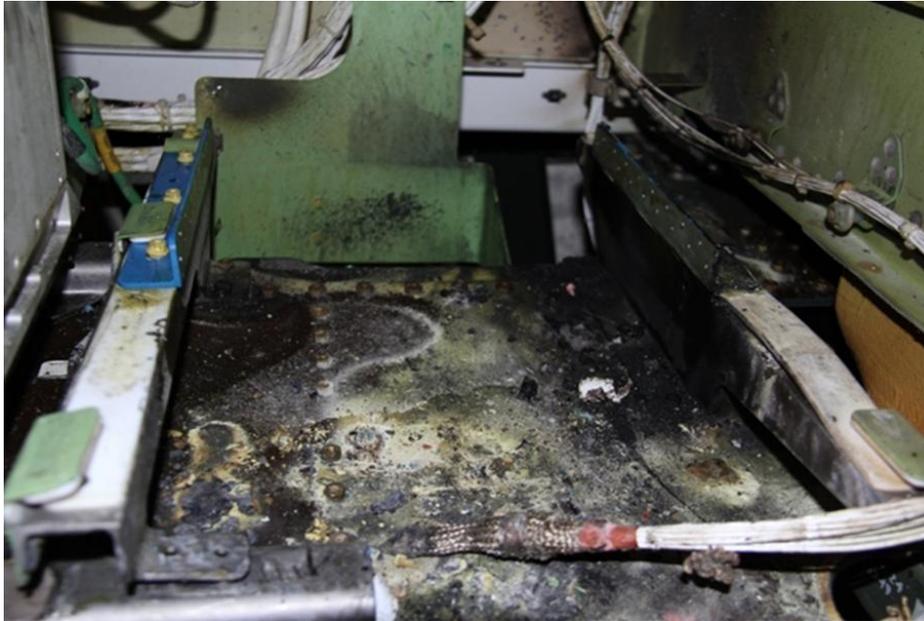
The APU battery installation location showed damage consistent with (1) heat generated from the APU battery and (2) smoke, hot gases, and electrolyte discharged from the battery, as shown in figure 5. Evidence of material expelled from the battery was seen in the areas behind the battery in the form of residue and thermal damage. The extent of thermal damage was confined to within about 20 inches from the battery installation. No primary structure (that is, those associated with airplane flight loads) was found damaged; secondary structure—specifically, the avionics rack²⁷ and the floor panel—exhibited thermal damage near where the APU battery had been installed.

Figure 5. Auxiliary power unit installation location with battery removed.

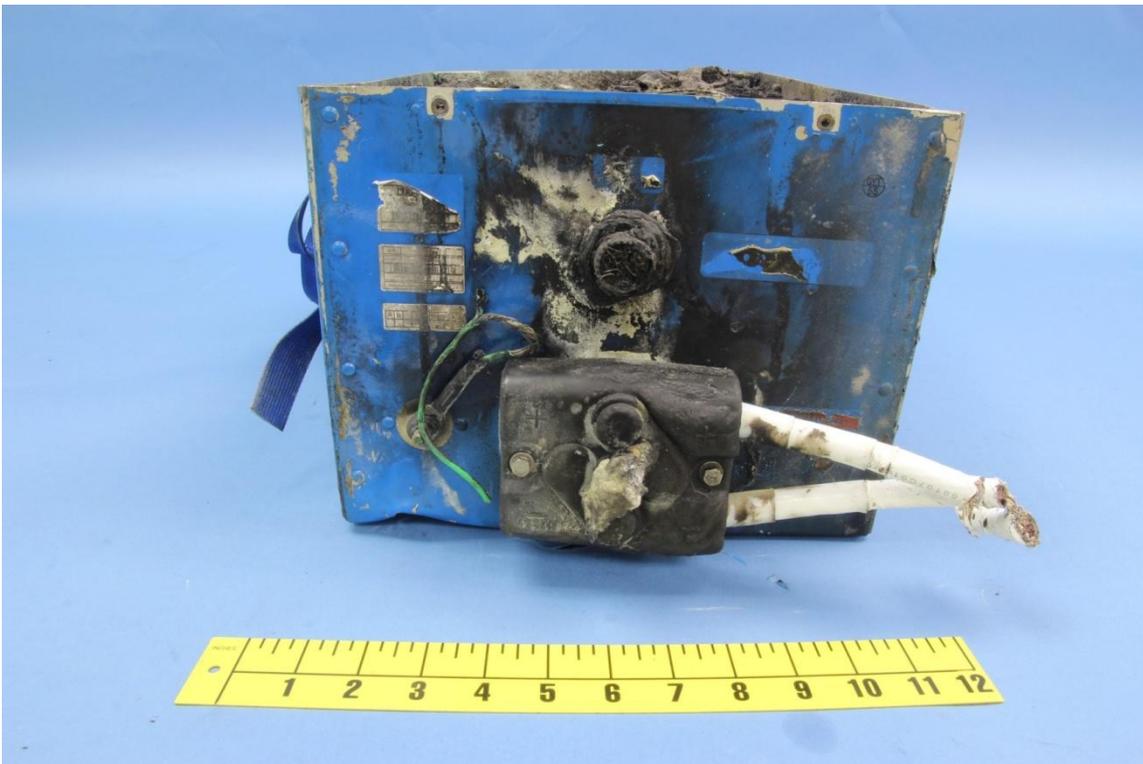
Side 1 of the battery case exhibited black residue and white powdery material on the exterior surface, which were consistent with the flames reported at the J1 and J3 connectors and the application of a dry chemical fire-extinguishing agent by the JAL mechanic. Additionally, on the lower edge of side 1, there was damage caused by a prying tool used by ARFF personnel in their efforts to remove the battery from the airplane. Side 2 of the battery case appeared to have the least visible damage of the four battery sides, with some soot residue observed and an area of bulking and a missing battery case attachment bracket associated with the battery's removal from the airplane. Sides 1 and 2 of the battery case are shown in figures 6 and 7, respectively.

Figure 6. Side 1 (forward face) of the battery case.

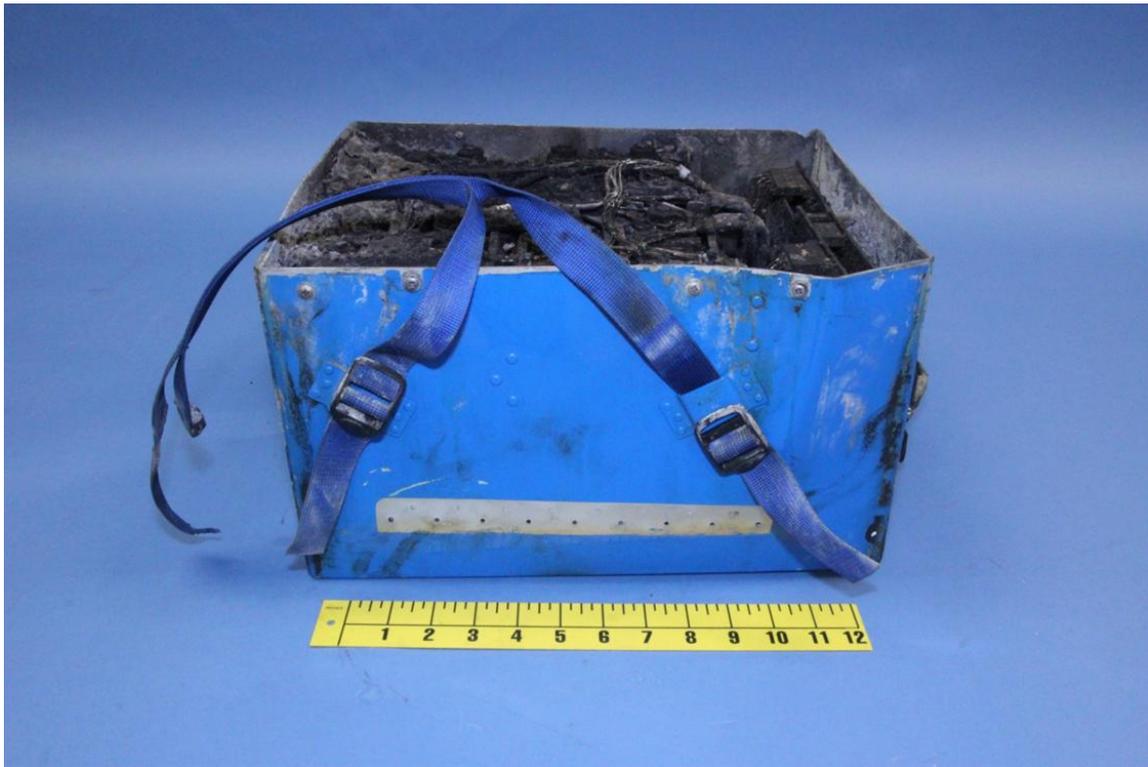
Figure 7. Side 2 (left side) of the battery case.

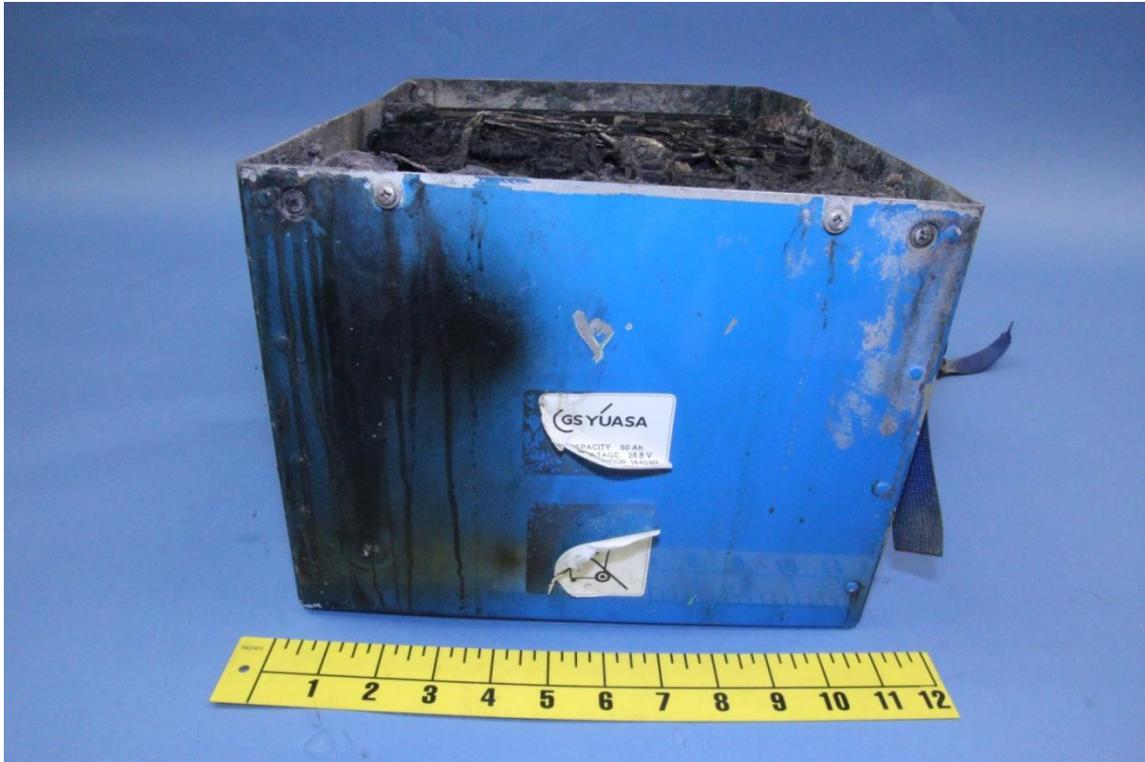
Side 3 of the battery case appeared to be minimally damaged near side 2 but was more heavily damaged near side 4. Vertical black streaks, which were consistent with residue from dripping liquid, were observed toward side 4 in a location that corresponded to the damaged corner of the battery lid. A roughly oval deposit of black residue covered the side 3 upper face near the side 4 edge. Side 3 had a mostly circular distortion—a paint discoloration about 1 inch in diameter with a 0.25-inch-wide nodular protrusion in the middle—near the lower corner adjoining sides 3 and 4. The protrusion was located about 1.5 inches from the bottom and 1.5 inches from the left edge. Side 3 of the battery case is shown in figure 8.

Figure 8. Side 3 (aft face) of the battery case.

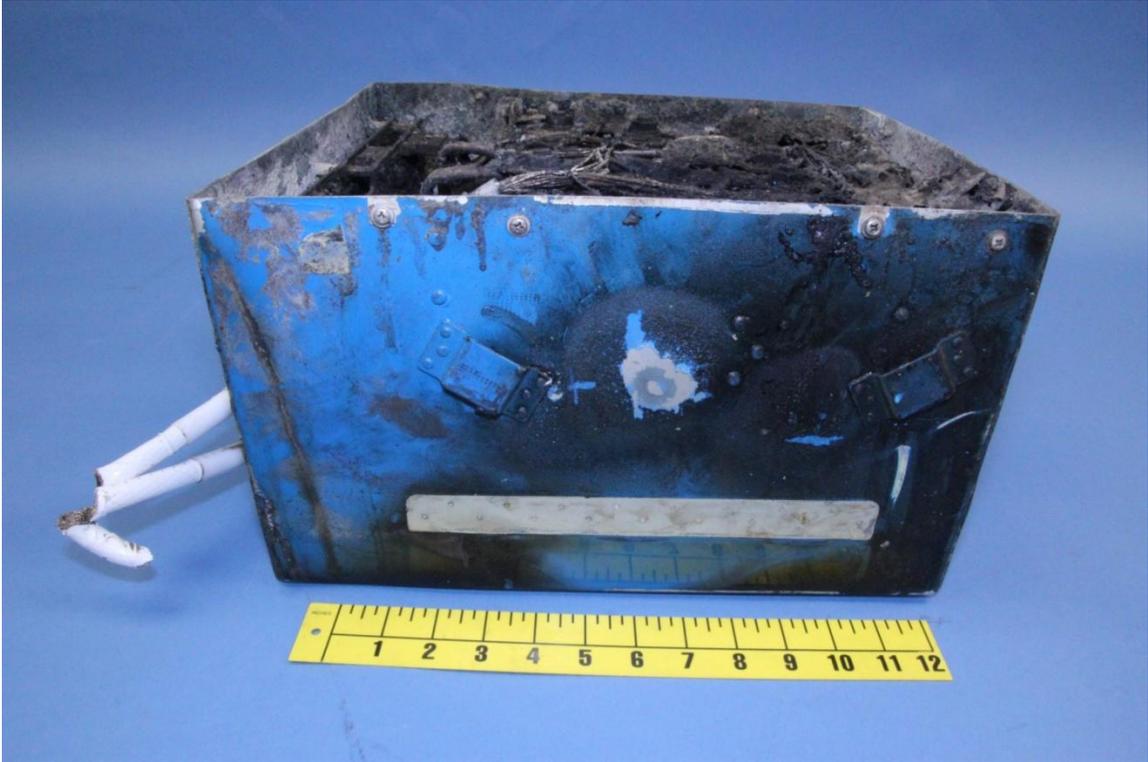
Side 4 of the battery case appeared to have the most extensive damage of the four battery sides. The exterior was heavily coated with black residue that was concentrated near side 3. Thicker black deposits were visible on the right side near the battery lid. Large, mostly circular areas of thermal damage to the paint were located at the same elevation as the battery cell vent discs,³² as viewed from the exterior. A distortion and an area of missing paint were adjacent to and opposite of the cell 7 vent disc. An area of thermal damage to the paint was adjacent to and opposite the cell 6 vent disc. In both of these vent disc locations, the black residue that remained had a different appearance than the surrounding residue. For the cell 7 vent disc location, the soot and paint had disbonded, leaving a relatively concentric appearance. Paint discolorations were also visible at the cell 5 and 8 locations. The battery case attachment bracket was missing from this side, which was consistent with the removal of the battery from the airplane by ARFF personnel. Side 4 of the battery case is shown in figure 9.

Figure 9. Side 4 (right side) of the battery case.

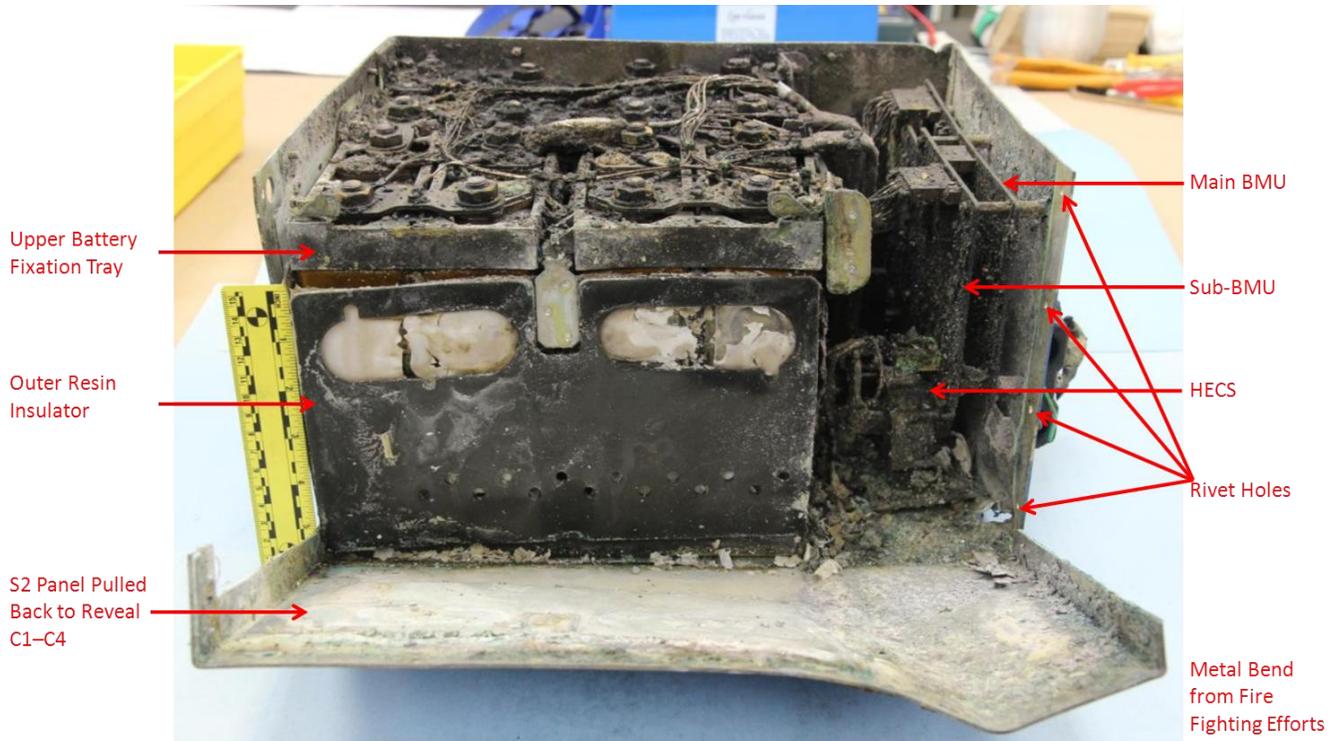
The battery was disassembled so that the internal components could be examined. Side 2 of the battery case was folded down to reveal cells 1 through 4, as shown in figure 10. The insulation sheet remained in place adjacent to the battery cells. Behind the insulation, a portion of the insulation sheet was visible but was missing some sections. Although the insulation between cells 1 through 4 was damaged, the material was distinguishable from other thermally damaged material in the battery case. The interior surface of folded-down side 2 had a clean area with a similar outline to that of the insulation sheet. The rest of the interior surface of side 2 was coated with residue.

Figure 10. Battery case with side 2 folded down.

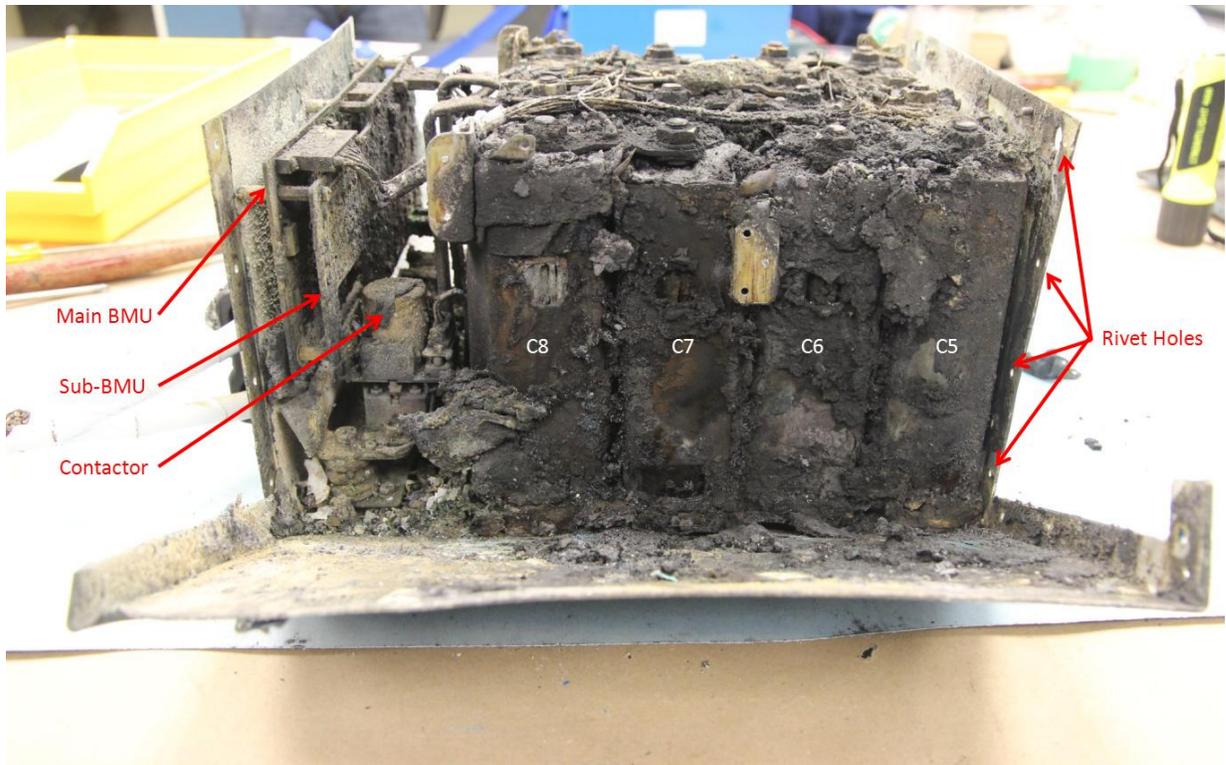
Battery case side 4 was folded down to reveal the position of cells 5 through 8, as shown in figure 11. The cells exhibited a darkened, charred appearance. The insulation sheets were completely charred and were indistinguishable from each other and other thermally damaged material in the battery case, and portions of the charred insulation adhered to the cells. The interior surface of folded-down side 4 had portions of the charred insulation adhering to areas where the insulation sheets contacted the interior surface. The rest of the interior surface of side 4 was coated with residue.

Figure 11. Battery case with side 4 folded down.

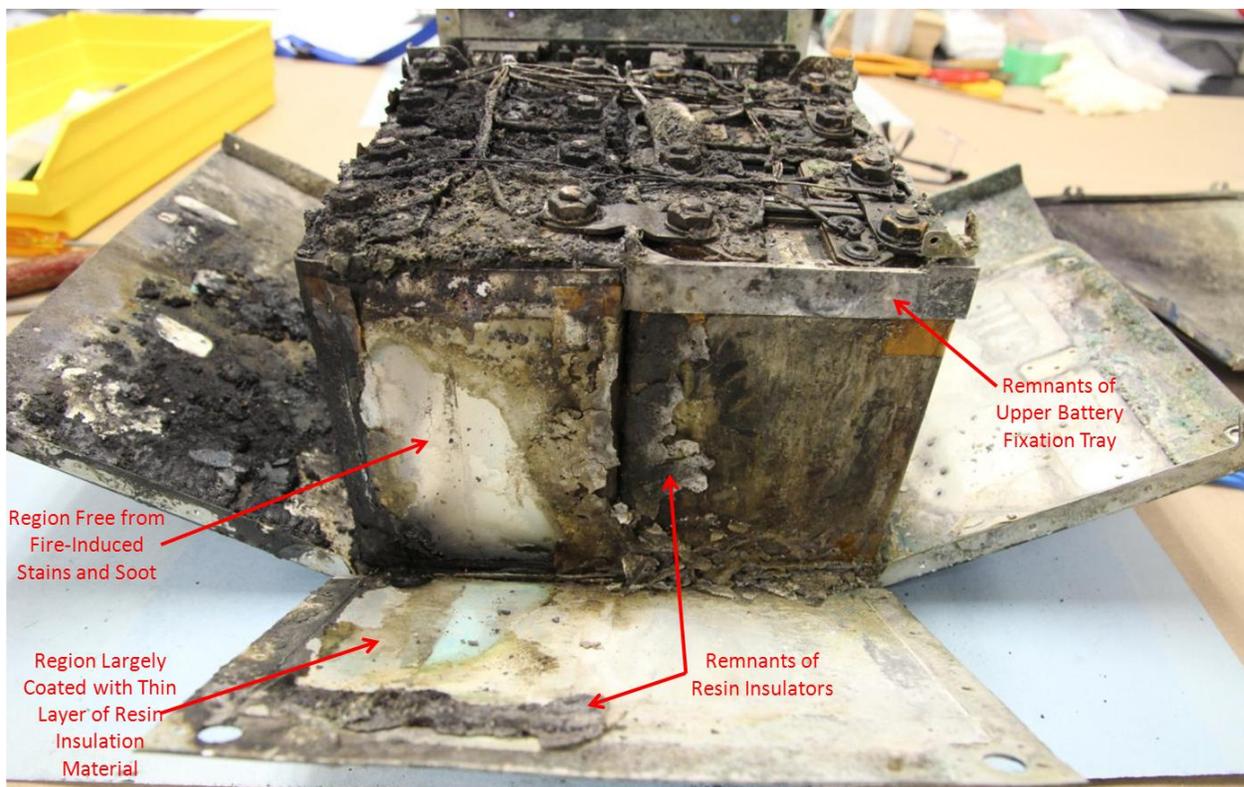
Side 3 of the battery case was folded down to reveal the sides of cells 4 and 5, as shown in figure 12. The side of cell 4 had staining that resembled a flowing residue. The side of cell 5 had similar staining but also had a clean area on the cell case. The corresponding area on the interior surface of folded-down side 3 had large portions of insulation adhering to it. The insulation along side 3 was thermally degraded and fragmented, and the portions of the insulation adhering to the battery case directly behind cell 5 exhibited some thinning. The damage in the area of the nodular protrusion that was observed on the side 3 battery case corresponded with damage to the cell 5 case, as discussed in section 1.5.3.

Figure 12. Battery case with side 3 folded down.

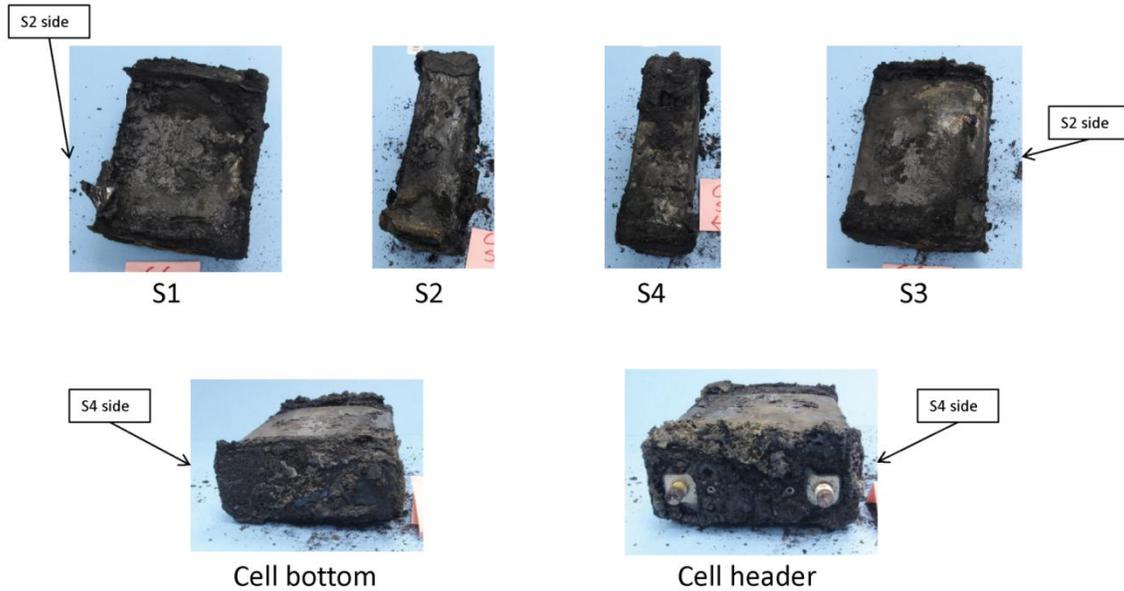
The battery cells exhibiting the least thermal and mechanical damage were cells 1 through 4, which were located along the left side of the battery assembly. Of these cells, cell 3 appeared to be the most thermally damaged. Cells 1 through 3 had vented (that is, their vent discs had opened slightly), but the cell 4 vent disc remained intact, although weight measurements indicated that the cell lost some electrolyte. The battery cells exhibiting the most thermal and mechanical damage were cells 5 through 8, which were located along the right side of the battery assembly. The thermal damage was indicated by thermal decomposition and degradation of the materials in contact with these cells. These materials included bisphenol A (commonly referred to as BPA) thermoplastic polyester, which decomposes at a temperature of about 550° F, and sulfide crystalline thermoplastic, which decomposes at a temperature of about 545° F. Thermal damage was the most severe near cell 6, as shown in figure 13. The vent discs on cells 5 through 8 had ruptured in a manner indicative of a rapid pressure release.³³ Cells 5 through 8 had sustained gross mechanical plastic deformation with cells pressing into neighboring cells.

Figure 13. Views of cell 6.

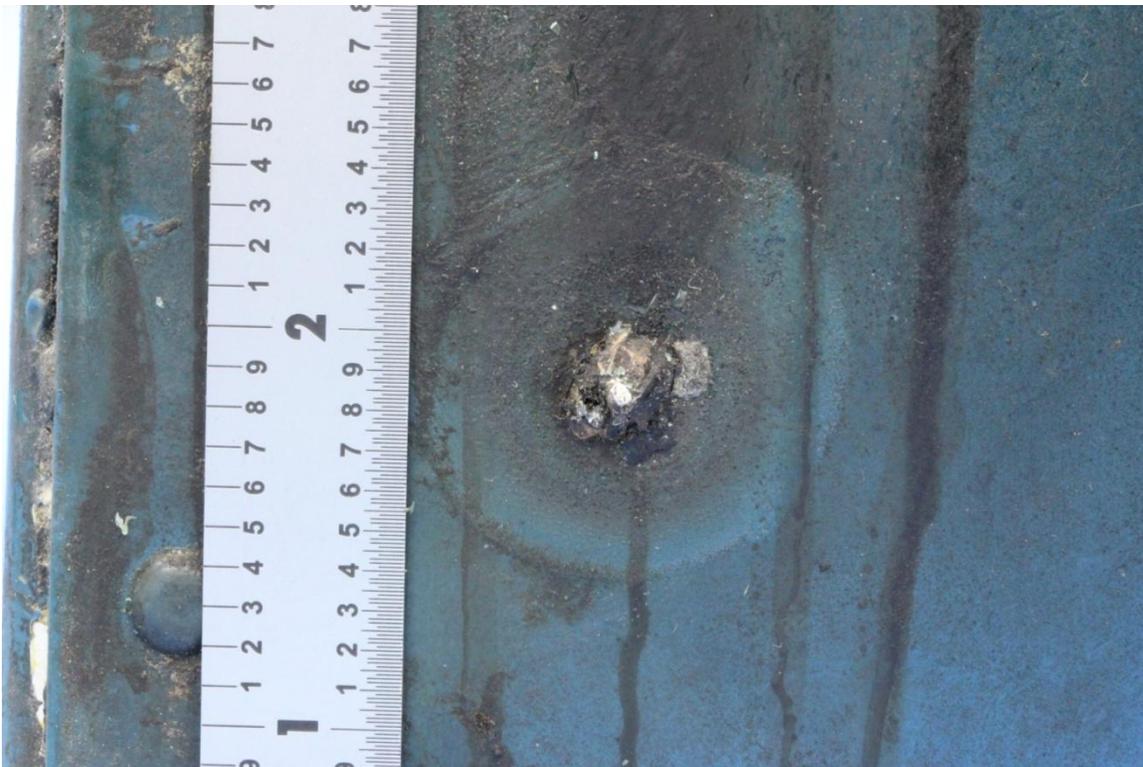
As previously stated, the battery case exhibited a 0.25-inch-wide nodular protrusion on the lower left of side 3, as shown in figure 14. The protrusion extended about 0.12 inch from the case. Two concentric rings surrounding the protrusion corresponded with the discoloration of the exterior paint. (The protrusion appeared metallic and was absent of paint.) Deposits consistent with thermally degraded materials were observed on and near the protrusion, and at least three holes in the battery case and on the periphery of the protrusion were identified. The largest of these holes was elliptical in shape, with its longest dimension measuring 0.080 inch. The two other holes, which were similar in size, measured about 0.004 inch. Most of the interior side of the protrusion contained dull gray flakey material that was consistent with spatter and shiny black material that was consistent with charred plastics and tars.

Figure 14. Protrusion on the lower left of battery cases side 3.

The side of the cell 5 case that faced side 3 of the battery case had been heavily damaged, especially on its periphery. Four holes measuring between 0.005 and 0.050 inch were identified on the lower portions of this side of the cell case, all of which exhibited large amounts of dark, rough-appearing features consistent with decomposition products. The largest hole (in terms of size and amount of decomposition products) corresponded with the location of the protrusion on the battery case.

The protrusion was inspected using a scanning electron microscope (SEM) and energy dispersive x-ray spectroscopy (EDS). The inspections determined that arc damage occurred from contact between the cell 5 case and the battery case.³⁴ Evidence of material transfer between the cases was only found on the interior surface of the battery case and exterior surface of the cell case. The case for cell 5 is located about 0.2 inch from the battery case. The battery case exhibited no inward deformation at the protrusion, whereas the cell case exhibited outward expansion. These features are indicative of arc damage between the cases after expansion of cell 5. SEM and EDS inspections also showed that all the holes on the cell 5 case exhibited various compounds and alloys that were not part of the cell case material, and inspection by EDS showed that this material was consistent with the battery case material.

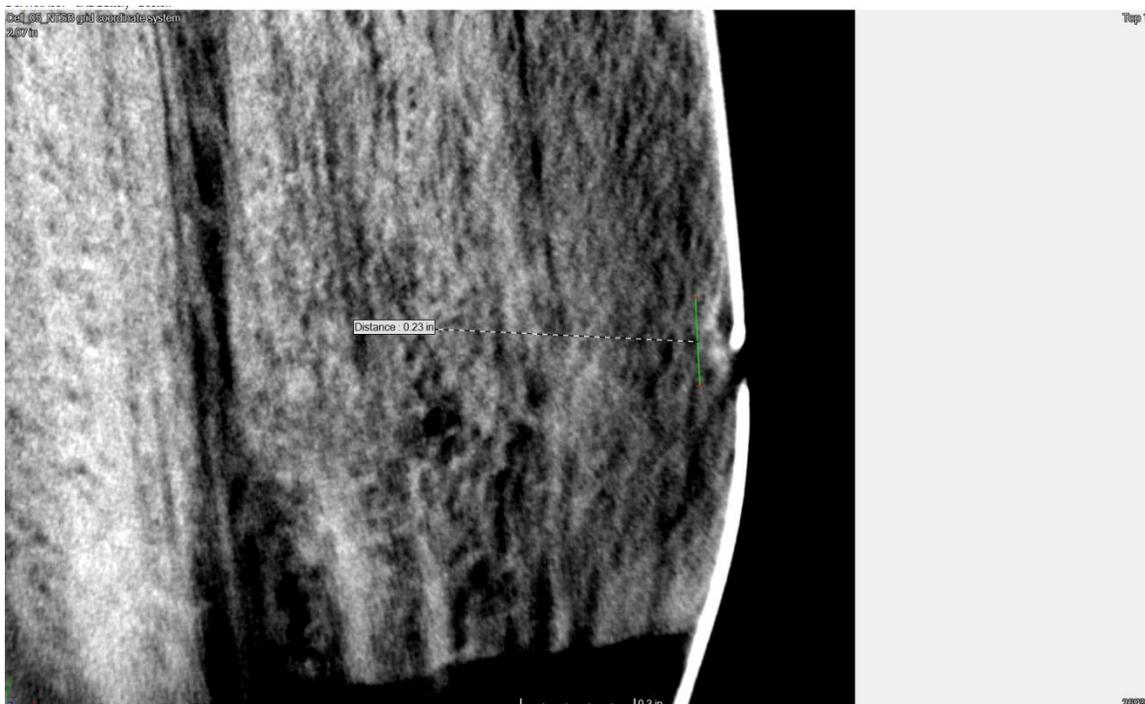
- There were two cell wall breaches in separate locations identified during the radiographic examination.³⁷ The larger of the two breaches appeared to consist of separate smaller holes, as shown in figure 16. The smaller breach appeared to consist of a single hole with some material missing from the outer cell wall around the hole. There were some anomalies inside the cell near the breaches; these areas differed from the general appearance of the cell.

Figure 16. Top view of cell 5 showing cell wall breach.

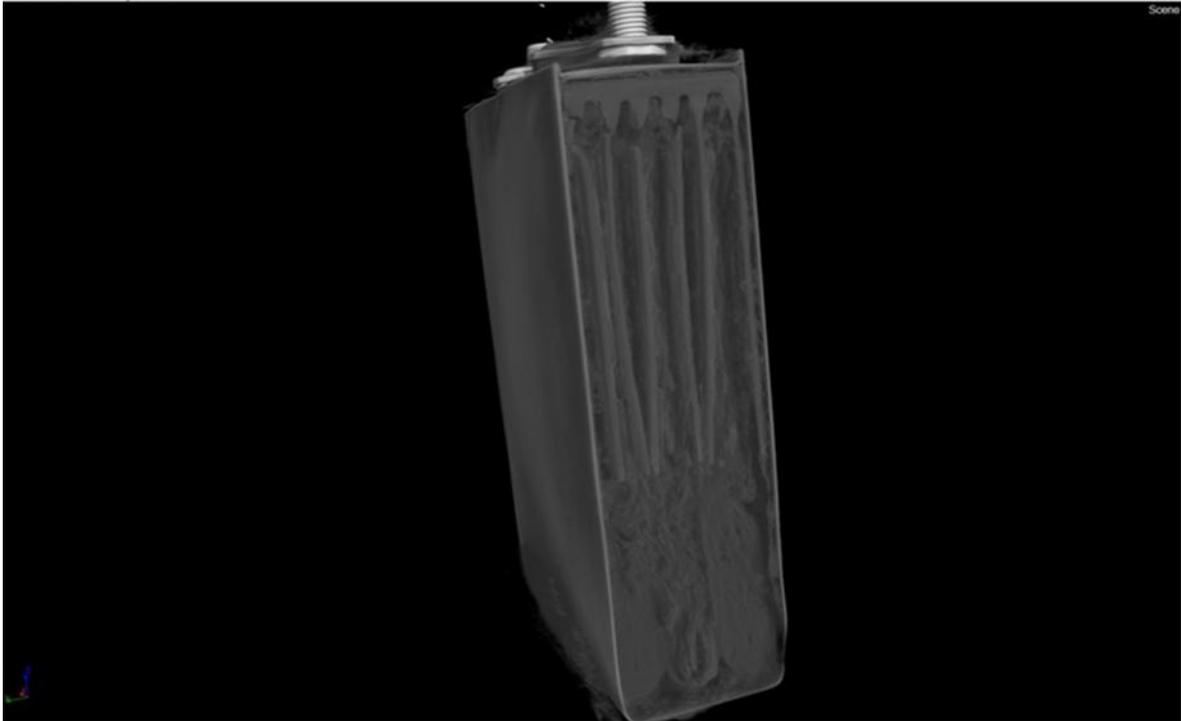
- Four of the six aluminum (cathode) current collector fingers had breaks, as shown in figure 17, including one that had multiple breaks and one that was missing more material in its break than the other current collector fingers with breaks. The gap in missing material measured about 0.15 inch. The copper (anode) current collectors were intact.
- There were a number of locations where a lump of medium-radiodensity material appeared to have flowed outside of the electrode assembly. In general, a small ribbon of material connected the lump with the rest of the electrode assembly.

Figure 17. Three-dimensional view of aluminum current collectors in cell 6.

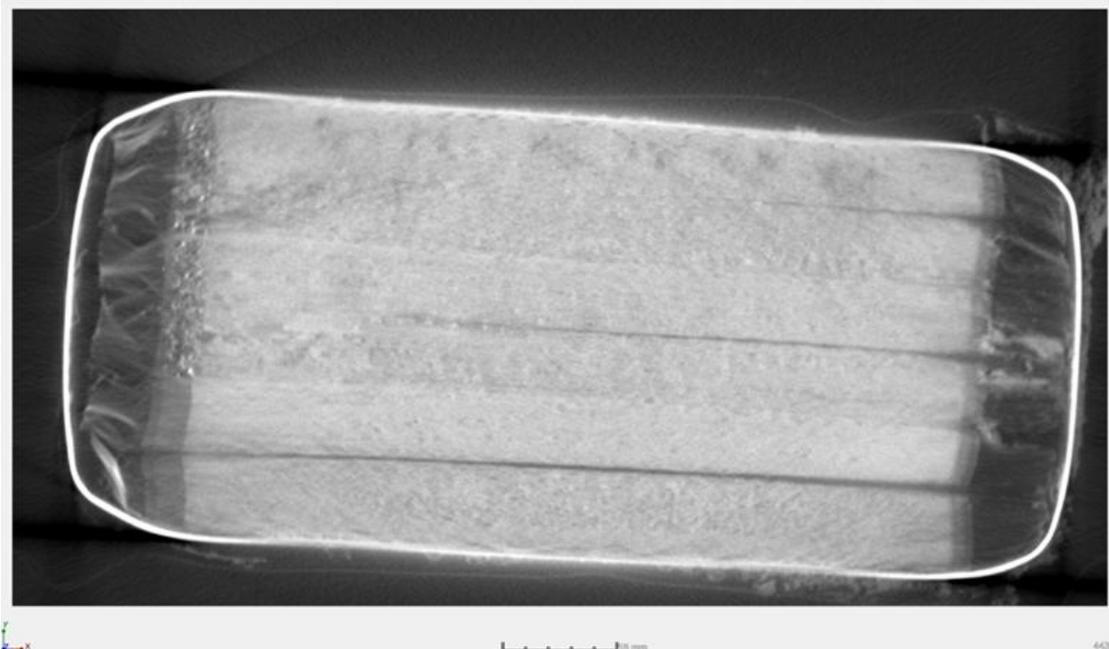
- A possible low-radiodensity area was noted at the top of the cell between the electrodes, and a distinct high-radiodensity region was noted in the cell wall.
- Four of the six aluminum (cathode) current collector fingers had breaks, including one that had multiple breaks. All six fingers appeared to be displaced from their original positions. The copper (anode) current collectors were intact.
- There were some variations in the appearance of the electrode assembly throughout the cell. In particular, the electrode assembly in one location appeared to be more granular than other areas in the cell, as shown in figure 18.

Figure 18. Granularity noted in top view of cell 7.

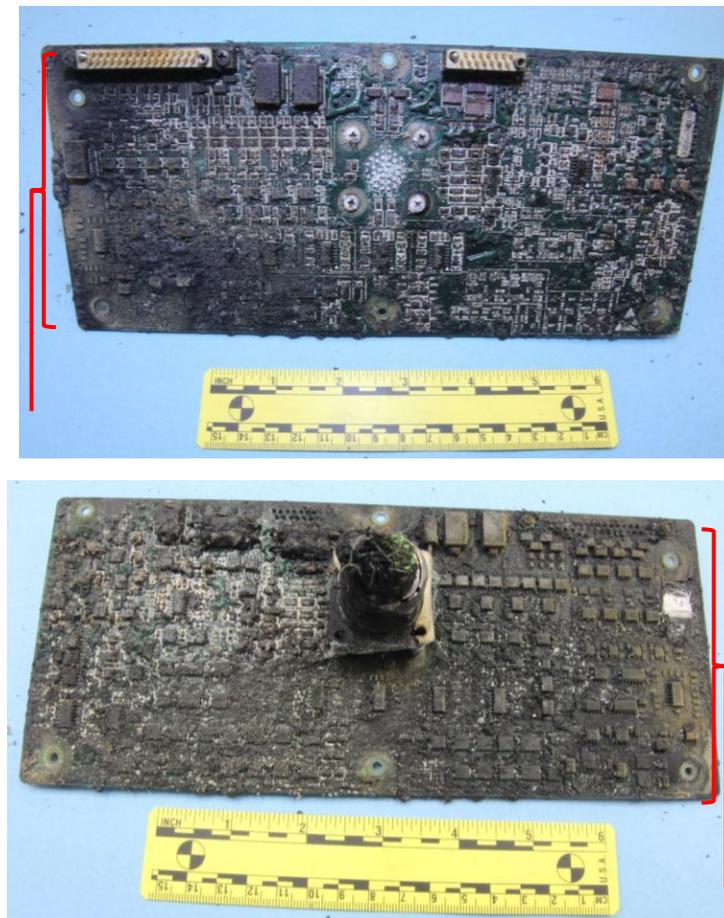
The BMU main circuit card and sub-circuit card were visually inspected before functional testing began. The visual inspections found thermal damage to various components, including the printed wiring boards⁴⁰; the damage to the BMU main board is shown in figure 19. The thermal damage precluded the ATP from being performed. (The ATPs for the BMU main circuit card and sub-circuit card were completed successfully during the manufacturing process in May and June 2012, respectively.)

Figure 19. Battery monitoring unit main board.
