In-Flight Inferno

BY MARK LACAGNINA

This article is based on the English translation of Republic of Korea Aircraft and Railway Accident Investigation Board Aircraft Accident Report ARAIB/AAR1105, “Crash Into the Sea After an In-Flight Fire, Asiana Airlines, Boeing 747-400F, HL7604, International Waters 130 km West of Jeju International Airport, 28 July 2011.” The report is available at <araib.go.kr>.

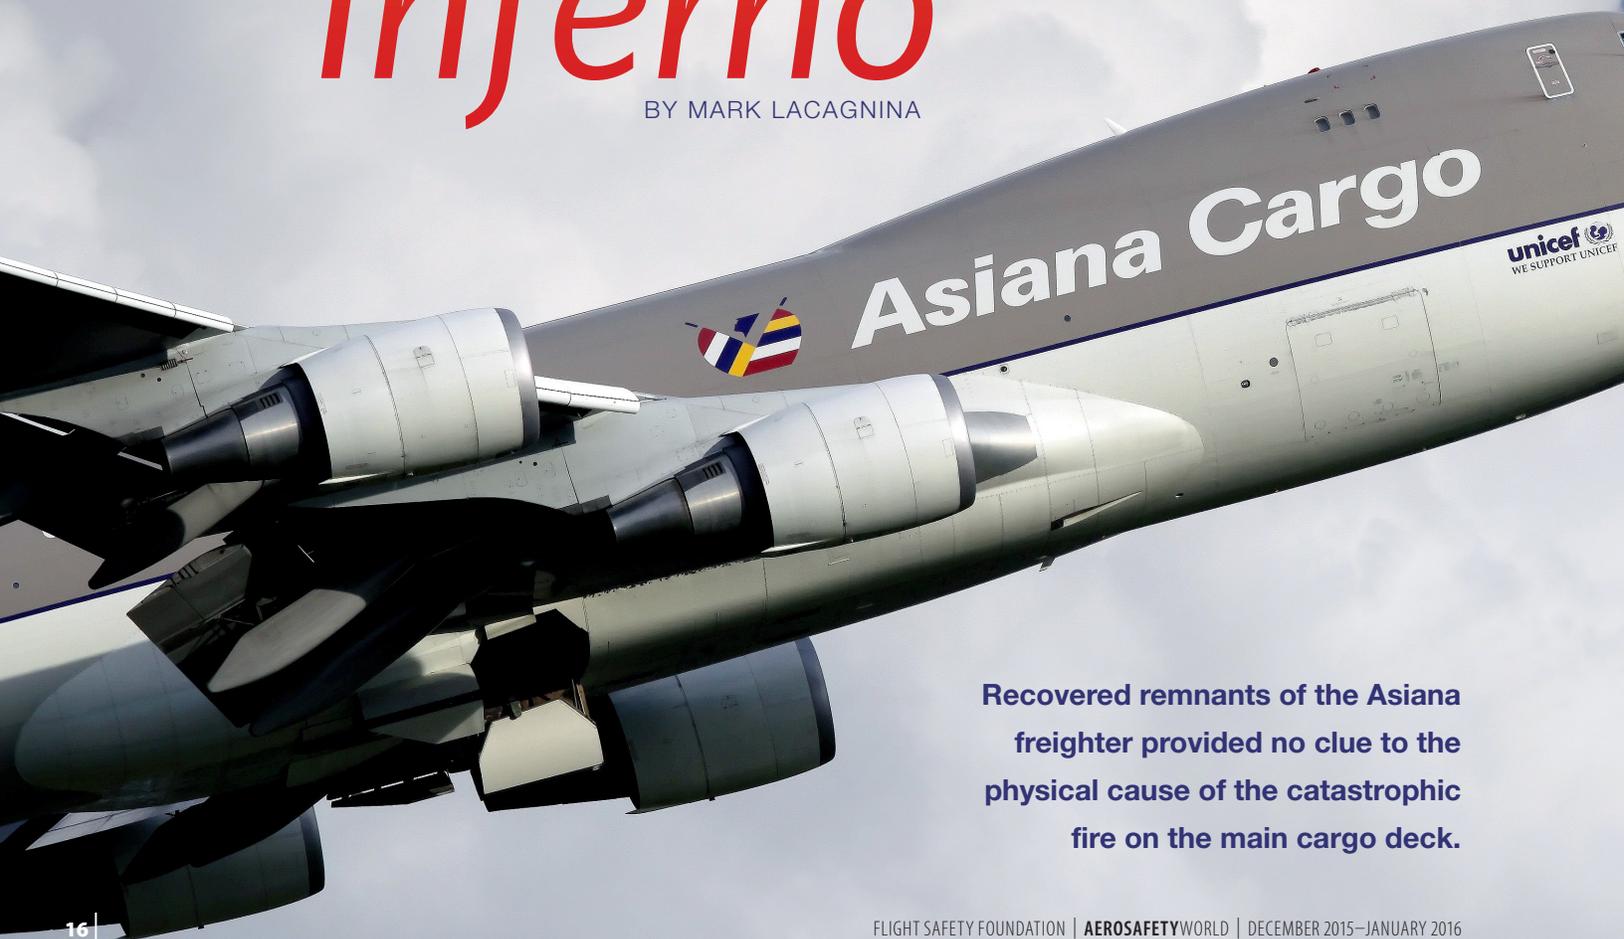
Recovered remnants of the Asiana freighter provided no clue to the physical cause of the catastrophic fire on the main cargo deck.

Areas of the main cargo deck near the dangerous-goods pallets had "shattered into many pieces due to dangerous goods' explosive energy," the report said. Residues of the flammable liquids and paint were found on the upper surface of the right wing, and small electronic devices packaged among the cargo were found embedded in composite wing structures.

The energy that caused this "was generated by fire-induced explosion of flammable materials and lithium-ion batteries," the report said. "The ARAIB assumes that a fire likely broke out first on or near the pallets containing the dangerous goods, but physical evidence of the cause of the fire was not found."

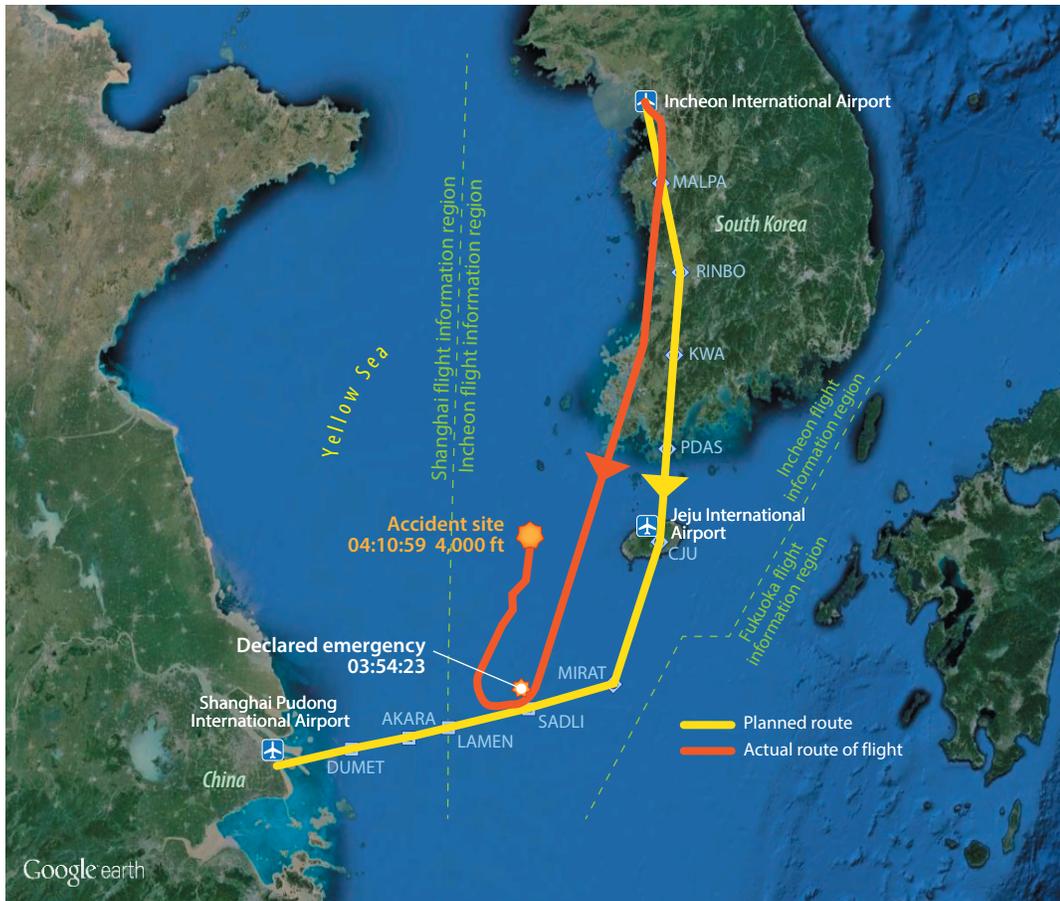
The flight crew lost control of the crippled aircraft while attempting to divert to Jeju International Airport.

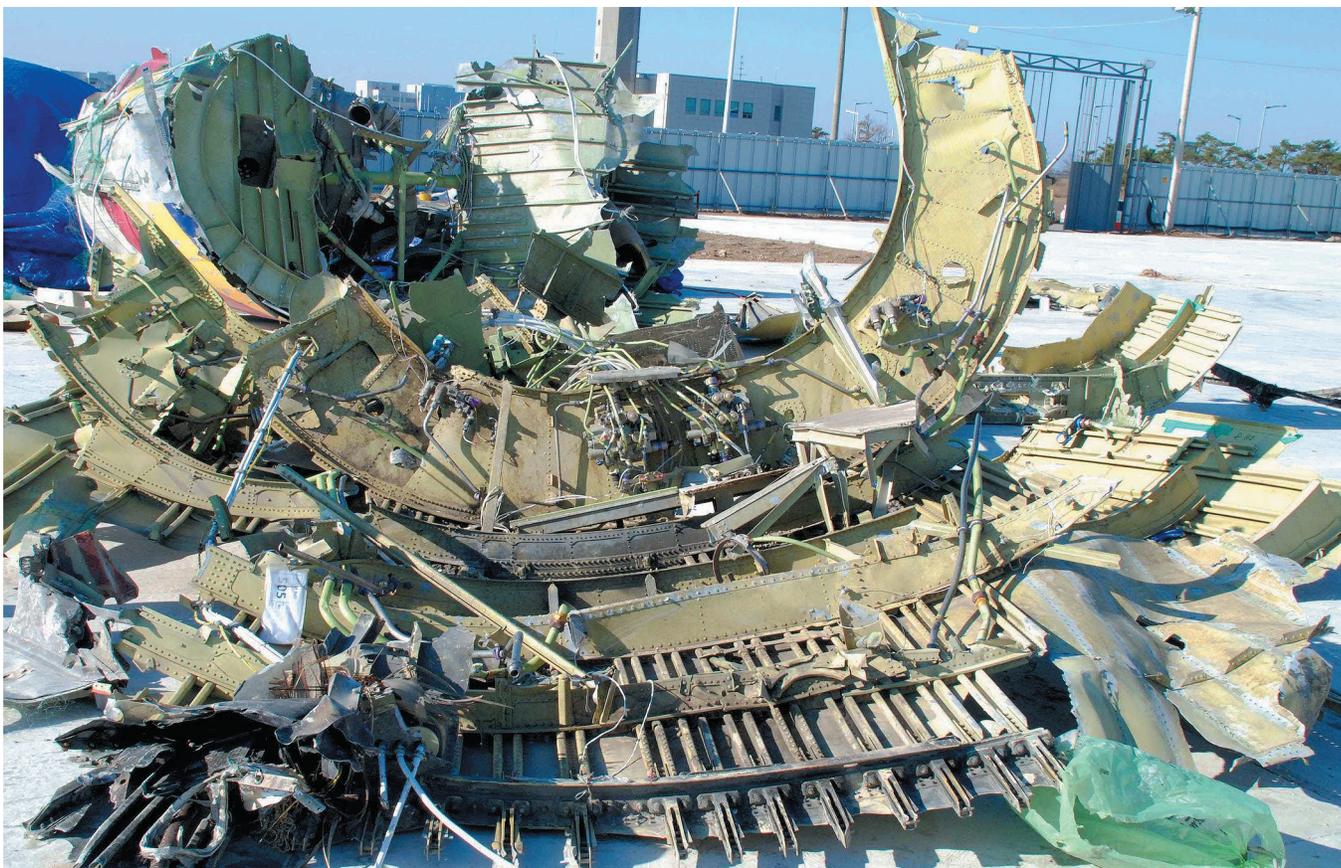
Only a portion of the wreckage, including about 40 percent of the fuselage skin and 15 percent of the cargo, was recovered from the sea floor, about 87 m (285 ft) below the surface of the Yellow Sea.

Only a portion of the wreckage was retrieved from the sea floor.
