Investigation Report

Type of Occurrence:	Serious incident
Date:	19 December 2010
Location:	Köln/Bonn
Aircraft:	Airplane
Manufacturer / Model:	Airbus / A319-132
Injuries to Persons:	Two persons with minor injuries
Damage:	None
Other Damage:	None
Information Source:	Investigation by BFU
State File Number:	BFU 5X018-10

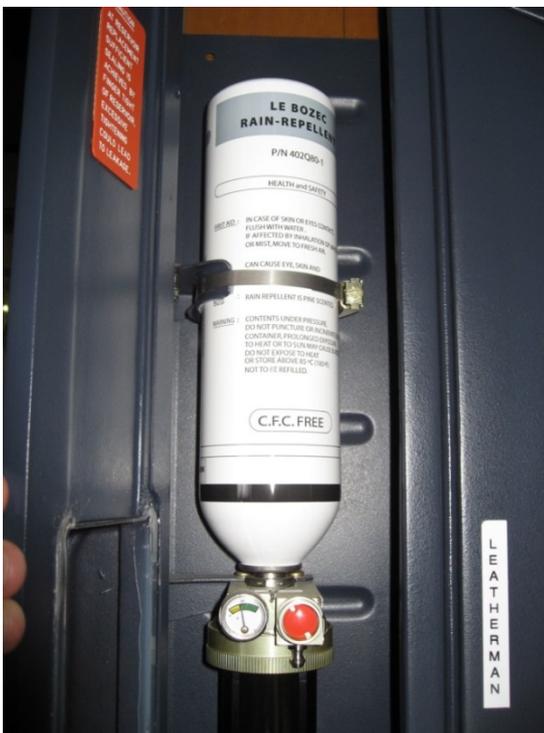
Image 6: Rain repellent cartridge Source: BFU

The BFU is of the opinion that a leakage in the rain repellent system is not very likely. Components of the system are installed in the cockpit and smell development would have been linked with leakage of the fluid. Such leakage was neither determined during maintenance nor did it occur on subsequent flights.

Furthermore, the description of the smell did not correspond with the description (pine scented) the manufacturer had given. The Safety Data Sheet classified the fluid as hazard-free. The manufacturer stated that in high concentrations irritations, indisposition and shortness of breath occur when inhaled. Both pilots confirmed that they had not noticed any irritations of their respiratory system or any acute shortness of breath.
