## ***Report RL 2008:01e***

**Aircraft incident to SE-DSP in airspace  
south-west of Stockholm, AB county,  
Sweden, on 22 March 2007.**

Case L-04/07

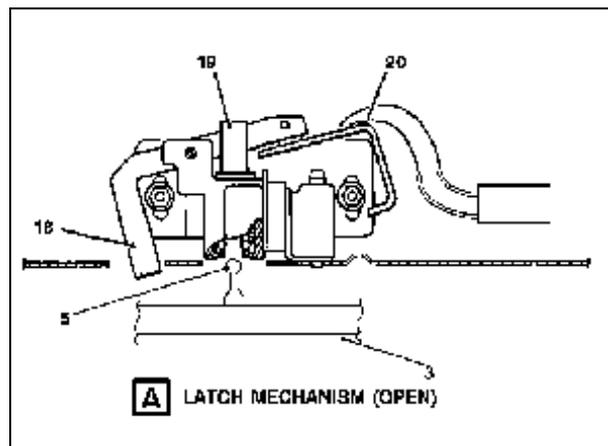
*Fig. 3*

The reason why 20 of the oxygen mask hatches did not open was that the company’s quality control was deficient in connection with the repacking of the hatches.

The hatches have a latching mechanism that consists of a ball-shaped plunger on the hatch cover that projects into the hatch frame and is locked by a spring-loaded catch that can be electrically opened. See Fig. 3 below.

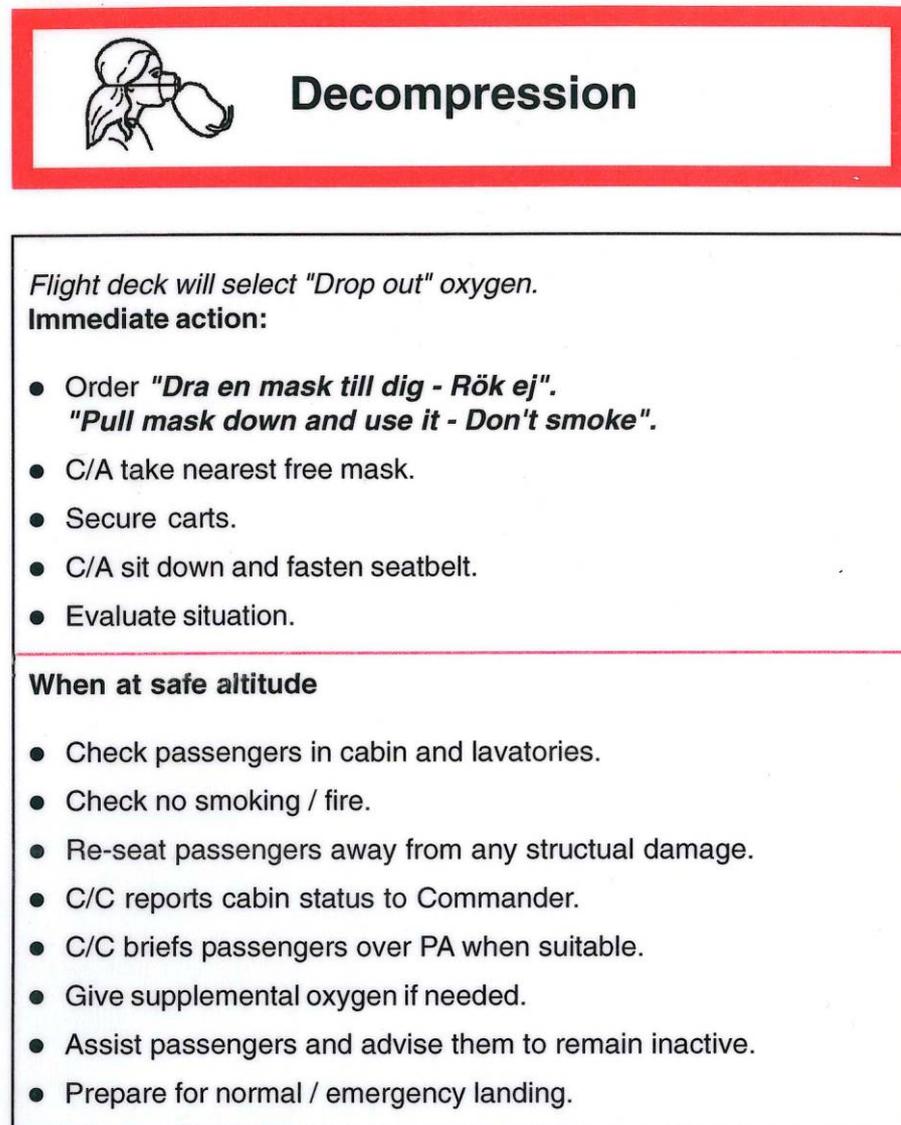
*Fig. 5*

From the checklist it can be seen that instructing the passengers is the first action for the CAs when the masks drop down, after which they should see to their own oxygen supply. The serving carts are to be put away and secured, after which the CAs should sit down with seat belts fastened. No checks or communication with the cockpit are prescribed in this part of the checklist.

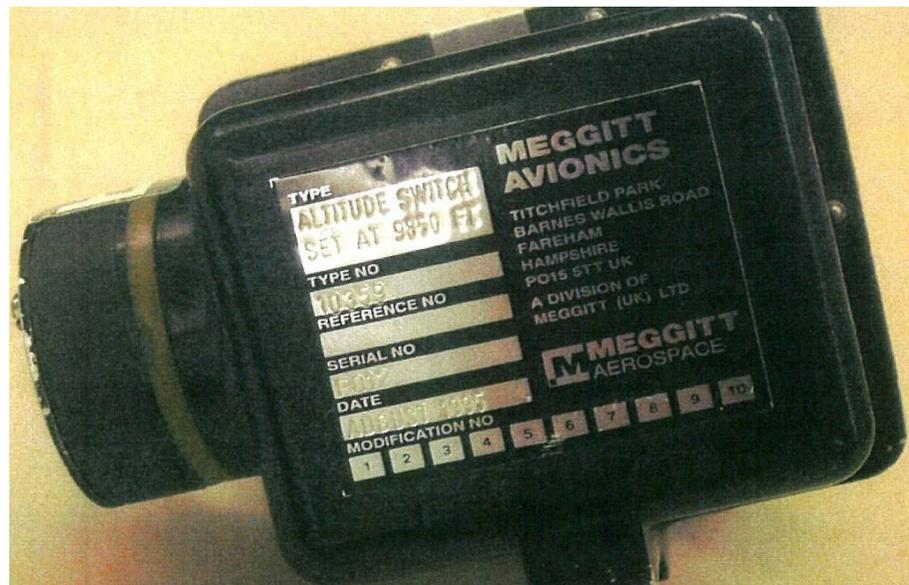
*Fig. 6. The pressure sensor*

During testing it was found that the unit was physically damaged and that there was a major leakage of air at a ventilation screw.

Even though the damage did not in a laboratory environment show any measurable effect on the tests, it is not unlikely that in its operational environment in the aircraft, this contributed to incorrect functioning of the unit. It cannot be considered very surprising that a 12-year-old unit that does not need to be functionally tested more often than every 15 000 flying hours, and that does not normally operate in the outer pressure area where

the warning should activate, does not perform its intended function when in a damaged condition.

SHK has not been able to find out how the damage to the sensor occurred, or how long ago, but considers that a shorter inspection interval for these units probably provides a greater possibility for discovering damage and thereby preventing incorrect operation.

- f) Damage and leakage were found on examination of the pressure sensor.
- g) The checklist for "Avionics Fan Off" did not include a note that this fault could be caused by low cabin pressure.

- Takes steps to ensure that the inspection interval for cabin pressure sensors in this particular type of aircraft is reduced (*RL 2008:01e R2*).
- Takes steps to ensure that the emergency checklist in this particular type of aircraft is complemented with a note in the respect of checking cabin pressure when the “Avionics Fan Off” warning is activated while airborne (*RL 2008:01e R3*).
