COMISIÓN DE INVESTIGACIÓN DE ACCIDENTES E INCIDENTES DE AVIACIÓN CIVIL

TECHNICAL REPORT

**Accident occurred on 21 May 1998 to
Aircraft Airbus A-320-212 Registration G-UKLL
At Ibiza Airport, Balearic Islands**

A - 19/98

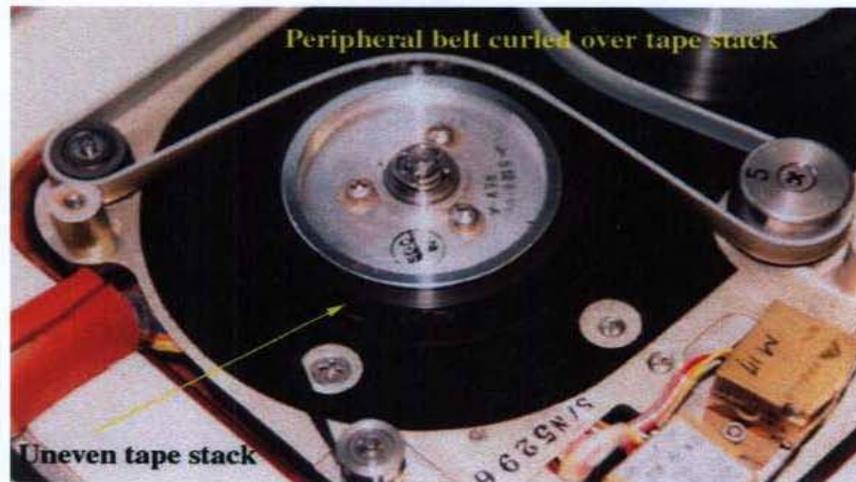
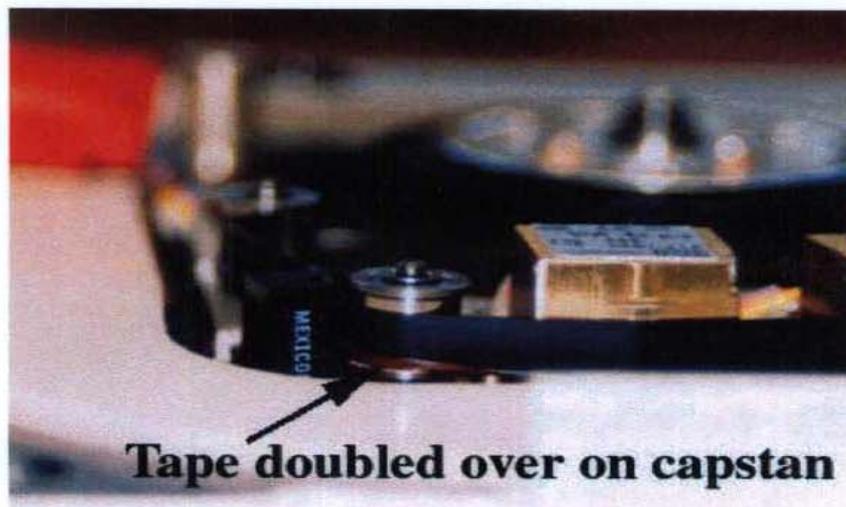
The unit was then examined in Madrid at the airline workshops. The tape enclosure was opened and the tape found to be damaged such that the unit would not run. The supply and take up reels are driven by a peripheral belt. As found, the peripheral belt was curled over the reel and the tape stack was uneven. The tape path from the supply reel to the take up reel, over the record heads, passes over a number of tape guides. At one of these tape guides, the tape had actually become doubled over causing damage to the tape.

During replay the FDR runs continuously and the most frequently reported failure mode in this condition is tape 'coning', where the flat disk appearance of a normal tape pack is distorted. When this occurs the tape becomes misaligned with the heads and no signal is obtained from the tape. In

this case the tape probably ‘coned’ during the initial replay by standard means, and continuing to run the recorder caused the damage seen in the tape assembly (see Appendix C).

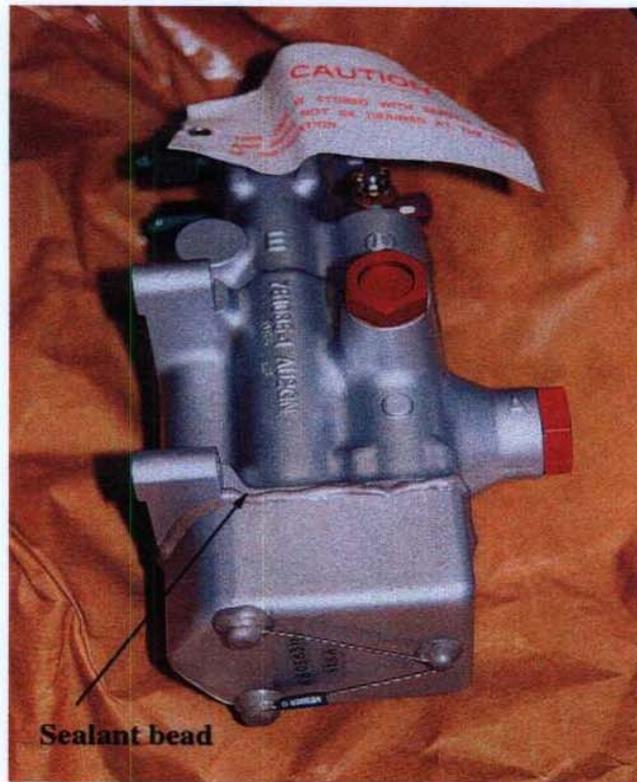
FIGURE 1. VIEW OF NEW BDDV TOGETHER WITH UNIT FROM G-UKLL

After the chamber had been force-warmed to ambient temperature, the BDDV was subjected to a further test to confirm that it was fully functional again, before being removed from the test rig. The cup-shaped cover at the base of the valve body was removed and found to contain a quantity of fluid. This consisted of 30 ml of dirty water and 3.5 ml of what appeared to be a mixture of hydraulic fluid and grease. This was later analysed by the Fuels and Lubricants laboratories at DERA, Pyestock, United Kingdom, along with the samples of hydraulic fluid taken from the BDDV prior to its installation in the environmental test rig.

The moving parts of the valve had been assembled with silicone grease and it was apparent that emulsification had occurred as result of contact with the water. However, there was no visible corrosion that may have impeded the operation of the valve. As a final check, the BDDV was reinstalled, with its cover, in the test chamber and cooled to

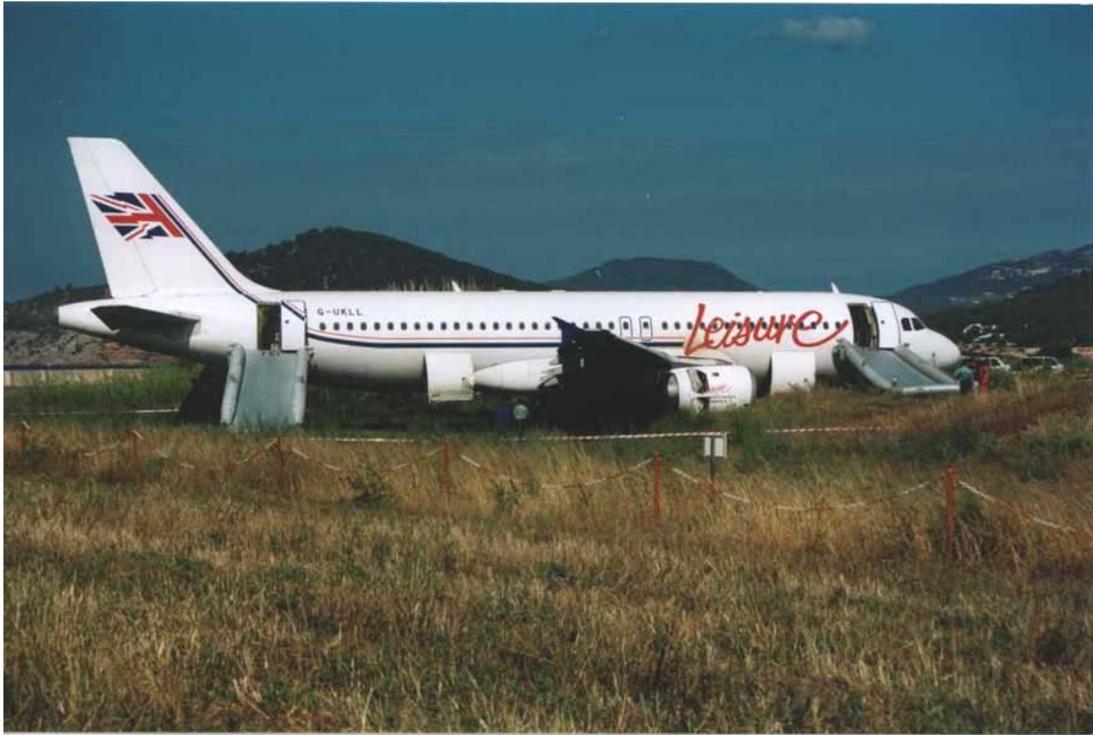
N° 1

- Nr. 1.- GENERAL VIEW.-- Right side.
- Nr. 2.- FRONT VIEW.-- Nose above a low earth bank.
- Nr. 3.- PATH ONROUGH TERRAIN.
- Nr. 4.- REAR VIEW.
- Nr. 5.-A/C PATH AND AIRFIELD LIGHTS BROKEN.
- Nr. 6.- RUBBER MARKS ON RWY 24.
- Nr. 7.- LEFT ENGINE.-- Embedded in ground.
- Nr. 8.- NOSE LANDING GEAR.-- Collapsed and broken.
- Nr. 9.- BRAKE CONTROL PANEL.
- Nr. 10.- COCPIT CENTRAL INSTRUMENT PANEL.
- Nr. 11.- RIGHT HAND LANDING GEAR. BAY.-- BDDV place.
- Nr. 12.- BSCU computer.
- Nr. 13.- Water an detergent found into BDDV lower cover.
- Nr. 14.- Lower part of BDDV jammed by presence of frozen water in its lower cover.

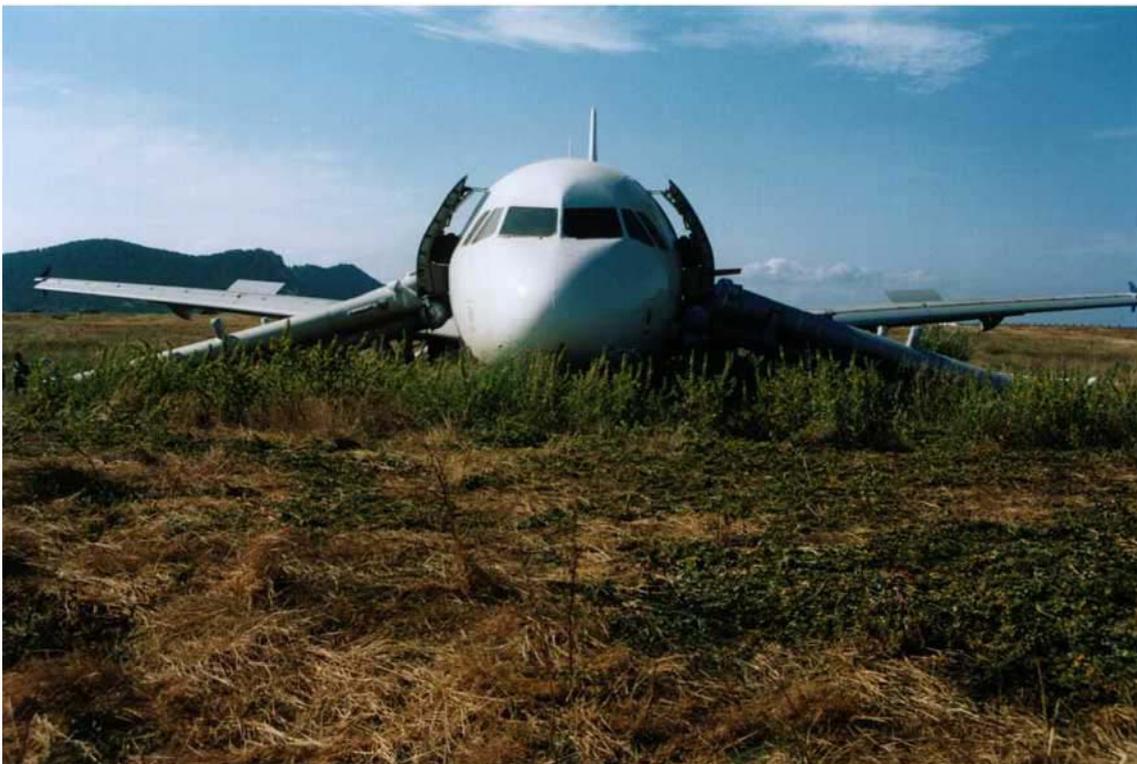
N° 2

The nose landing gear had collapsed rearwards and was broken. It was found between the two main landing gear doors, which were open.

Both engine nacelles were distorted at the bottom and were partially embedded in an earth embankment. Both engines suffered damage from ingress of earth and stones. Both engine reverses were deployed. The flaps and slats were extended to the landing position.
