## A340 Crew Conducts Emergency Landing With Left-main Gear Partially Extended

*The report said that a wheel-brake torque rod detached and prevented the left-main gear from extending fully. The aircraft was substantially damaged during the emergency landing at London Heathrow Airport. Seven occupants received minor injuries during evacuation.*

FSF Editorial Staff

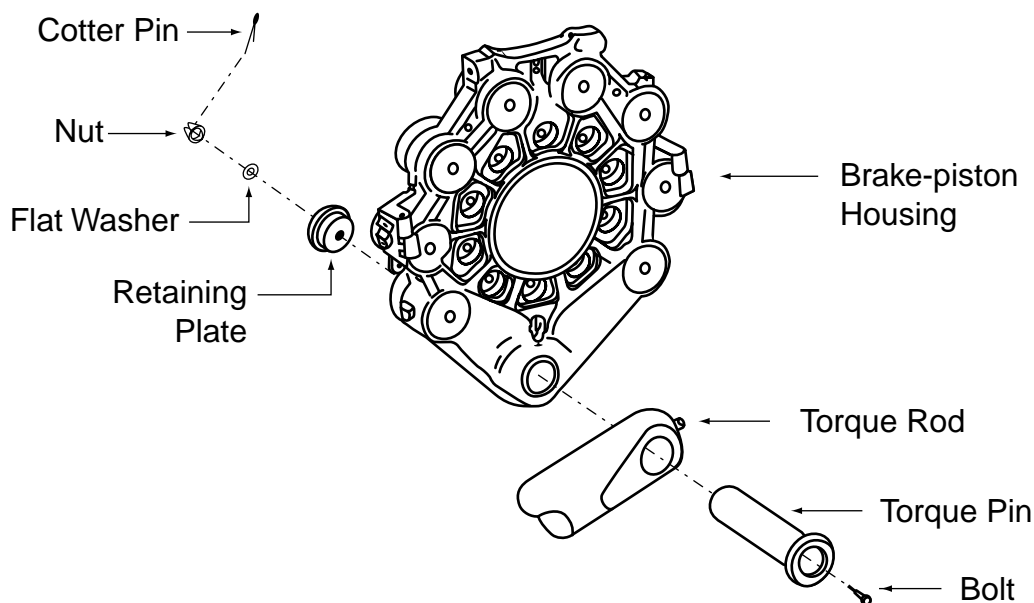
Figure 1

Postaccident examination of the aircraft showed that the no. 6 brake torque rod had disconnected from the brake-piston housing but had remained connected to the left-main landing gear strut. The disconnected end had moved from its normal alignment and had become trapped in the keel-beam structure inside the wheel bay.

The torque rod is designed to resist torque forces generated during braking and, thus, to prevent the brake-piston housing and related components from rotating. The torque rod normally is attached to the piston housing by a torque pin (Figure 1). The torque pin is installed through a slot in the torque rod and a bore in the piston housing. Two bushes (metal linings) are installed between the torque pin and the piston-housing bore. The torque pin is retained by a bolt, retaining plate, flat washer, nut and cotter pin.

### Brake-piston Housing and Torque-rod Assembly; Virgin Atlantic Airways Airbus A340; London, England; Nov. 5, 1997

Examination of the bushes in the accident-aircraft’s piston housing showed that the bush closest to the torque rod had moved slightly from its normal position. One side of the bush had moved 0.58 millimeter (0.023 inch); the other side of the bush had moved 0.48 millimeter (0.019 inch).

The piston-housing bore, normally round, had an oval indentation of 0.23 millimeter (0.009 inch). The indentation extended about one-third of the way along the bore.

“Compression, not wear, was responsible for the dimensional change,” the report said. “Furthermore, the void thus created between the bush and the bore had become contaminated with debris . . . . This indicated that the damage was ‘old’ and had occurred long before the accident flight.”

The report said that the bore damage showed that “the braking loads transmitted through the torque rod in service had been greater than [the braking loads] anticipated during the design of the attachment assembly.”

The report said that tests by the brake manufacturer showed that torque-pin tensile (i.e., stretching) loads were higher than predicted during braking because of elastic deformation of the wheel axle, brake housing and torque rod.

“The increased tensile loading on the torque pin retaining assembly could have overstressed or fatigued the associated

bolt, or possible additional torsional [i.e., twisting] loads due to brake-rod rotation during bogie [wheel-assembly] articulation could have sheared the cotter pin and permitted the unsecured nut to disengage from the bolt,” the report said.

Actions taken after the accident included a redesign of the torque pin and retaining hardware, and the introduction of a secondary restraint system to prevent the torque rod from coming in contact with the aircraft structure after detachment of a torque pin.
