AAIB Bulletin No: 2/96

Ref: EW/C95/9/3

Aircraft Type and Registration: Airbus A340-311, G-VBUS

Location: Runway 09R at London Heathrow Airport

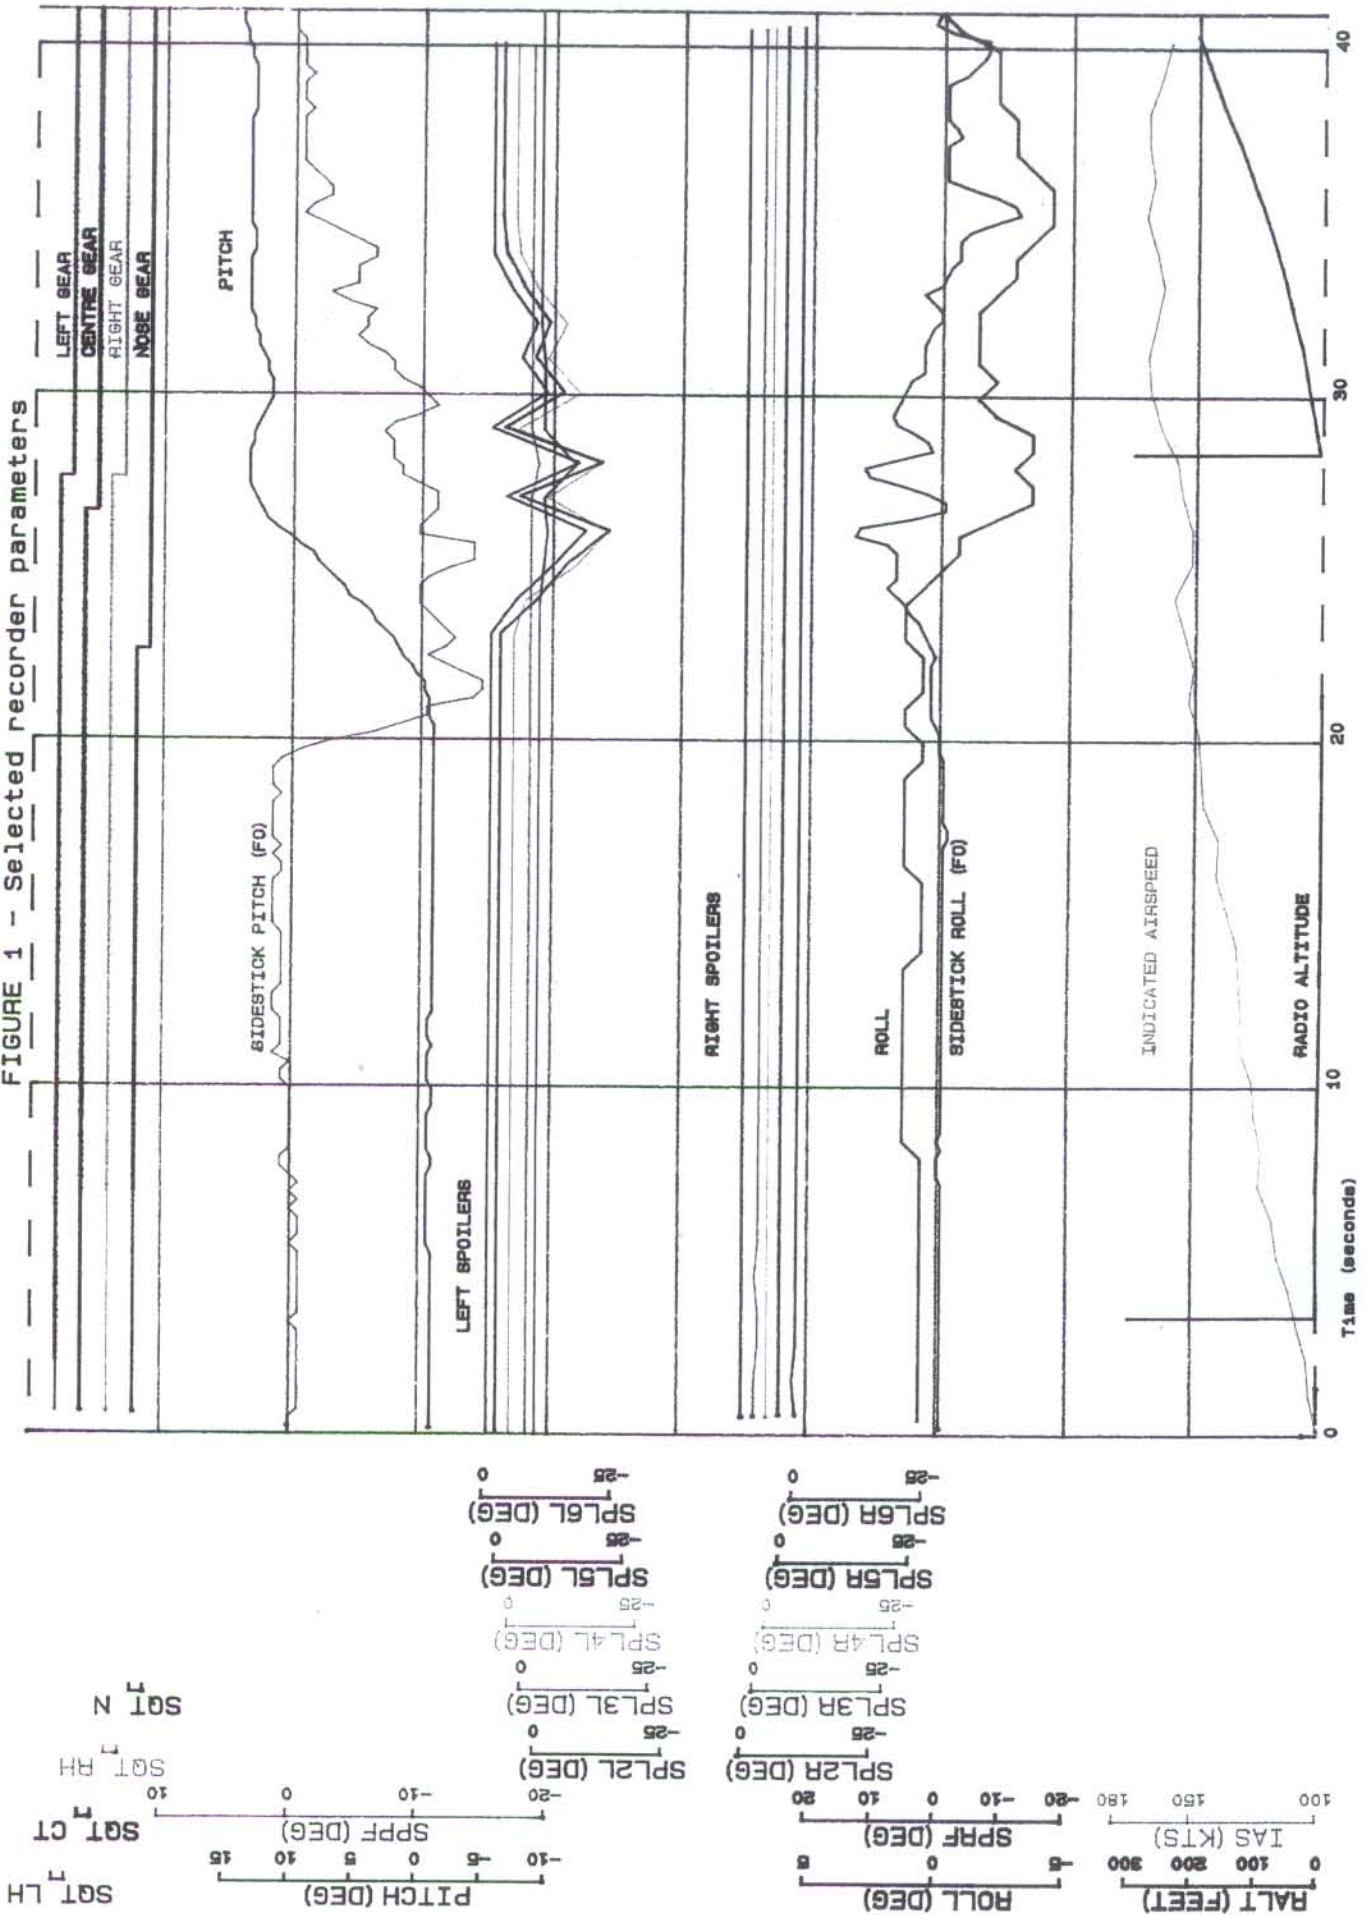
FIGURE 1 - Selected recorder parameters

The selected flight trace printout shown in Figure 1 shows that at an IAS of 148 kt (V_R-5 kt) the first officer began to pull on his sidestick and reached 14.8° of back stick over a period of 2 seconds (full aft sidestick deflection is 16°). The aircraft started to pitch-up and the first officer eased forward on the sidestick to a position of 12° aft. The nosewheel left the ground at a recorded IAS of 151 kt (154 kt corrected).

Over the subsequent 3 seconds the aircraft pitch rate stabilised at an average of 2.8°/sec and the aircraft achieved a pitch-up of 8° at a recorded IAS of 152 kt (158 kt corrected). During this period, the first officer applied up to 8° of left sidestick which resulted in the number 5 and 6 spoilers on the port side deploying to 7° and the aircraft rolled from 1.5° right wing down to 0.5° left wing down.

The first officer then pulled the sidestick back to 14° aft for a period of 0.75 seconds at the end of which the aircraft had reached a pitch of 10° and an IAS of 152 kt (158 kt corrected). The main centre gear fully extended at this time.

During the next half second, the aircraft pitch rate peaked at 3.3°/sec. The first officer applied 13° of left sidestick for half a second and the three outboard port spoilers deployed to 20°. The aircraft rolled from 0.5° to 3.4° left wing down. The sidestick was returned to the neutral roll position and both left and right main gear fully extended at an IAS of 156 kt (161 kt corrected which equals V_2+1 kt).

The aircraft achieved a maximum pitch of 13.4° one second after main gear extension. The sidestick was again moved 13° left for 0.5 seconds and the three outboard port spoilers deployed to 20°. The roll attitude of the aircraft remained unchanged at 3.5° left wing down.

The tailsrape occurred just prior to the lift-off with the aircraft pitched-up between 12 and 13° and an indicated airspeed of between 152 kt (158 kt corrected) and 156 kt (161 kt corrected).
