AVIATION INVESTIGATION REPORT
A02P0261

ENGINE POWER LOSS IN FLIGHT

CATHAY PACIFIC AIRWAYS
AIRBUS A340-300 B-HXN
TIMMINS, ONTARIO 40 nm W
20 OCTOBER 2002

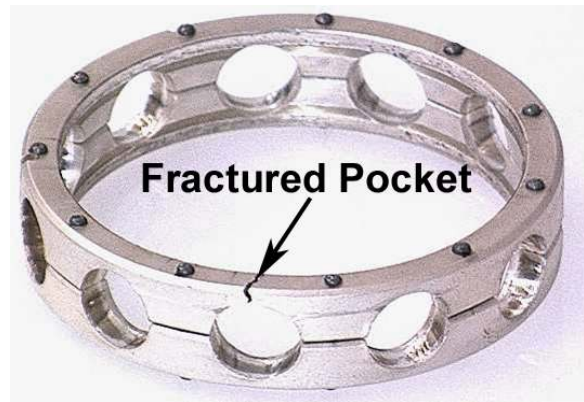
Photo 1. Ball bearing cage

When the replacement PMA was removed and inspected, it showed scoring and burning similar to the original PMA. The entire PMA drive shaft assembly—comprising PMA rotor, roller bearing, drive shaft, ball bearing support, and ball bearing—was removed and examined. A visible crack was found in the ball bearing cage that supports the drive shaft where it exits the gearbox (see Photo 1). The crack could not be seen with the drive shaft assembly in place in the gearbox. A new drive shaft assembly and a third PMA were then installed, and another engine run was performed, this time without anomaly.

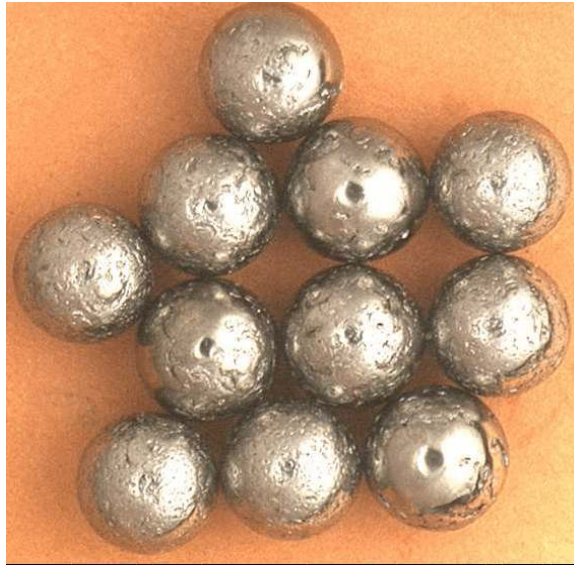
Photo 2. Spalled balls

The PMA drive shaft assembly was sent to CFM for examination and analysis. The CFM analysis of the failed ball bearing (part number 305-100-410-0, serial number UR06967) indicated that there was generalized spalling³ of the balls, wear on the cage pockets (including a fractured pocket), and sectorial spalling on 90° of the inner race (see photos 1 and 2). The ball bearing at this particular location is subject to temperatures as high as 160°C, and it rotates at about 20 000 rpm. There was no indication of corrosion. The roller bearing (part number 301-480-926-0) had two separate serial numbers on the races (inner race: UR31008, outer race: UR28466). No other anomalies were found on the remainder of the drive shaft components. The root cause of the spalling was not determined by CFM.

CFM concluded that the incident ball bearing failed as a result of radial overload stress, which induced inner race spalling, the origin of which occurred 50 to 70 μm in depth. Radial overload stress, also known as “contact fatigue,” results from two curved surfaces moving over each other in a rolling motion, as seen in a ball bearing over a raceway.⁵ The contact geometry and the motion of the rolling elements produce alternating subsurface shear stress, which generates and accumulates cracking. The cracking then propagates until a surface pit is formed and spalling results. If this degeneration continues, complete bearing failure occurs. Rolling contact components have a fatigue life, that is, a number of cycles to develop a noticeable fatigue spall.

1. As a result of radial overload stress (contact fatigue), spalling damage occurred to the balls in the inner race of the ball bearing on the drive shaft of the permanent magnet alternator (PMA) on the number 1 engine, resulting in bearing failure.
