**AVIATION INVESTIGATION REPORT
A05H0002**

RUNWAY OVERRUN AND FIRE

**AIR FRANCE
AIRBUS A340-313 F-GLZQ
TORONTO/LESTER B. PEARSON INTERNATIONAL
AIRPORT, ONTARIO
02 AUGUST 2005**

Report Number A05H0002

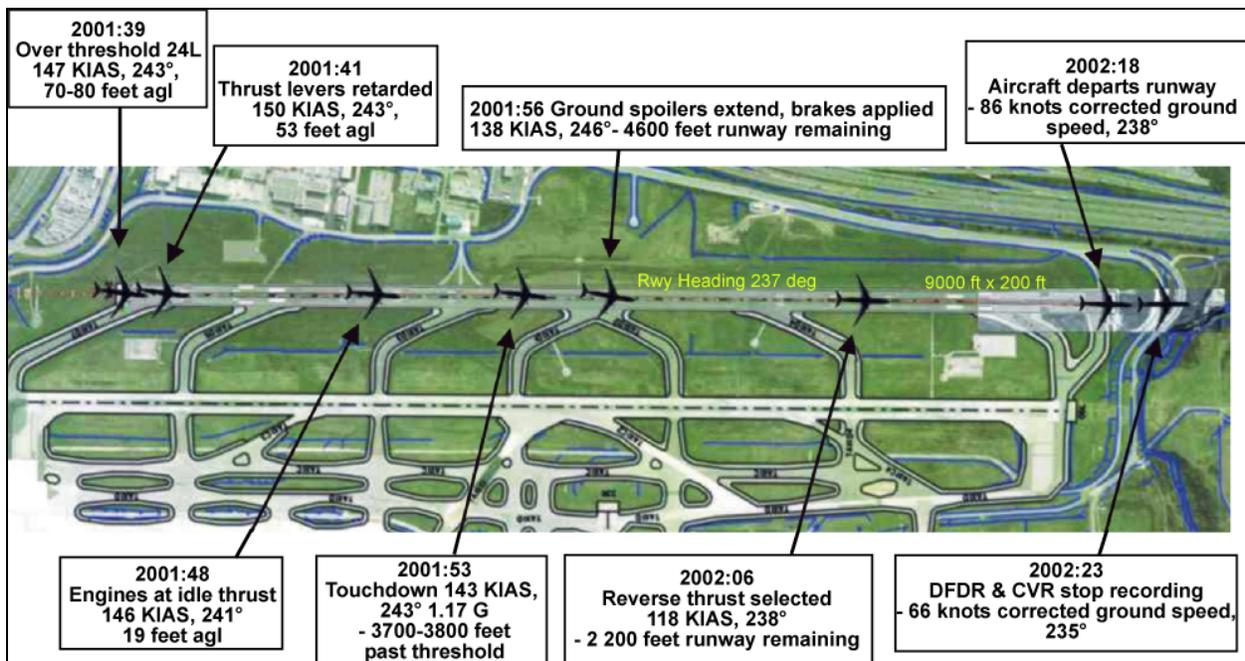
Figure 1. Landing sequence key events

The PF began the flare when the aircraft was about 40 feet above the runway. From this point to touchdown, there were numerous and sometimes significant pitch inputs made on the PF side stick, and the aircraft levelled off at approximately 25 feet for a period of 2½ seconds. During this time, there were also regular and sometimes large inputs in roll on the PF side stick. Combined, these inputs would indicate that significant workload and attention were required on the part of the PF to control the aircraft. The crew began a progressive reduction in thrust from a 76 per cent N1 when the aircraft was at 50 feet, with the throttle levers reaching the idle position when the aircraft was about 20 feet above the runway.

The aircraft touched down at 2001:53, approximately 3800 feet down the 9000-foot runway. On touchdown, the right main landing gear was slightly left of the runway centreline, and the aircraft was crabbed about six degrees to the right. The spoilers deployed automatically, as designed, after the main wheels contacted the runway. The flight crew immediately applied maximum manual braking and attempted to align the aircraft with the centreline. Idle reverse was selected 12.8 seconds after main gear touchdown, and full reverse was selected 16.4 seconds after main gear touchdown. Standard callouts to indicate spoiler and reverser deployment were not made by the PNF. The aircraft was not able to stop on the remaining runway. It departed the end of the runway at a groundspeed of approximately 80 knots and came to rest in a ravine. The aircraft left the runway at 2002:19.

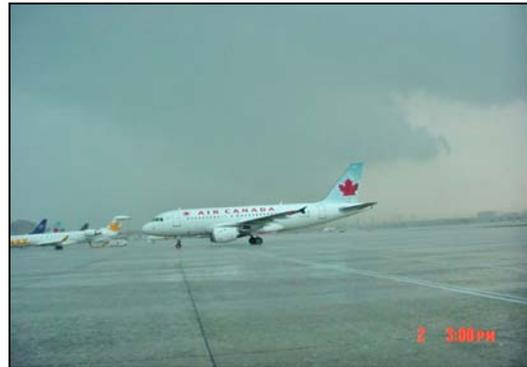
Photo 1. Weather at threshold about two minutes before landing

Photo 1 was taken two minutes before the arrival of AFR358. It is raining at the time and the visibility is good with a number of aircraft visible along the flight line.

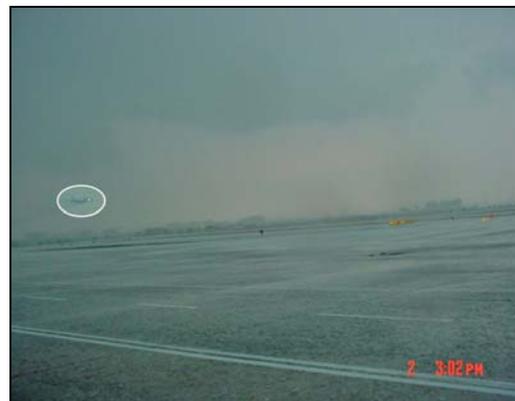
Photo 2. AFR358 on short final

Photo 2, taken two minutes later, shows AFR358 on final approach approximately 230 feet agl. The camera is aimed slightly to the right from Photo 1 and the photo shows that the rain is heavier and the visibility is decreasing.

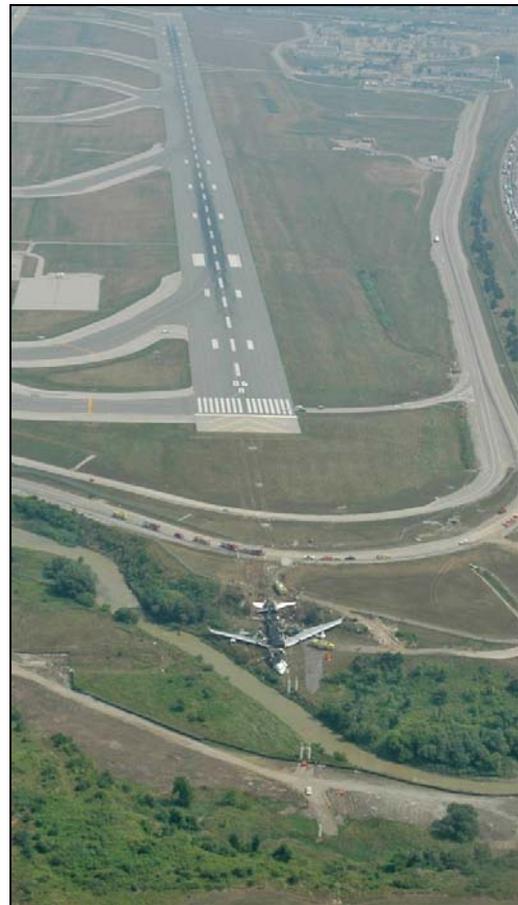
Photo 4. Accident site

A post-crash fire consumed most of the upper portion of the main fuselage, vertical fin, and inner wing sections. The fire was intense and mainly limited to the fuselage. Fire singed and burned some of the surrounding vegetation, but did not spread beyond the circumference of the aircraft.

The top of one of the passenger oxygen bottles exploded during the post-crash fire; the top was blown approximately 84 m (276 feet) across Etobicoke Creek.

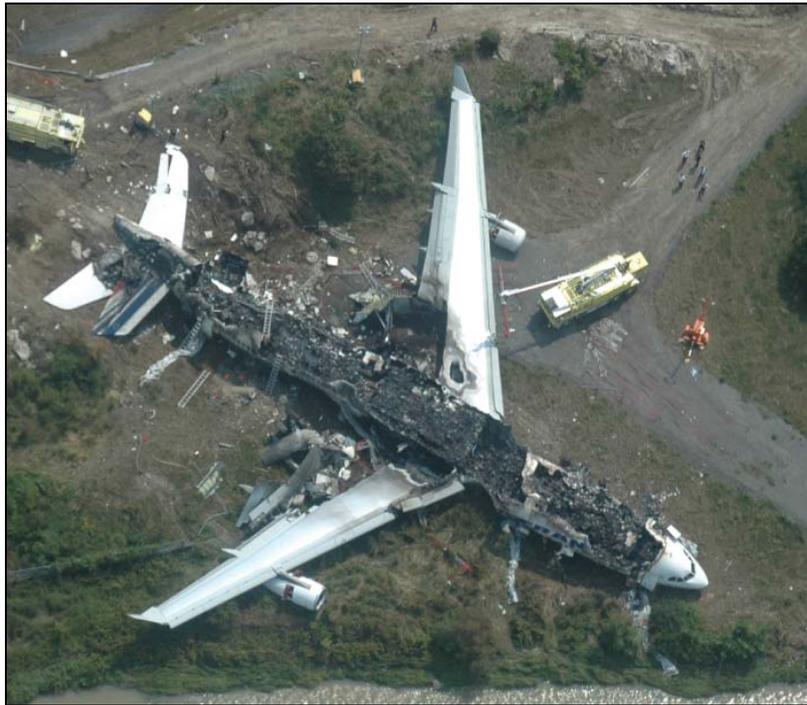
Photo 5. Aircraft wreckage

The rear portion of the fuselage on the left side was consumed by fire down to and including the cabin floor. Part of the left-side cabin wall was standing,

though heavily damaged by the fire. Approximately four feet ahead of cabin door R4, there was a fold in the outer fuselage skin, indicating that the location was subjected to substantial bending forces during deceleration and break-up. The permanent deformation of the fuselage was very likely transmitted to the door frame. This would explain the difficulty the cabin crew experienced when attempting to open the R4 door. The door initially resisted opening and required two cabin crew members to push the door open. The rear cargo compartment door was found in place and closed, though almost burned through. The bulk cargo door was found on the ground, with the charred remains of the cargo spilling out of the door opening.

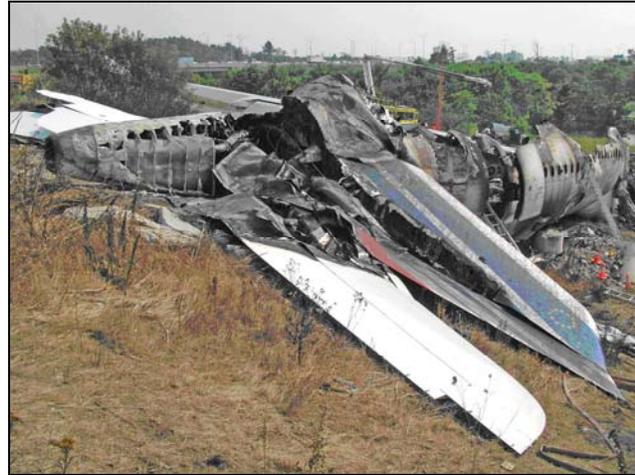
Photo 6. Aircraft stabilizers

The trimmable horizontal stabilizer was still joined to the fuselage through the main box. The left-hand stabilizer was attached in position and had impact damage. The left-hand elevator was partially detached, but in position, and had impact damage. The right-hand stabilizer and elevator were attached in position and partially burned away. The tailplane tips, made of an aluminum alloy and part of the lightning protection system, were examined for evidence of a lightning strike; none was found. The vertical stabilizer was attached to the aircraft and in position. It was only after the intense fire that the lower half of the fin and rudder burned away and the rest collapsed to the right side. The rudder was separated from the fin box.

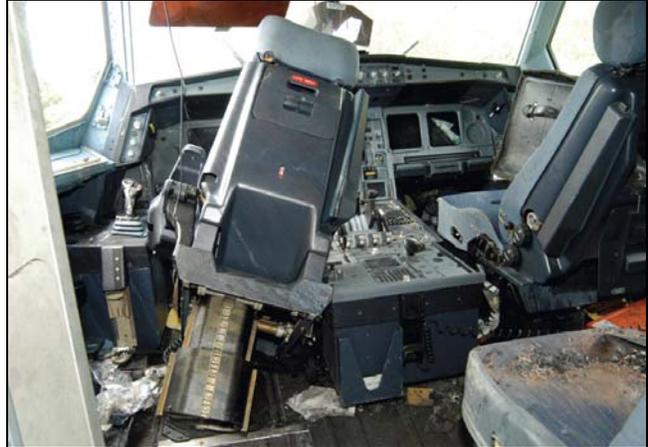
Photo 7. Cockpit seats

Both seats experienced high vertical forces during the event. The captain seat was displaced from its normal position. The floor of the seat base had fractured, allowing the chair to detach from the base. The nut attaching the centre screw to the bottom of the base on the first officer seat had pulled through the retainer. The force necessary to pull the nut through the retainer was mathematically calculated. It was determined that a vertical acceleration of a minimum of 16 g was likely reached before the seat broke. The seats were designed to withstand 5.7 g vertically and 9 g longitudinally.

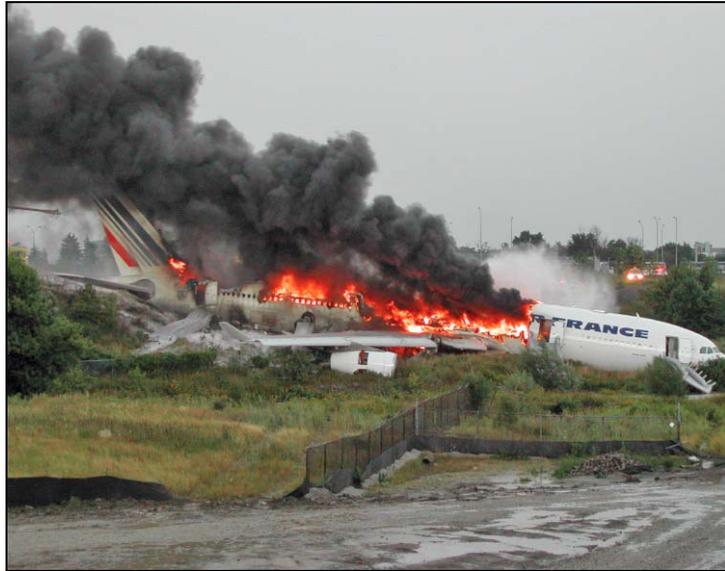
Photo 8. Aircraft fire in progress

Evaluation of the wreckage trail indicated that there was no fuel leakage until the aircraft crossed Convair Drive. The first debris related to the fuel tanks and the fuel distribution system was found in the field adjacent to the ravine. Traces of fuel were visible at the top of the embankment on the left-hand side of the aircraft trajectory. A piece of an internal wing box rib was also found in the same area. A wing access door panel with slight fire damage was identified among the debris deposited halfway between Convair Drive and the edge of the ravine. There was no indication of fire on top of the embankment because no scorched grass or soil was visible.

The fire intensified as the aircraft came to a halt. The fire path was from the wing area toward the fuselage. By the time the fuselage was seriously threatened by fire, the aircraft had been totally evacuated. There were four principal areas of fire:

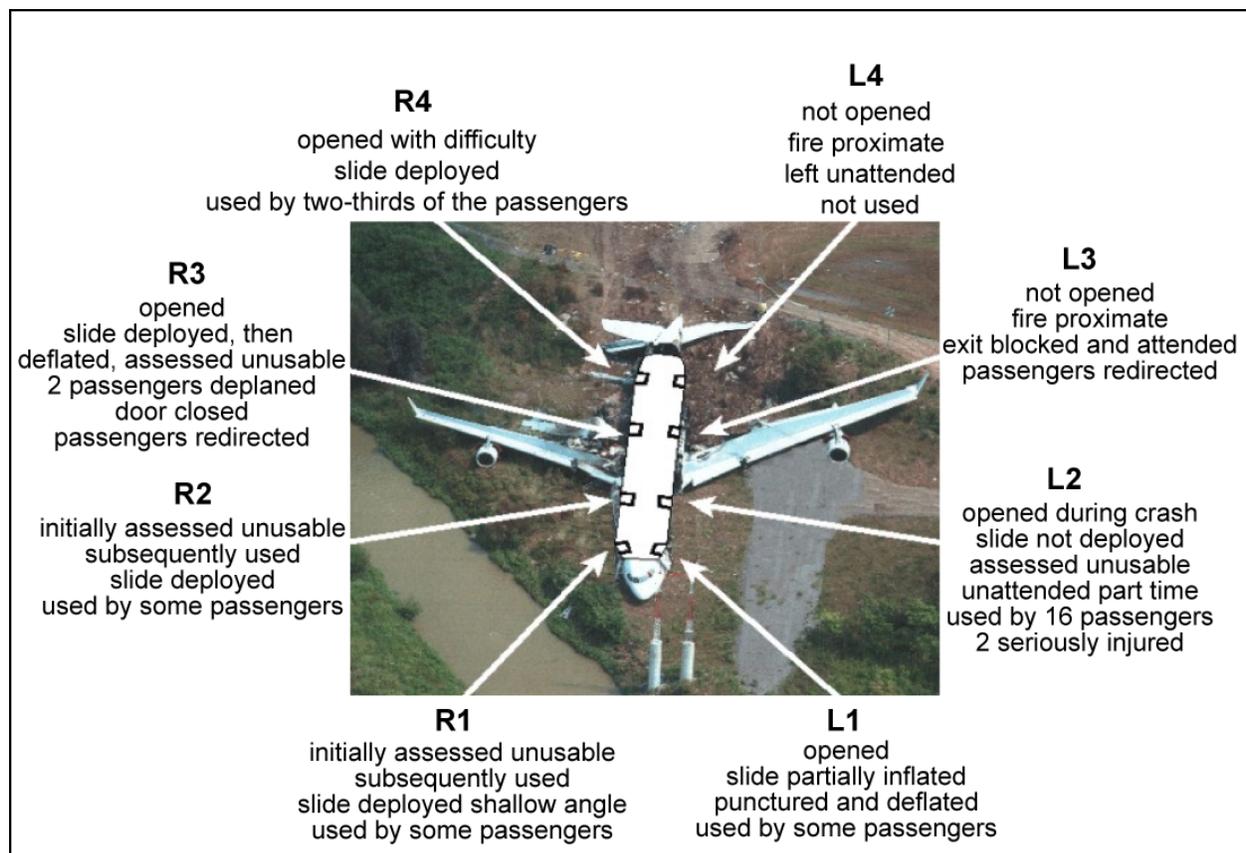
Figure 4. Emergency exits

At the onset of the evacuation, exits R1 and R2 were assessed by cabin attendants as unusable because the creek was immediately outside the exits. Both attendants followed the prescribed procedure for unusable exits. As the evacuation progressed, the attendants reassessed their

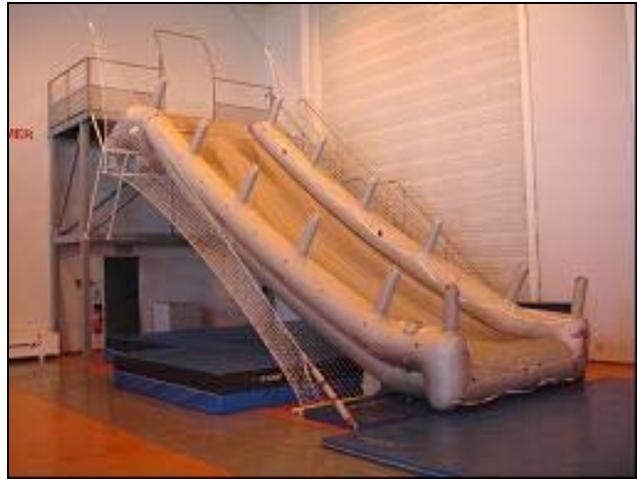
Photo 9. Slide training device

The occurrence cabin crew noted that there was not enough room to form two lines of passengers at the entrance of the slide. Moreover, cabin crew conveyed that it was somewhat difficult for two passengers to jump onto the slide simultaneously, given the position of the slide in relation to the door opening and the location of the exit door alongside the exterior fuselage. One cabin attendant assisting at the bottom of a slide noted that passengers tended to jump onto the middle of the slide. All of the escape slides used during the evacuation of AFR358 were dual-lane slides. Only 23 per cent of passengers who indicated that they evacuated via an escape slide reported that they went beside another passenger.
