TECHNICAL REPORT

A-070/2004

Accident of aircraft
BOEING B-737,
registration PH-BTC,
at Barcelona Airport
(Spain), on 28
November 2004

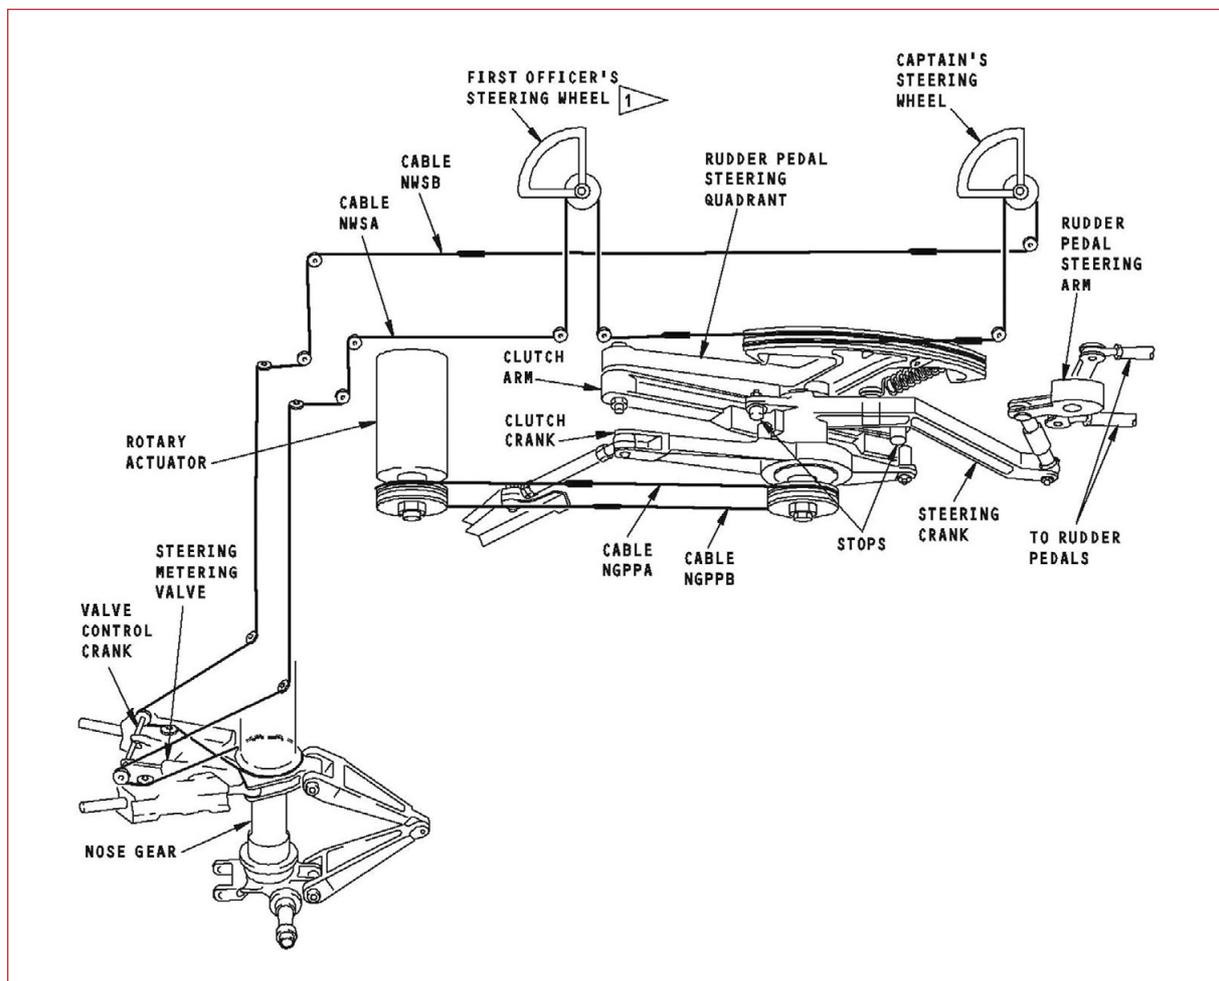
Figure 1.6.1. NWS mechanism from the AMM. Cable NWSB (on the right side of the NLG when looking in the direction of the flight) was found broken after the accident

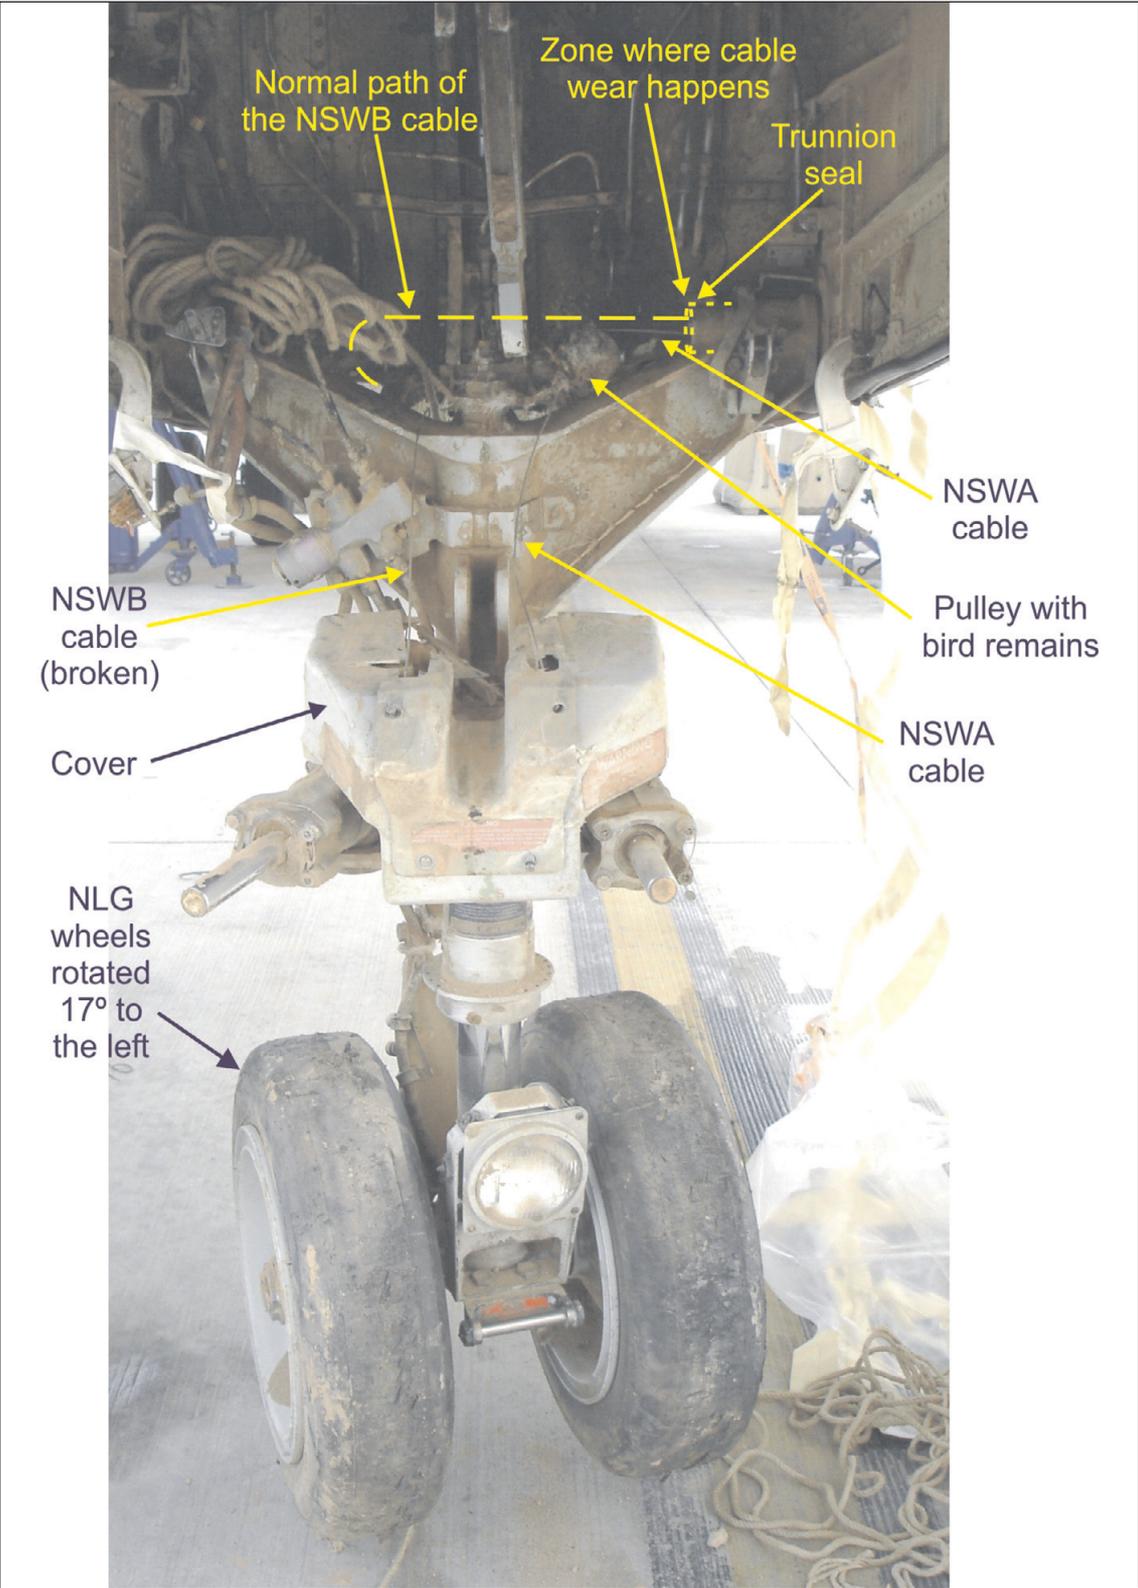
There had been a service history of wear observed on the stainless steel cables. This was traced to be due to the rubbing of the cable against sand particles that had been trapped by lubricating grease produced as the cable passed in and out the pressurized zone through the trunnion pressure seal. Therefore, the Fleet Team Digest 737-FTD-32-03008 (last revised on 24 September 2004) issued by the manufacturer stated that grease should not be put in that area. The AMM also contained a statement «Do not grease stainless steel (CRES) cables, it may be only cleaned with a clean rag...».

Figure 1.6.2. View of the front part of the NLG after aircraft recovery. The NSWB cable was found broken. The NSWA cable did not break, although it was also worn in the zone of the trunnion seal and its pulley had bird remains

In the nose wheel steering system, the bearings in both upper shock strut pulleys were pushed out such that the pulleys were wedged against the pulley bracket and did not rotate. The NWSB cable was fractured at a point 56 cm from the turnbuckle (see Figure 1.6.2). It appeared to be at the approximate point where it entered into the trunnion pin pressure seal. Examination of the cable under a magnifying glass showed signs of worn cable strands and wires. The upper pulley bracket for NWSB cable was fractured. Both cables and pulleys had bird remains on them. The steering valve cover was smashed in several places and attach brackets were fractured. Several other steering mechanism components were also fractured. The steering valve was intact. All components were heavily contaminated with dirt. First officer's tiller felt normal when operated left or right. Captain's tiller was very stiff in left direction and bound up prior to full turn inputs. Right turns had no resistance at all regardless of turn angle input. Rudder pedal operation felt normal.

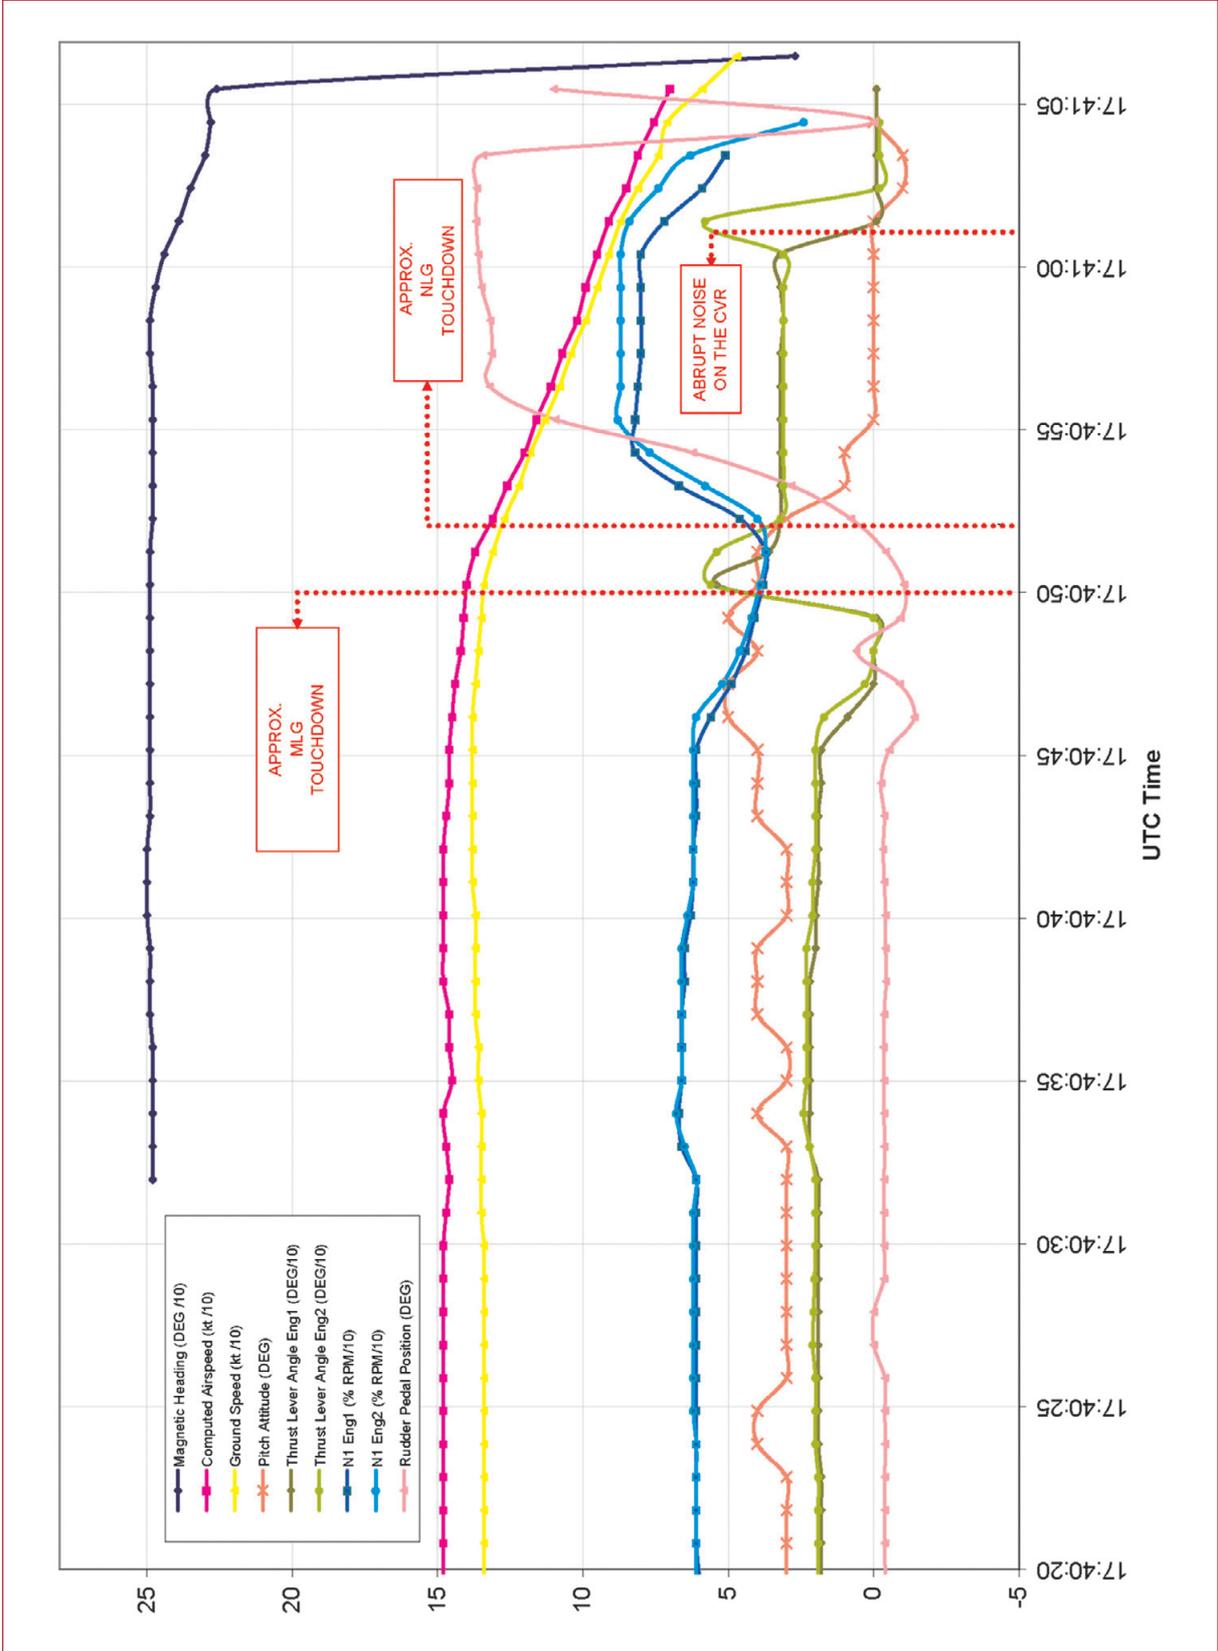
Figure 1.11.2.1. Several parameters during landing

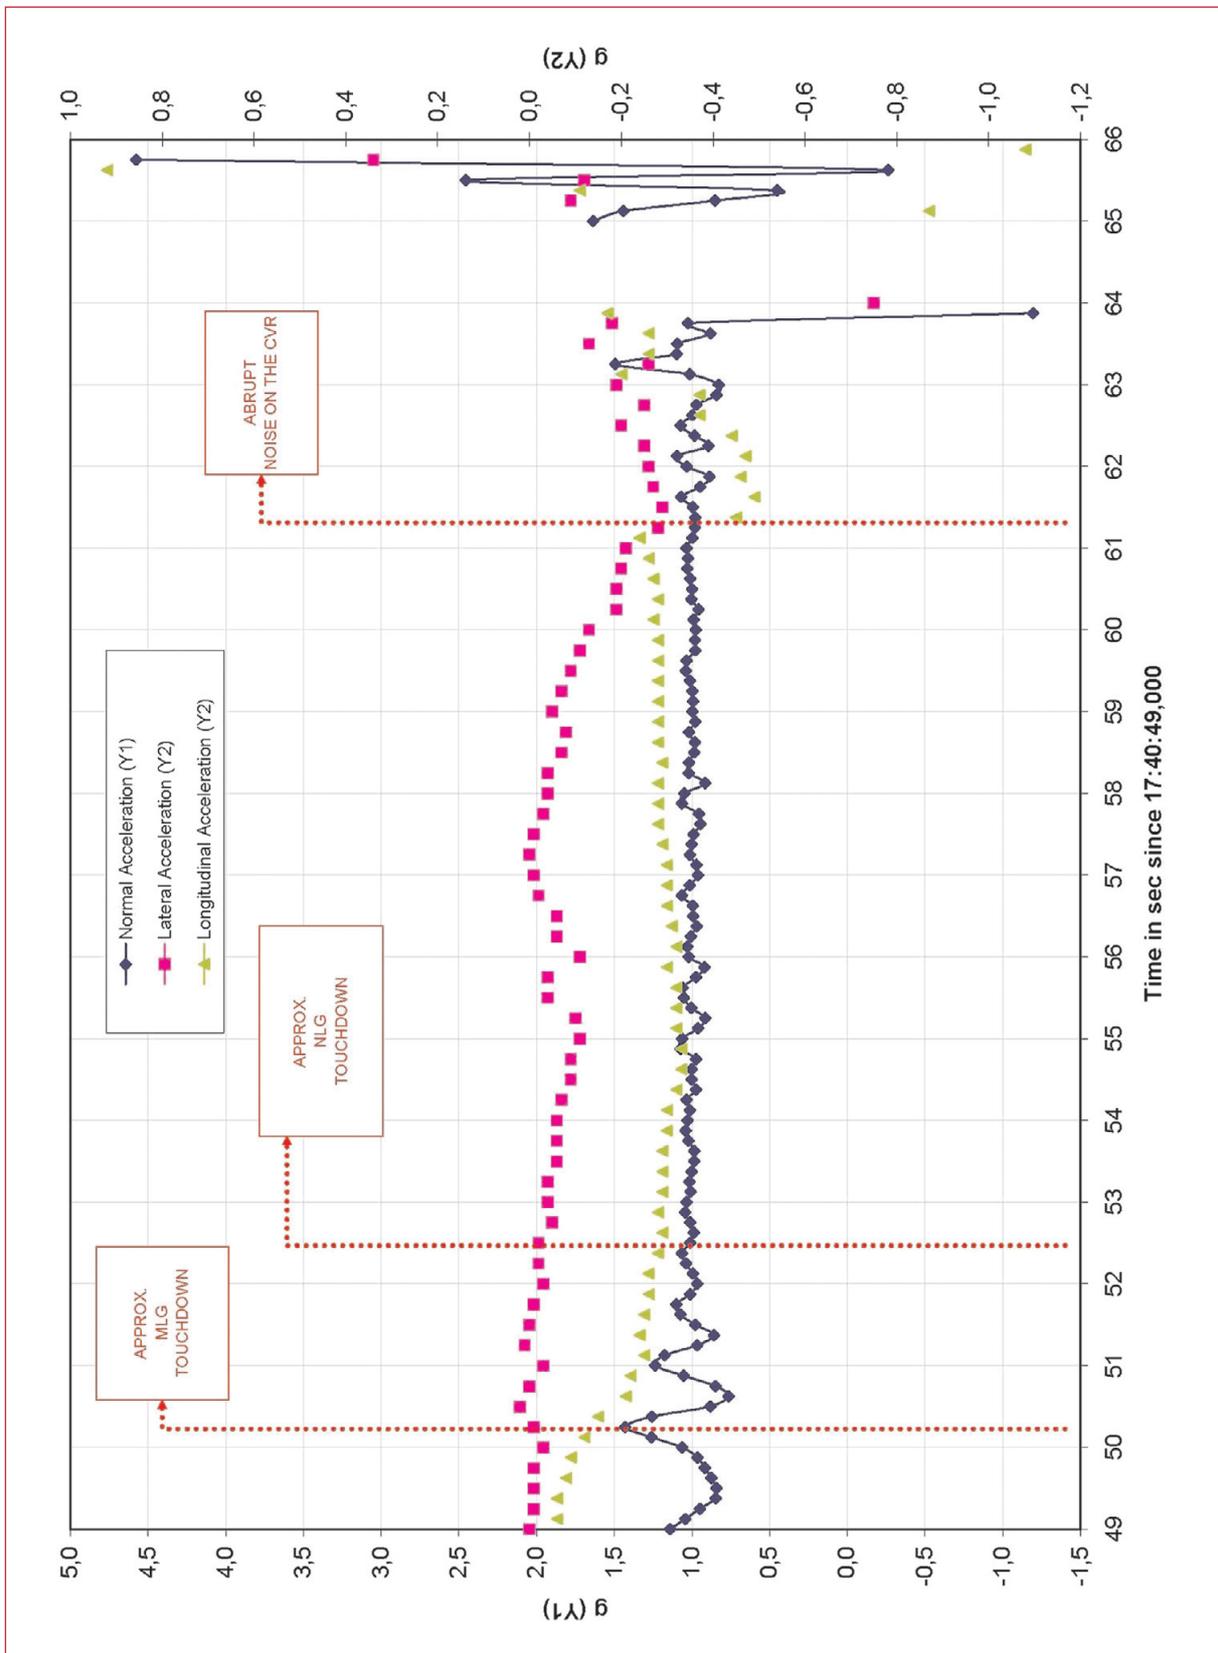
Figure 1.11.2.2. Accelerations during touchdown and landing roll

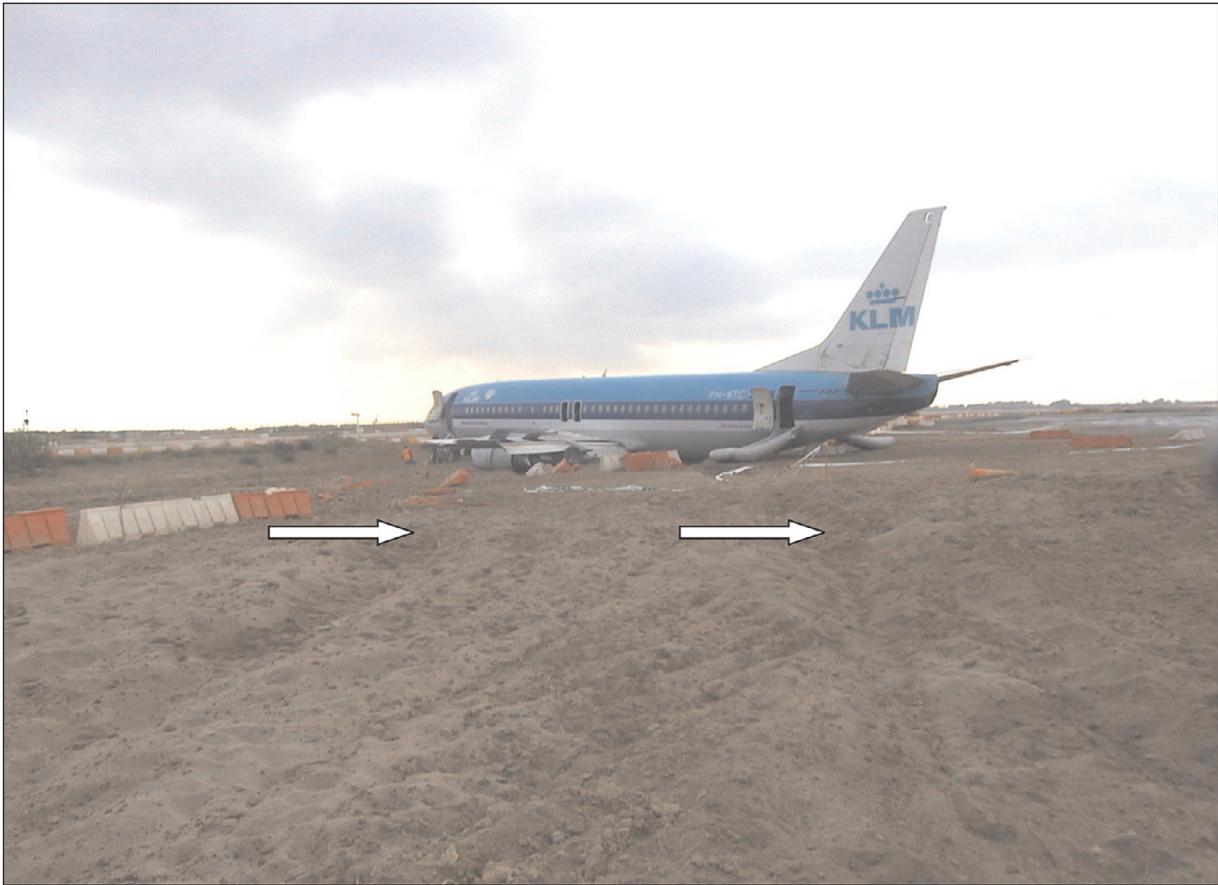
Additionally, there was a concrete pipeline buried around 20 cm under the loose sand against which both the NLG and LMLG impacted (see paragraph 1.12 below).

The aircraft exited the surface of runway 25R and went through another paved area under construction of some 10 m in width after jumping a step of approximately 10 cm of height. After passing over a trench around 20 cm deep, it then entered an unprepared zone covered mostly by sand and the landing gear dragged through the unprepared surface. The aircraft crossed a plastic fence line and suffered some damage from iron bars that were supporting construction signaling nets. The NLG and the LH MLG hit a buried pipeline that probably made them collapse and detach, respectively (see white arrows in the attached Photo 1.12.1).

Photo 1.12.1. Buried pipe noted in the tracks of the LH MLG and NLG

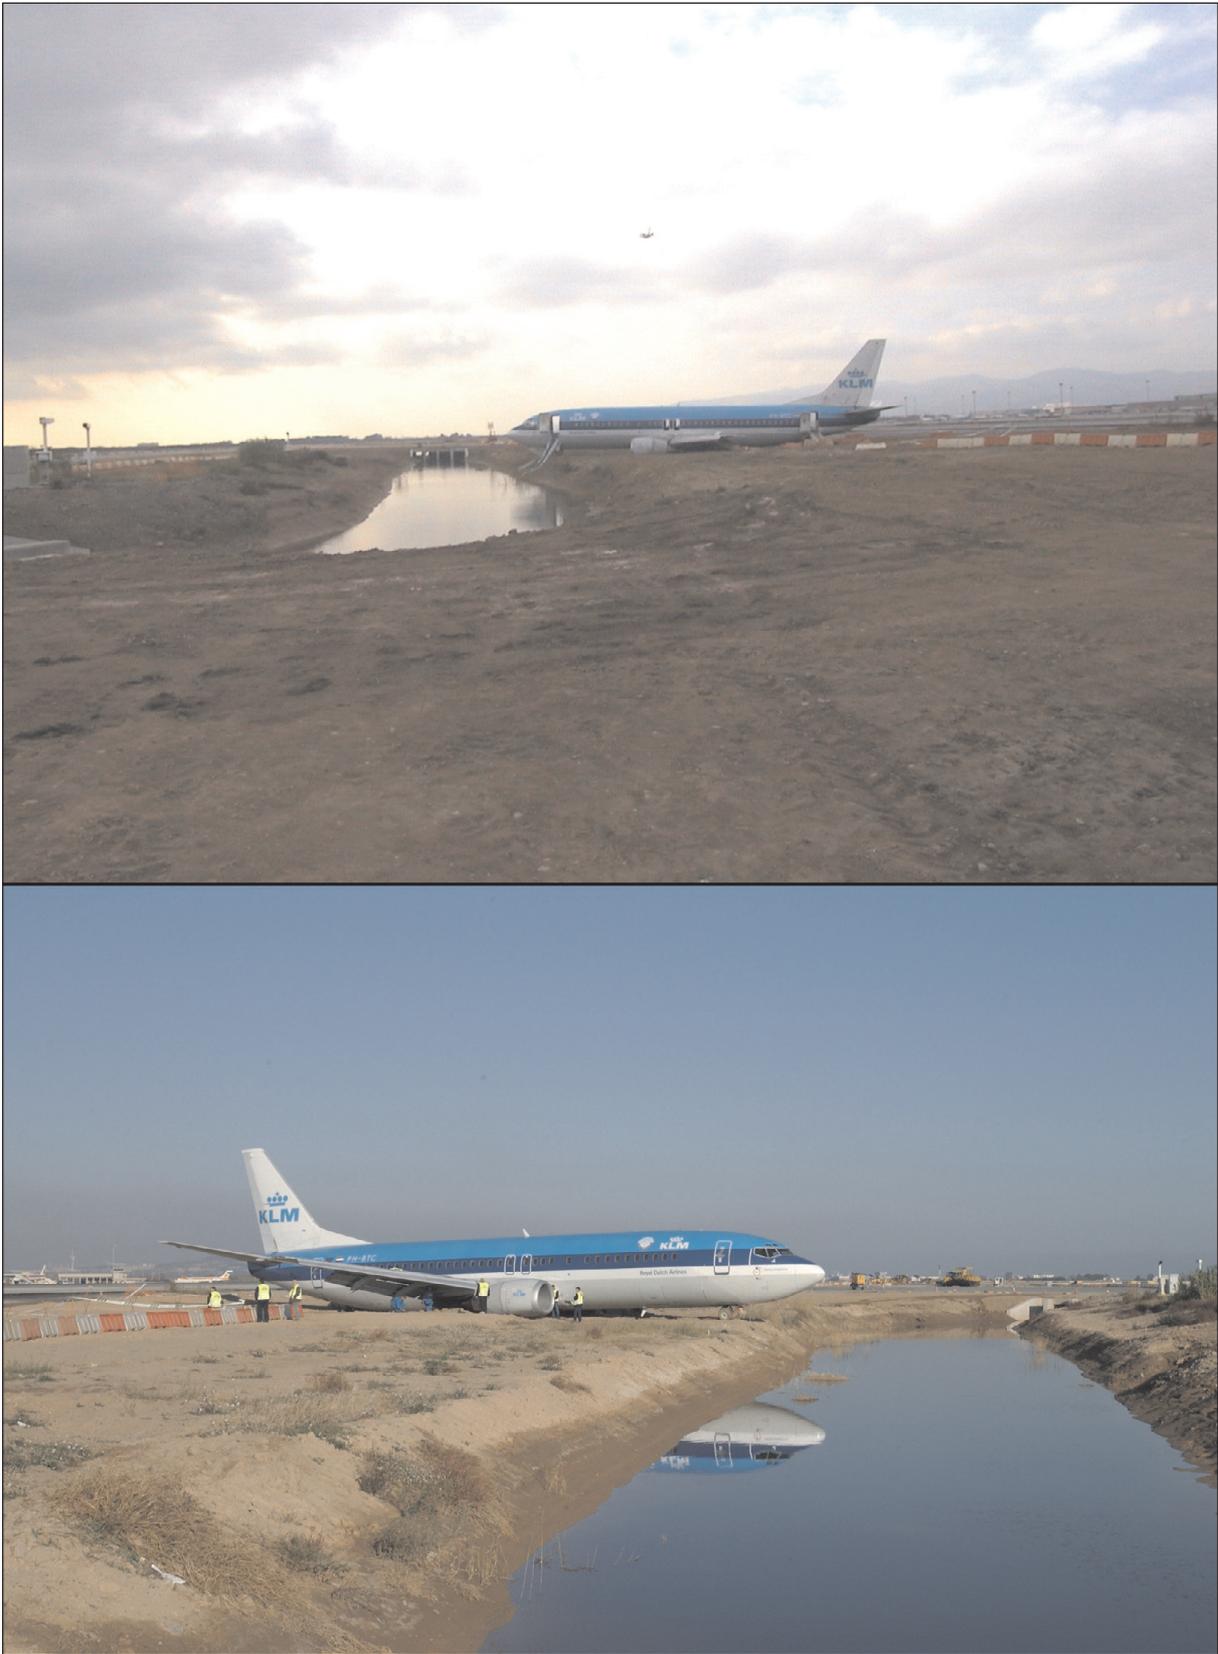
The aircraft came to a stop close to the edge of a rain drainage canal that ran approximately parallel to runway 25R. The canal was approximately 15 m wide, and 2.5 m high from the surface of the water. The water depth was approximately 1.5 m.

Photo 1.12.1.2. Final position of the aircraft close to the edge of the canal

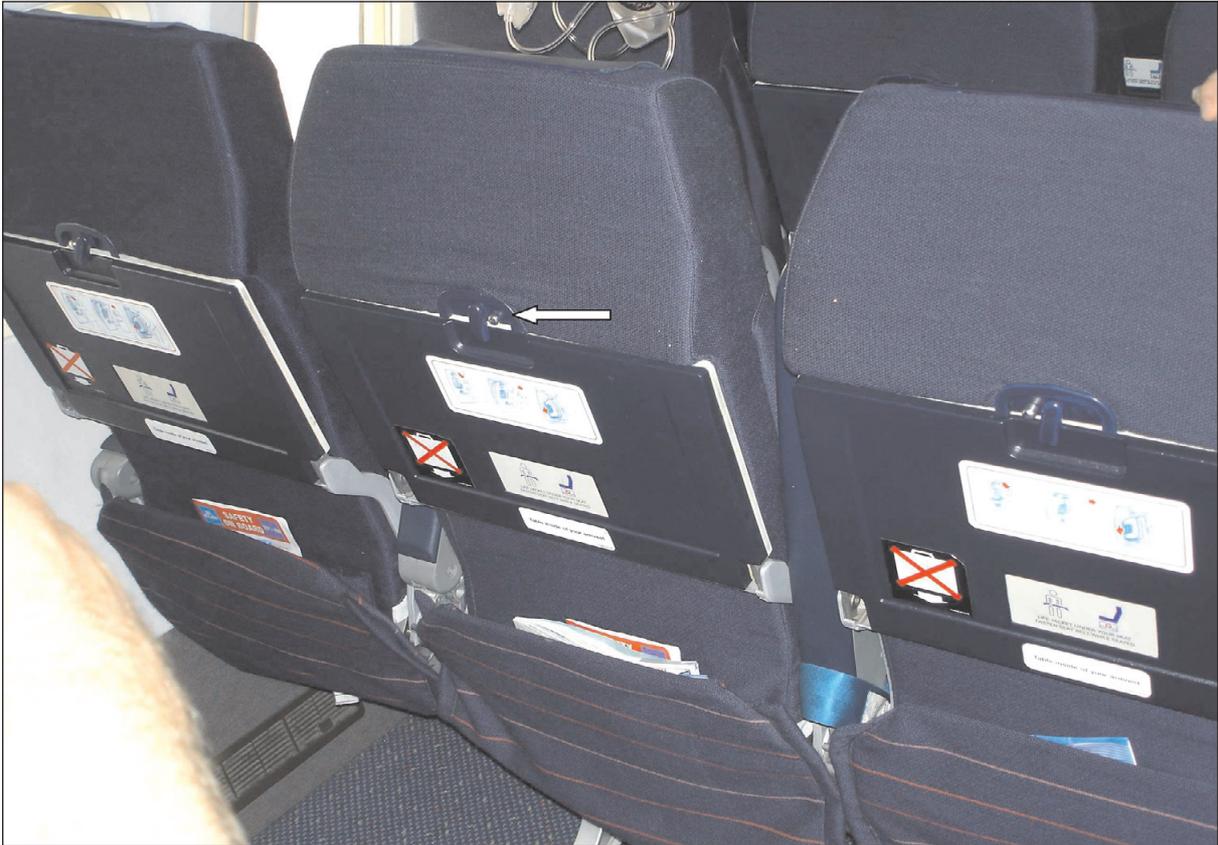
The meal tray table of the back of seat 10B (in front of seat 11B), which was located in the forward left hand emergency exit passageway, was found to have the restrain pin on its right hand side (i.e. towards the aisle). Therefore, the normal escape path of the passengers towards the type III emergency exit could easily release the tray (see Photo 1.15.1.1, white arrow in central seat back).

Figure 1.15.1.1. The latch of the meal table of the centre seat may rotate towards the sense of the Type III emergency exit escape path (to the left of the photo) and therefore it could be released during the emergency evacuation

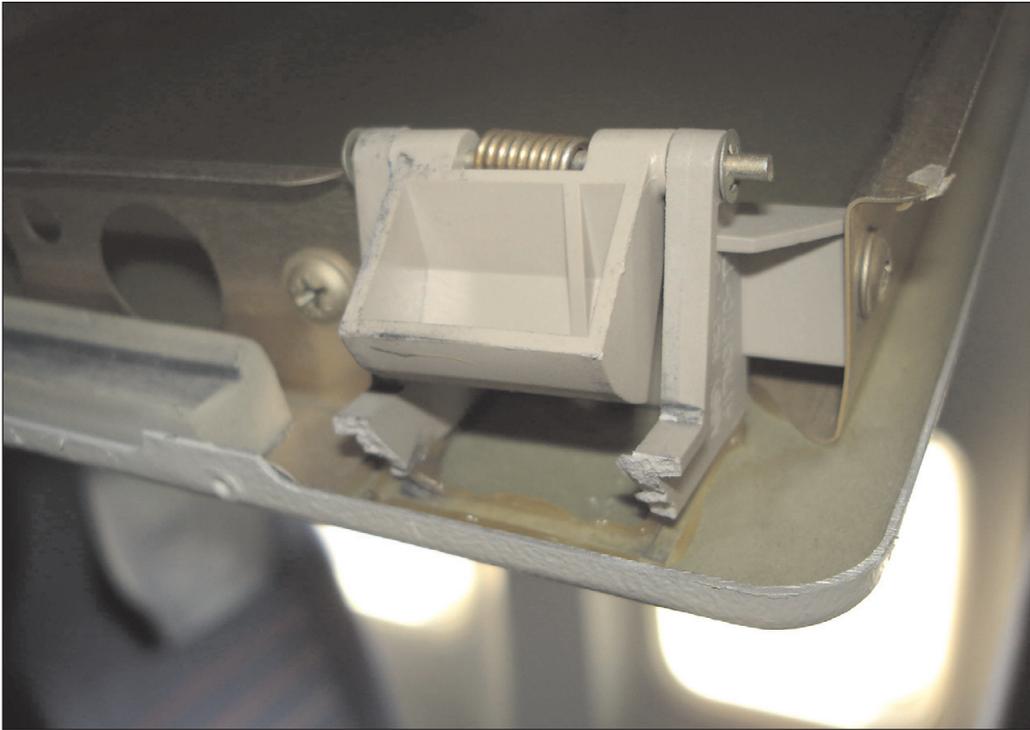
It was found that a lot of latches of the PSU panels were broken apparently due to lateral inertia loads towards the left of the aircraft or by the bending and torsion of the fuselage (see Photo 1.15.1.3).

Figure 1.15.1.3. Detail of a PSU panel latch broken on the left side of the aircraft

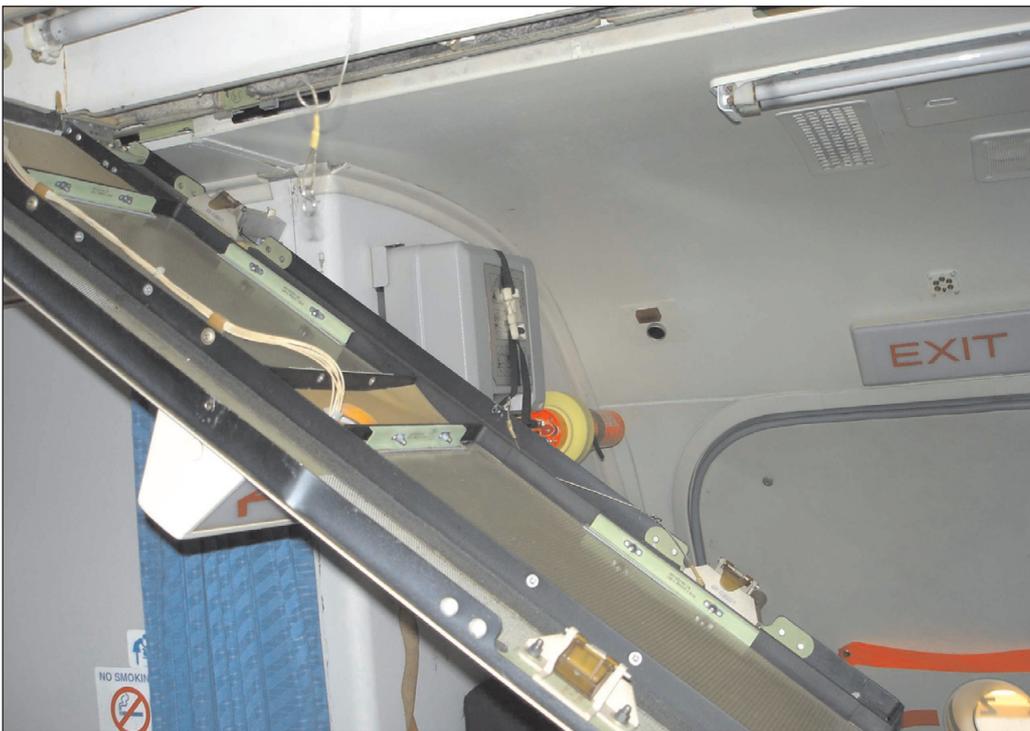
When the aircraft was inspected after the accident, the ceiling panels located in the forward and rear flight attendants compartments were in place. However, according to the statements gathered both panels detached after the accident and were put in place again by cabin attendants (see Photo 1.15.1.4). The lanyard of the forward ceiling panel broke, and that of the rear ceiling released without breaking. The hook was not at its normal position (in the middle of the lanyard).

Figure 1.15.1.4. Ceiling panel in the rear cabin attendant compartment. During the inspection after the accident it was found closed, but witnesses stated that it opened after the aircraft came to a stop, therefore obstructing the path towards emergency exits L2 and R2. The lanyard released. The hook is at the end of the lanyard assembly

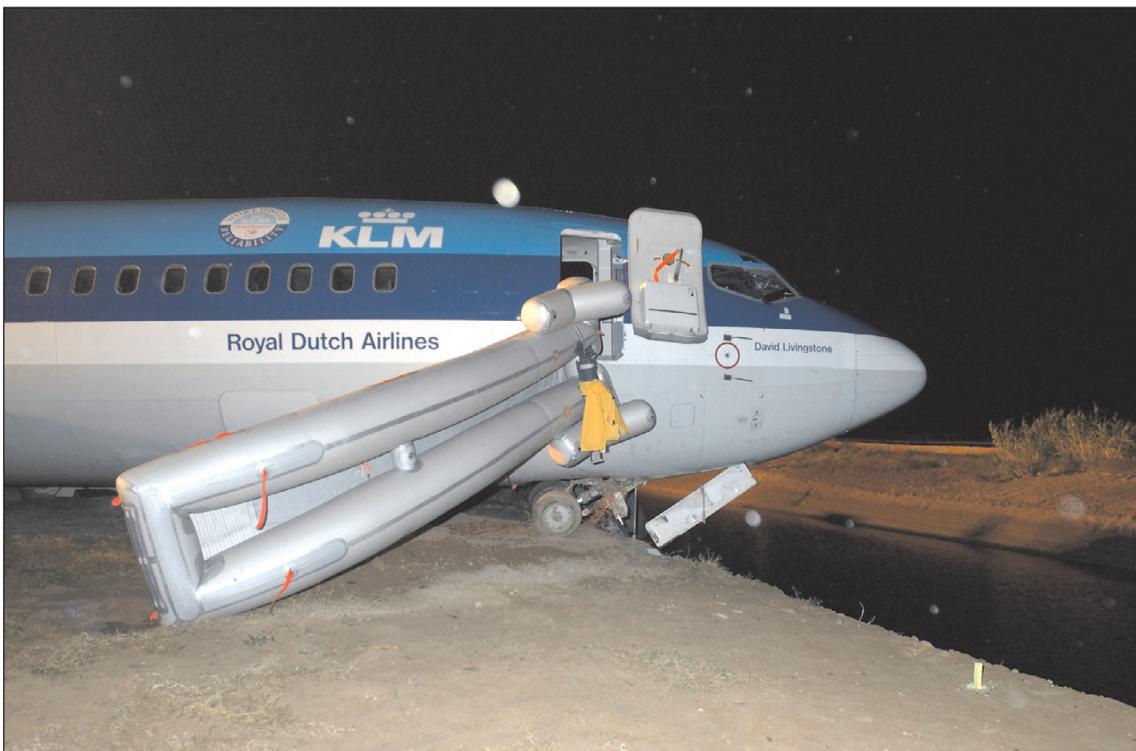
All the escape slides were found inflated, but the 1R slide was found twisted rearwards (i.e. front edge up and rear edge down) in a way that would have prevented its use for evacuation (see Photo 1.15.2).

Figure 1.15.2. Escape slide of door 1R was twisted

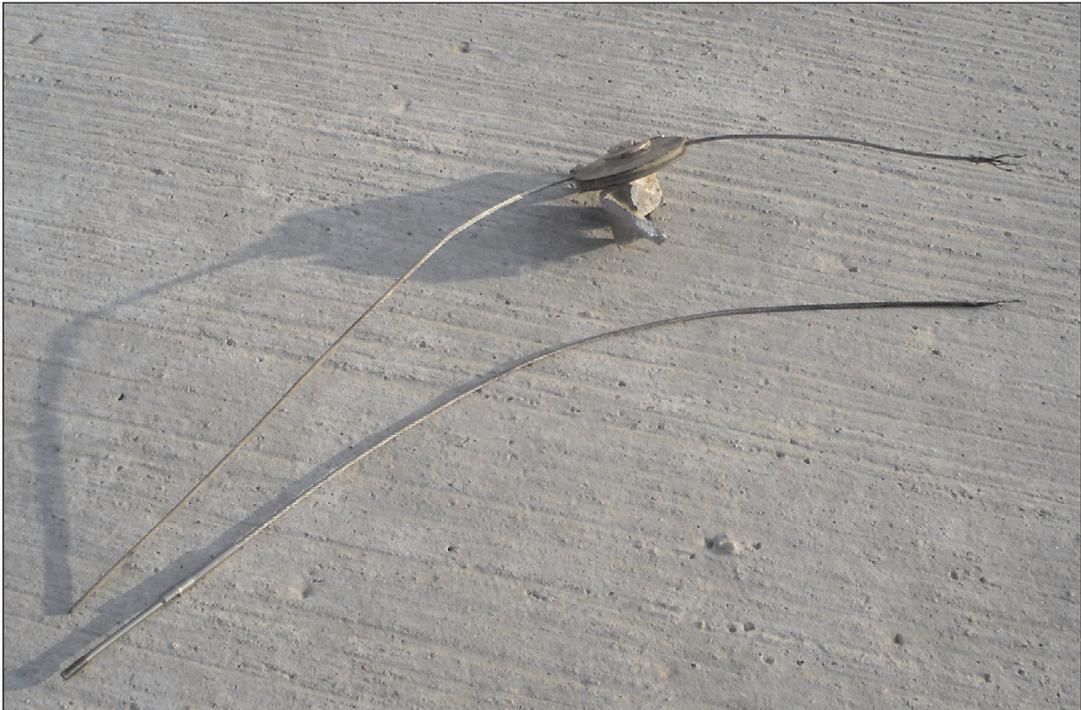
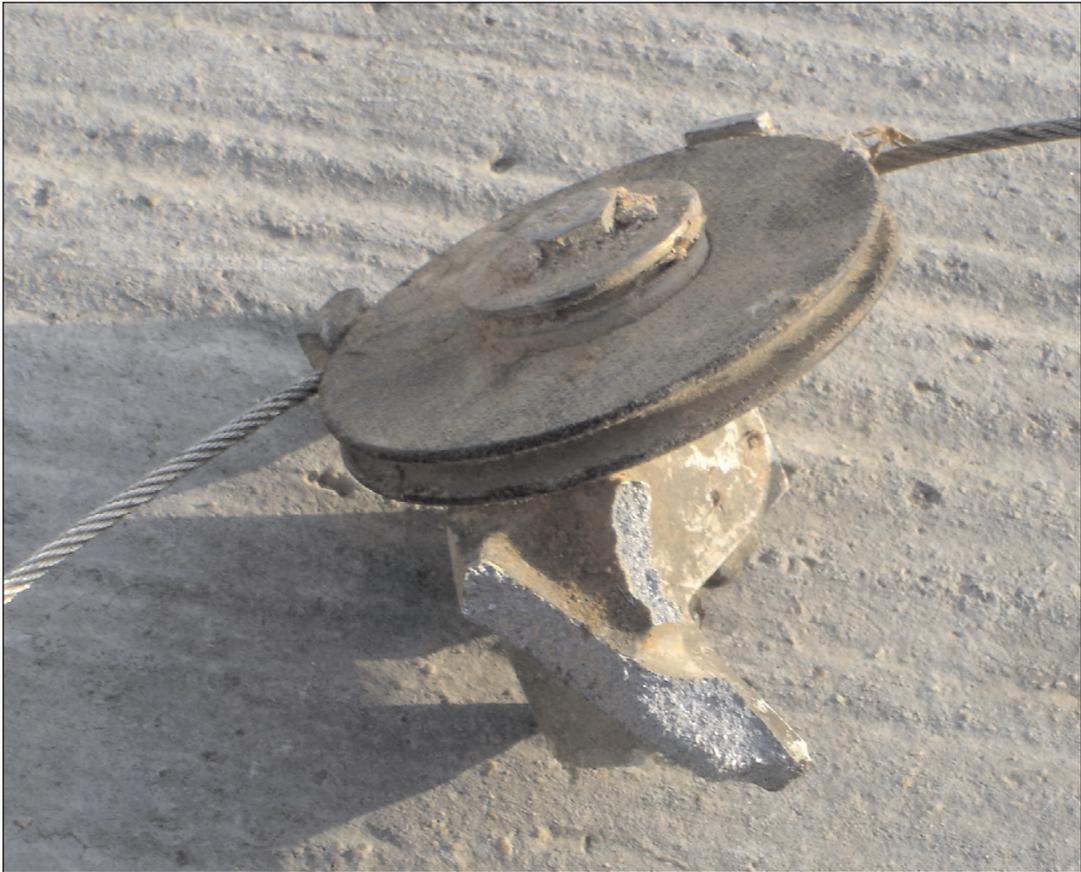
A part of the broken NWSB cable P/N BCRE7631 (of approximately 560 mm of length including the cable terminal) was sent to a laboratory for fracture analysis. The diameter of the cable was 3/32 in (2.4 mm), with 7 strands of each 7 wires. The wire diam-

Photos 1.6.2.1 and 1.6.2.2. Each part of the broken cable was sent to a laboratory

eter was 0.29 mm, and it was made of 304 stainless steel. The laboratory concluded that the seven wires from the core strand failed by ductile overload. The six outer strands showed severe wear. Approximately 5 wires from each outer strand were worn-through completely; the other wires were thinned severely. Wear damage was observed over a length of approximately 80 mm. No corrosion was observed. Their conclusion was that «It is obvious that severe wear preceded the failure of the cable. The wear of the outer strands was so severe that nearly all load had to be carried by the core strand. A relatively low load was sufficient to cause cable failure».
