## **Tail strike during take-off**

Boeing 737-800, registration PH-HZB,  
Rotterdam Airport, January 12th 2003

The Hague, November 2006, project number 2003004

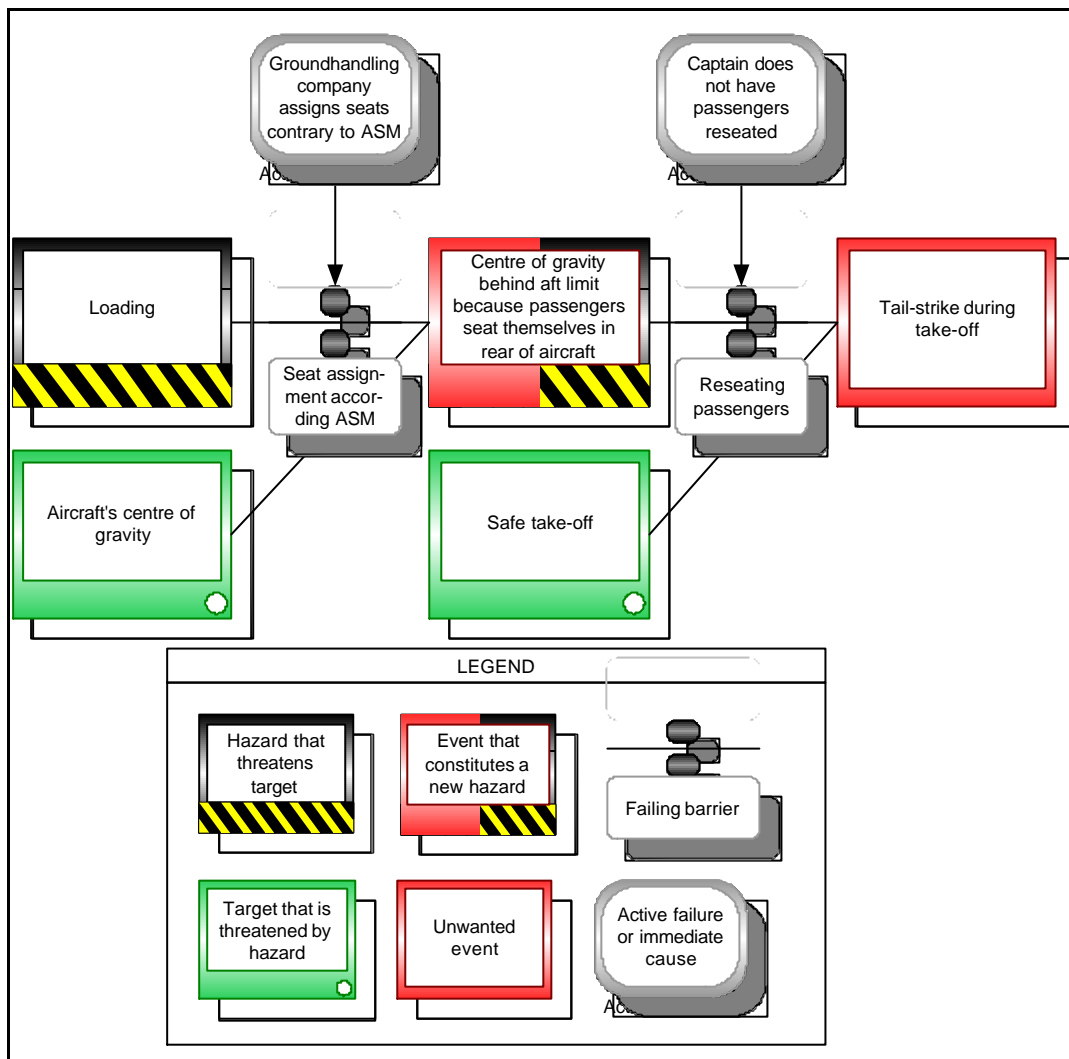
Figure 1 depicts the results of the Tripod analyses in a simplified diagram. More specifically, the sequence of events and corresponding hazards and targets (HET-trio's) that, eventually, resulted in the top event (i.e., tail strike) is presented. Furthermore, figure 1 indicates for each HET-trio (1) which barrier could have prevented the unwanted event and (2) which active failure formed the immediate cause for the barrier to fail. Inspection of figure 1 reveals that:

- Aviapartner did not assign the seats to the passengers in accordance with the passenger distribution table in ASM. As a result, passengers seated themselves in the rear of the cabin;
- Consequently, the aircraft's centre of gravity was situated behind the applicable aft limit. This deviation was not rectified by reseating the passengers;
- Because of this, the aircraft pitched nose-up just after take-off thrust had been selected. Subsequently, this movement stopped when the aft fuselage and the tailskid assembly contacted the runway (i.e., tail strike during take-off).

Figure 1: Simplified diagram of the Tripod analysis of the "Tail strike" of the Boeing 737-800 during take-off at Rotterdam airport on January 12<sup>th</sup> 2003
