**INCIDENT**

<b>Aircraft Type and Registration:</b>	Boeing 747-132, N481EV	
<b>No &amp; Type of Engines:</b>	4 Pratt & Whitney JT9D-7F Series turbofan engines	
<b>Category:</b>	1.1	
<b>Year of Manufacture:</b>	1970	
<b>Date &amp; Time (UTC):</b>	24 April 2004 at 1048 hrs	
<b>Location:</b>	Airborne near the Compton VOR beacon	
<b>Type of Flight:</b>	Public Transport (Cargo)	
<b>Persons on Board:</b>	Crew - 4	Passengers - None
<b>Injuries:</b>	Crew - None	Passengers - N/A
<b>Nature of Damage:</b>	None	
<b>Commander's Licence:</b>	Air Transport Pilot's Licence	
<b>Commander's Age:</b>	57 years	
<b>Commander's Flying Experience:</b>	About 16,000 hours (of which 4,000 were on type) Last 90 days - 116 hours Last 28 days - 53 hours	
<b>Information Source:</b>	AAIB Field Investigation

**Synopsis**

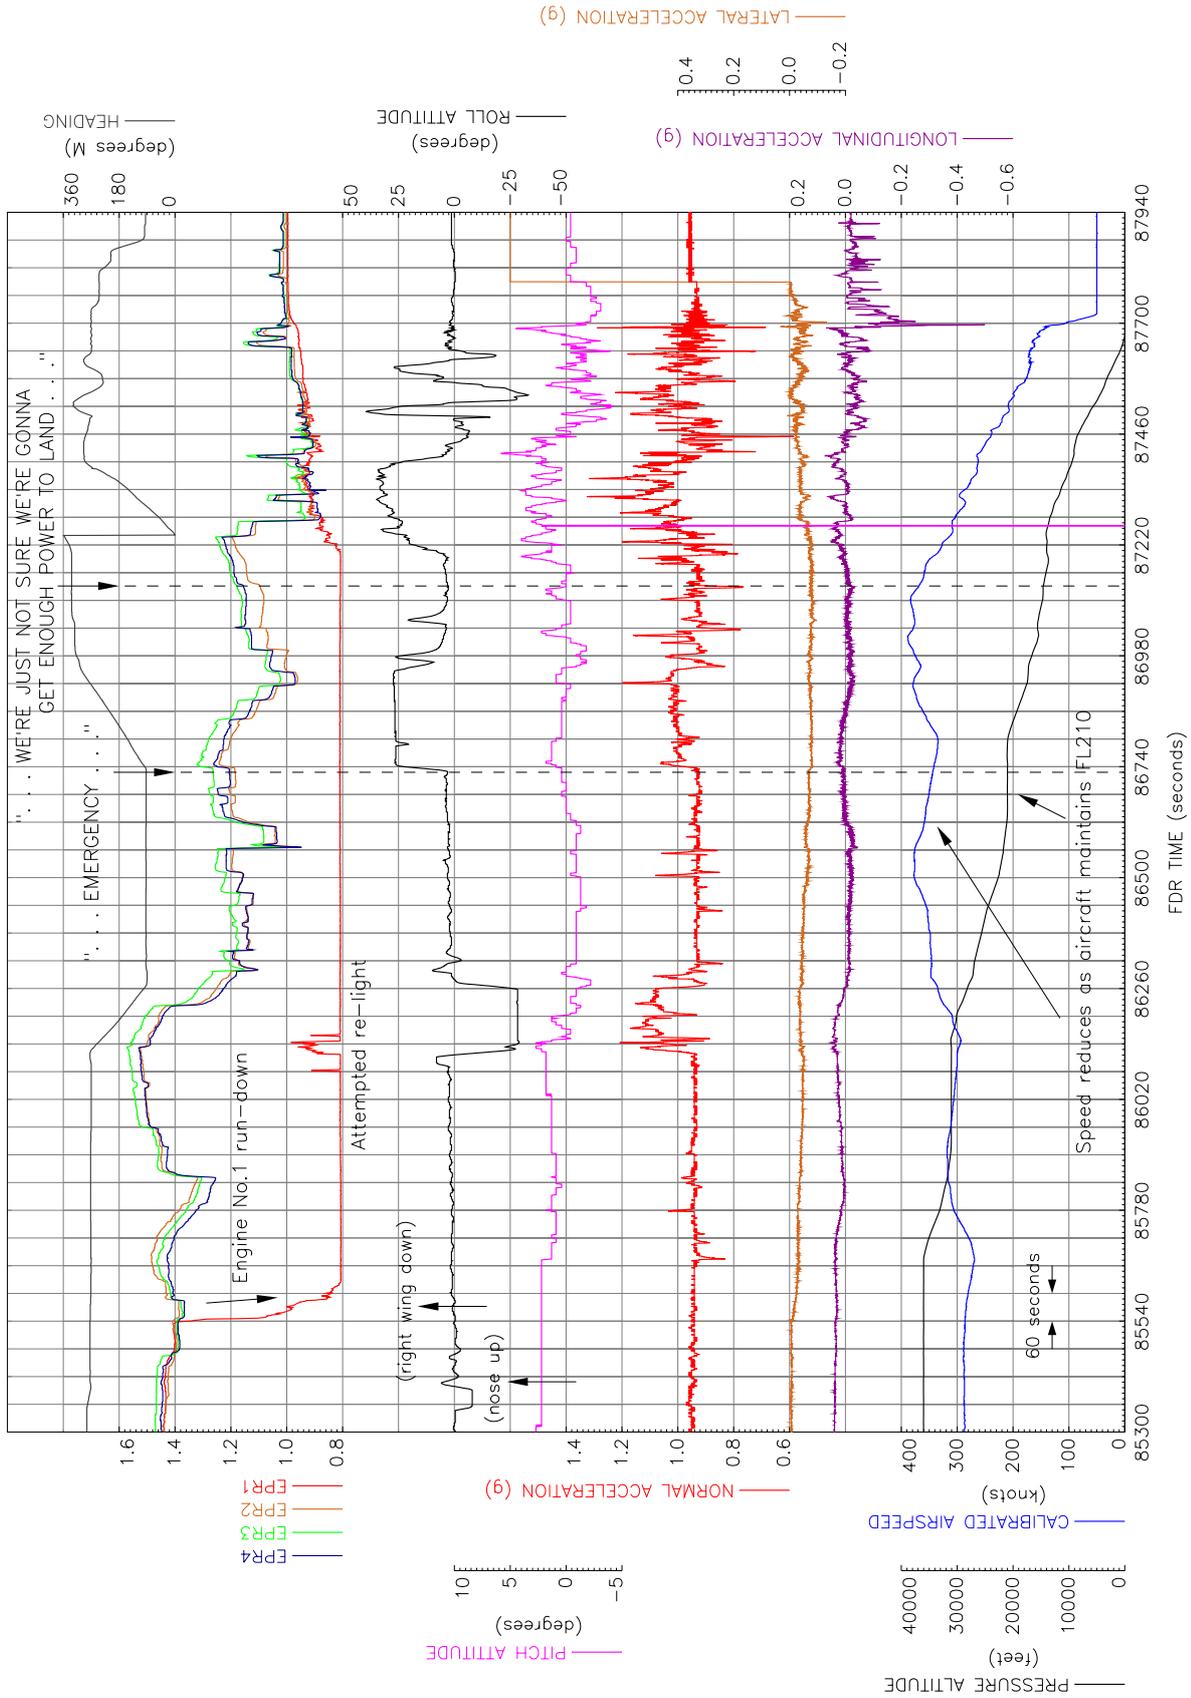
Figure 2

Three minutes later, the thrust on all engines reduced to about 1.4 EPR where they remained for one minute. The thrust on engine No 1 then fell to just under 1.1 EPR over a 10 second period. As the EPR for Engine No 1 reached 1.3, the EPRs for the remaining engines also began to fall, stabilising at about 1.37. The thrust on engine

No 1 continued to fall to 0.85 EPR over a 40 second period, and then more gradually to 0.81 EPR<sup>1</sup>. The aircraft's recorded altitude and pitch attitude remained constant throughout these thrust reductions, however; the airspeed slowed by 20 kt. Also, as the thrust on the No 1 engine reduced, the lateral acceleration and bank angles began to increase: the lateral acceleration in a negative sense and the bank angle right wing down, both from nominal values of zero and both consistent with the aircraft side-slipping to the right. (Angle of yaw was not recorded on the FDR.)

A time-history of the relevant parameters during the incident

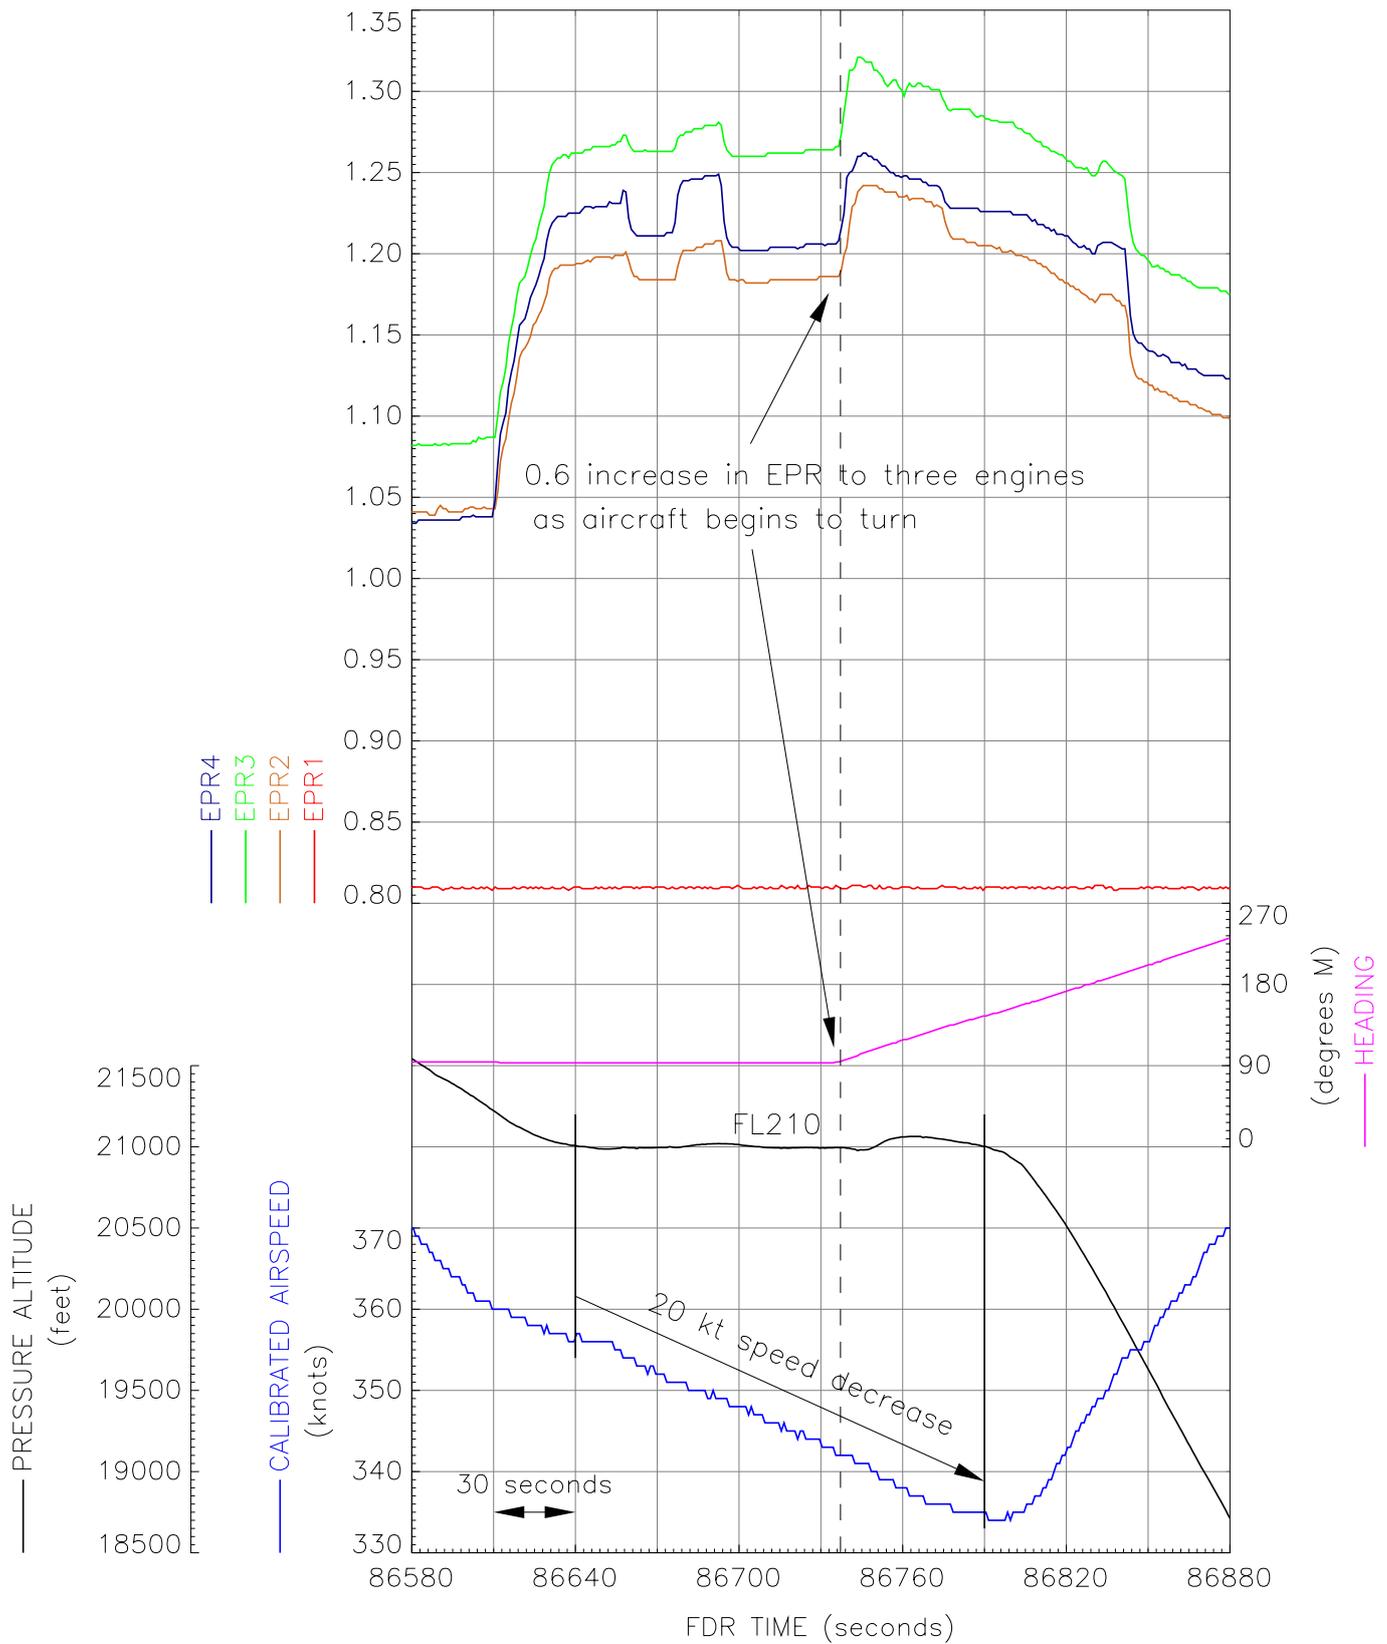
**Figure 3**

The aircraft remained at FL210 for two and a half minutes during which the CAS steadily reduced from 355 kt to 335 kt. Also during this period, the EPR levels on the other three engines were no lower than 1.18 (Engine No 2) and no higher than 1.32 (Engine No 3), each varying (in unison) and by no more than 0.06 (see Figure 3).

Whilst still at FL210 (just south of Maidstone), and coincident with the 0.06 EPR increase of the three engines, the aircraft began a turn to the right before commencing the descent towards Heathrow. The aircraft initially descended at about 2,000 ft/minute before making a 270° right turn (overhead London) on a heading for Heathrow, before continuing to descend at about 2,500 ft/minute until 30 seconds before touchdown. The approach glideslope into Heathrow was calculated at just over 6°, reducing to 2.7° when the aircraft was 1.5 nm from touchdown. The recorded airspeed during the latter stages of the approach was approximately 160 KCAS.

An expanded view time-history of the relevant parameters at FL210
