Report 06-009

**Boeing 767-319
ZK-NCK**

fuel leak and engine fire

30 December 2006

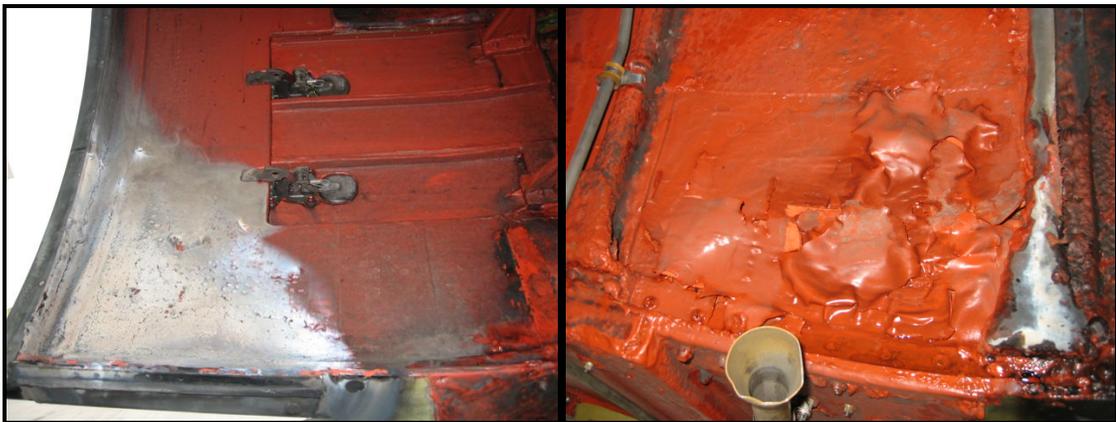
- 1.2.1 The aircraft was fitted with 2 General Electric Aircraft Engines Limited (General Electric) CF6-80C2-B6F³ turbofan engines. Further engine information is in section 1.4. Damage was confined within the left engine nacelle. The rubberised thermal protective coating of the thrust reverser inner diameters had patches of heat damage from the 5 o’clock to 6 o’clock positions⁴ below the fuel manifold (see Figure 2).

Figure 2
Damage to left engine cowls, ZK-NCK
Left: thrust reverser inner diameter. Right: damage at 5-6 o’clock position.

- 1.2.7 The left engine, serial number 704518, was replaced and the left engine thrust reverser halves required minor repairs before ZK-NCK was returned to service.

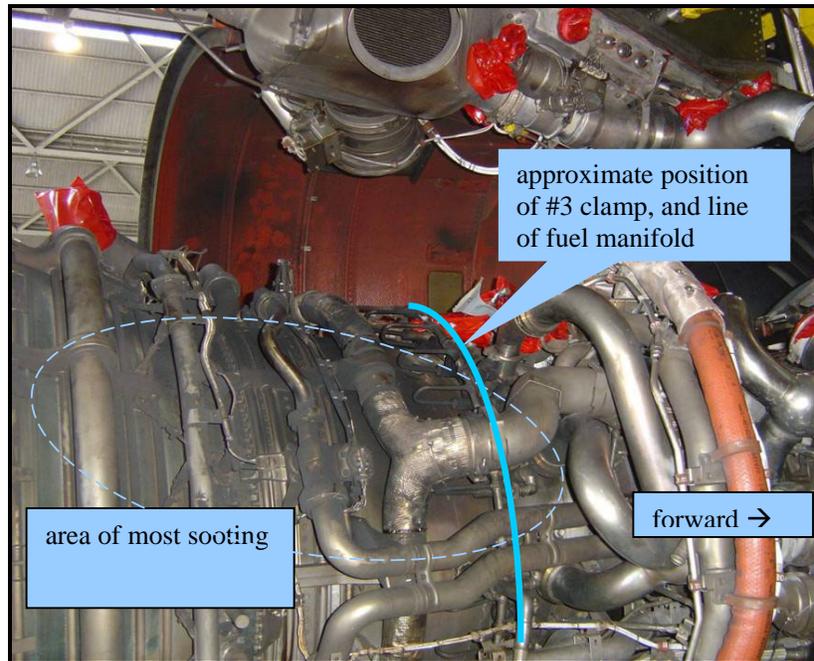
- 1.2.2 Soot was present on the compressor rear frame, except at the one o'clock position of the fuel manifold, by the #3 loop clamp (see Figure 3). General Electric advised that soot does not adhere to surfaces hotter than 700°F (370°C).
- 1.2.3 Once the engine had cooled, it was motored and a fuel leak was found at the #3 clamp location.

Figure 3
Area affected by fire, left engine of ZK-NCK

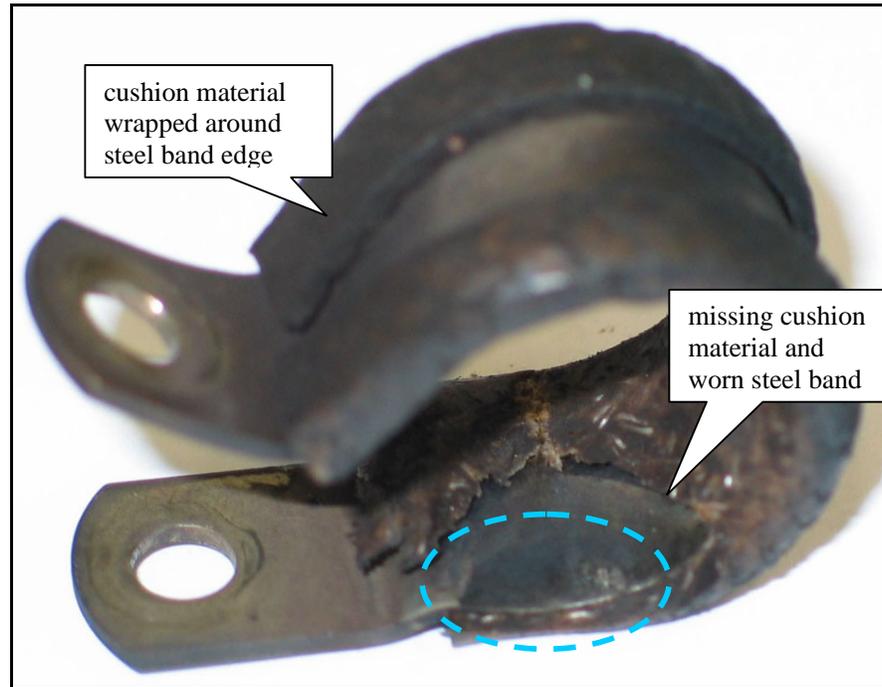
- 1.2.4 The #3 clamp was removed in the presence of the Commission's investigator. The clamp was loose on the manifold, but the attachment bolt break-out torque exceeded that specified. There was residue of a fibreglass tape, used to help achieve the required torque, under the clamp. Some cushion material was missing from inside the clamp and there were signs of metal-to-metal wear (see Figure 4). A pinhole was found in the fuel manifold where the clamp had been located.

Figure 4
#3 loop clamp from engine serial number 704518
Showing missing cushion material and metal wear.

- 1.9.3 The manifold pinhole was 0.014 by 0.031 inch (0.36 by 0.79 mm) in area and had originated in the region of missing cushion material on the #3 clamp. Some of the stainless steel band of the clamp had also worn away.

- 2.6 The fuel leak was in the manifold below the #3 clamp on the right manifold half, at approximately the one o'clock position on the engine. Although the clamp was properly bolted to the attachment bracket, it was missing some cushion material and metal-to-metal fretting had occurred between the manifold and the clamp.

The engine manufacturer revised the service bulletin to require the replacement of all of the manifold loop clamps at each inspection.

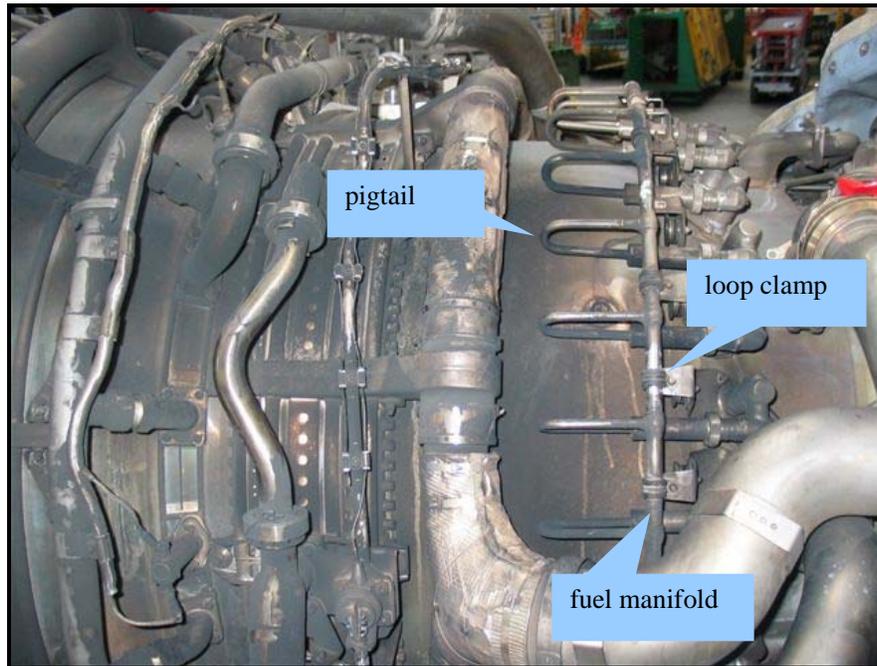
Figure 5
Fuel manifold and clamp locations, engine 704518

- 1.2.8 Examination of the fuel manifold found 5 other clamps with excessive sideways movement, although the torque on 4 of them met the requirement. The exception had a torque value just below that specified and was the only clamp without tape under it. The tape was abraded at all loose clamp locations, and through to the manifold at 4 of these.
