Report 07-001

Boeing 777-300ER

A6-EBC

incorrect thrust and configuration for take-off

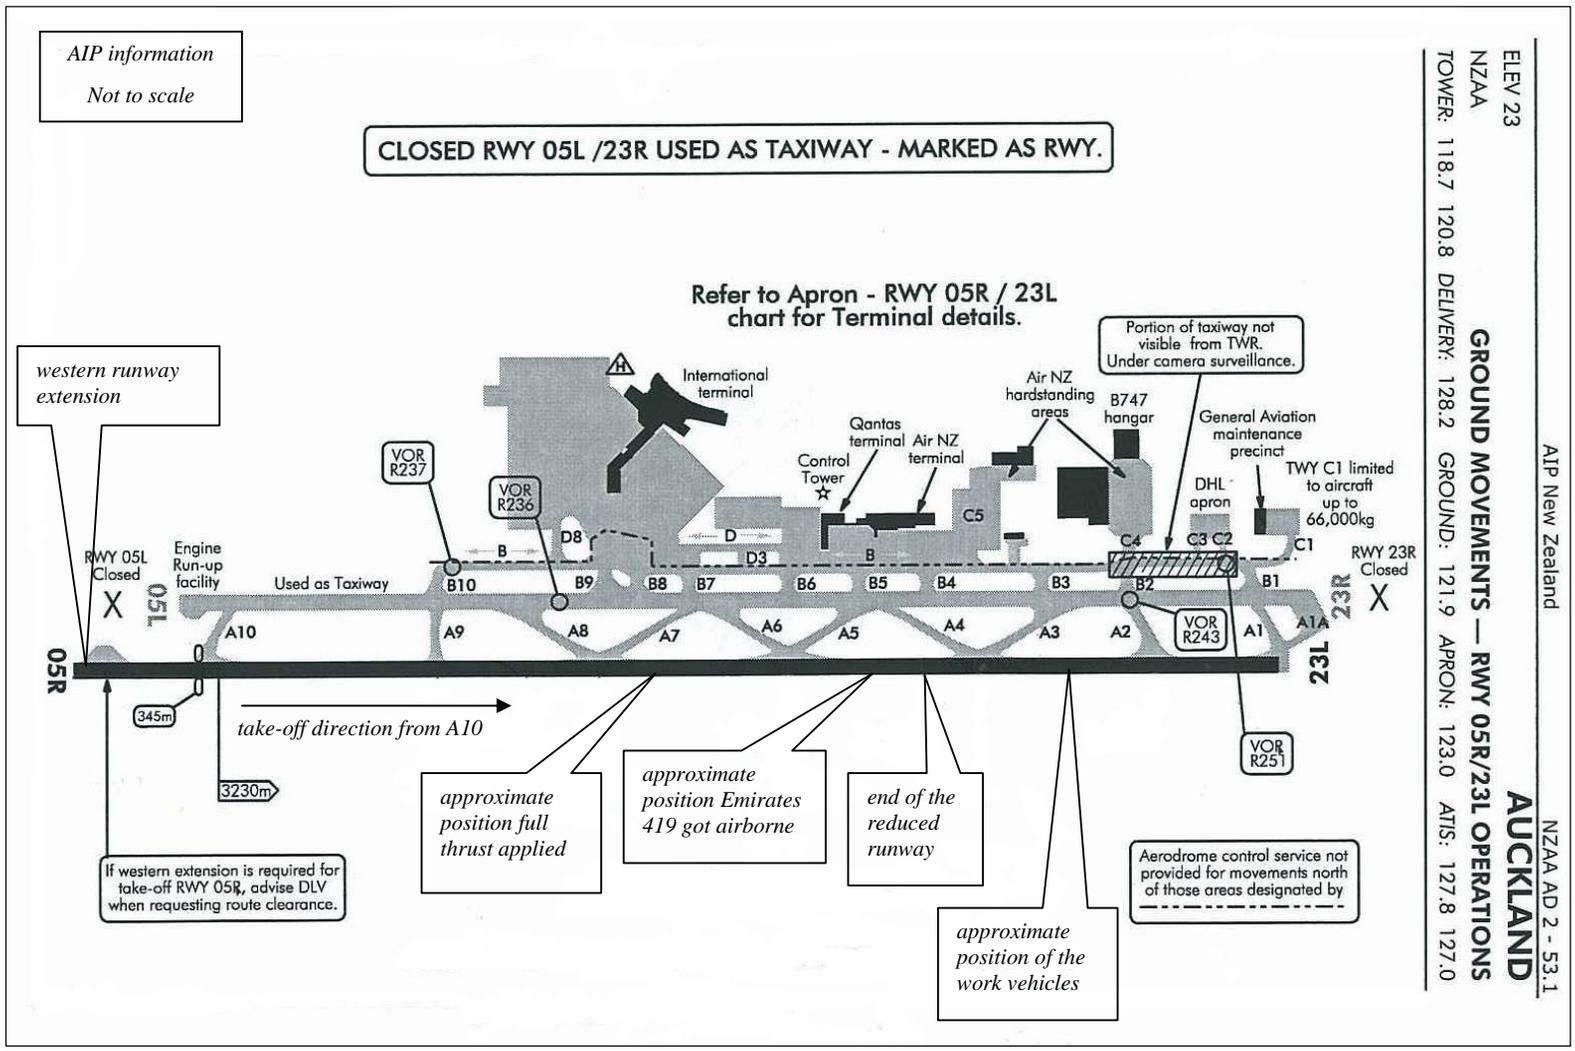
Figure 1
Auckland International Airport

- 1.1.7 At 1609 the first officer contacted the aerodrome ground controller for taxi instructions for Emirates 419’s return flight to Sydney. The controller gave the pilots instructions to taxi for runway 05R and to hold at taxiway A10 (see Figure 1). The first officer read back the

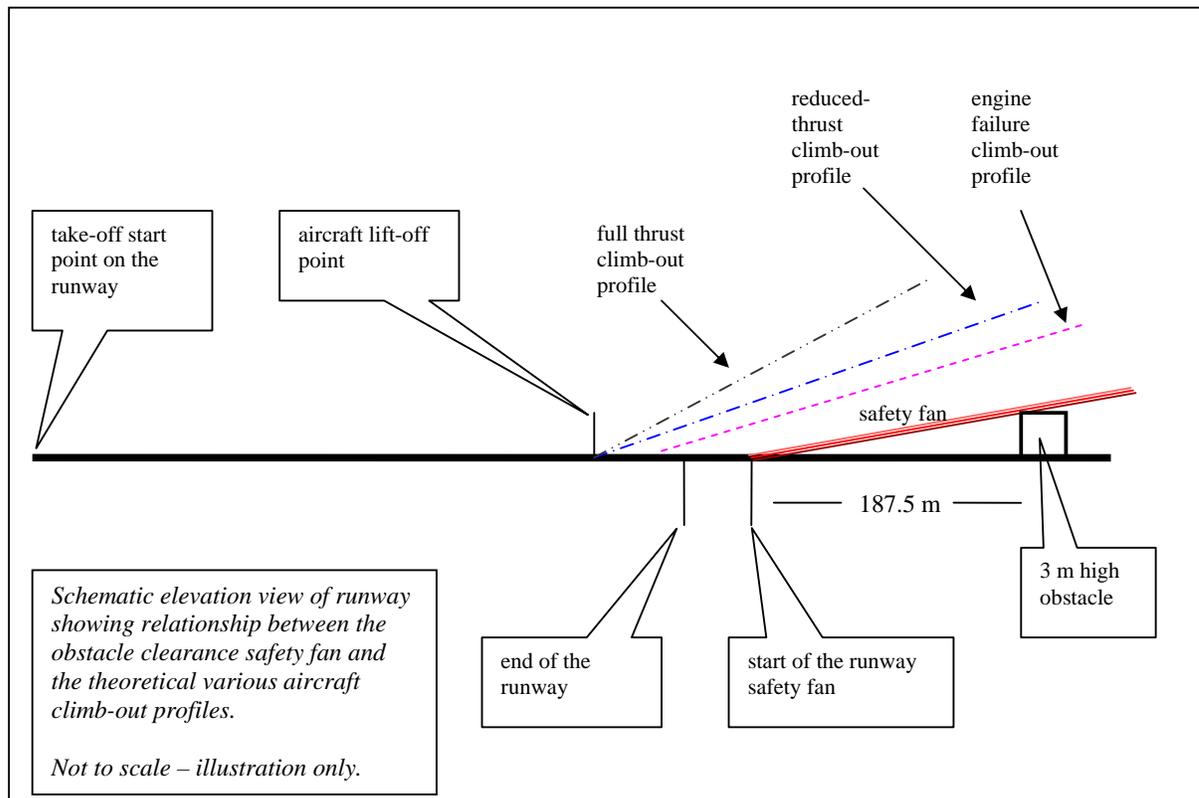
Figure 2
Illustration of aircraft runway performance

- 1.6.7 When preparing the MOWP and reducing the available runway length, the airport operator had to ensure that an obstacle clearance safety fan provided obstacle clearance to all aircraft during take-off and landing, including those aircraft with reduced performance following an engine failure (see Figure 2). The ICAO standards called for the fan to start no closer than 60m from the end of the available runway. In this case the airport operator's operations manager had started the fan 150m from the end of the reduced length of the runway, which gave additional safety.

- 1.6.8 For take-off, to provide the obstacle clearance fan, no obstacle could be higher than 1 m at the first 62.5 m horizontally from the start of the fan. For each additional 62.5 m horizontally, obstacles could progressively be a further 1 m in height, e.g. at 125 m from the start of the fan no obstacle could be higher than 2 m. A 3 m obstacle such as the rubber-removal truck could be no closer than 187.5 m to the start of the fan, or 247.5 m to the end of the available runway. The obstacle clearance fan widened progressively as it extended out.
