After takeoff from London Heathrow Airport a vapour trail was seen streaming aft of the aircraft. The flight crew diagnosed that the aircraft was probably leaking fuel from the centre wing fuel tank. They declared an emergency and decided to jettison fuel to reduce to maximum landing weight before returning to Heathrow. Their intention was to minimise heating of the brake units during the landing roll in order to reduce the risk of fire if fuel was to leak onto the wheelbrakes. After landing, the aircraft was met by the Airfield Fire and Rescue Service who reported some vapour emanating from the left landing gear but no apparent fuel leaks.

The fuel leak was caused by fuel escaping through an open purge door inside the left main landing gear bay, on the rear spar of the centre wing tank. The purge door had been removed during base maintenance at the operator's maintenance organisation in Cardiff, between 2 May and 10 May 2004, and had not been refitted prior to the aircraft's return to service.

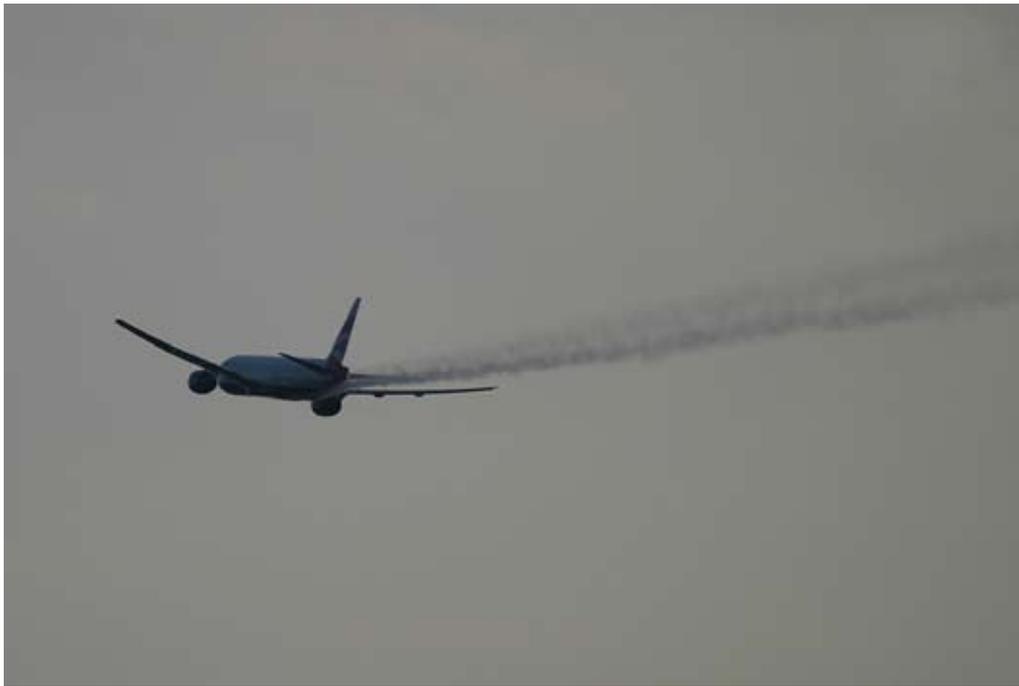
Figure 1

Fuel stream visible from G-YMME during departure from Heathrow
(photo courtesy Steve Flint)

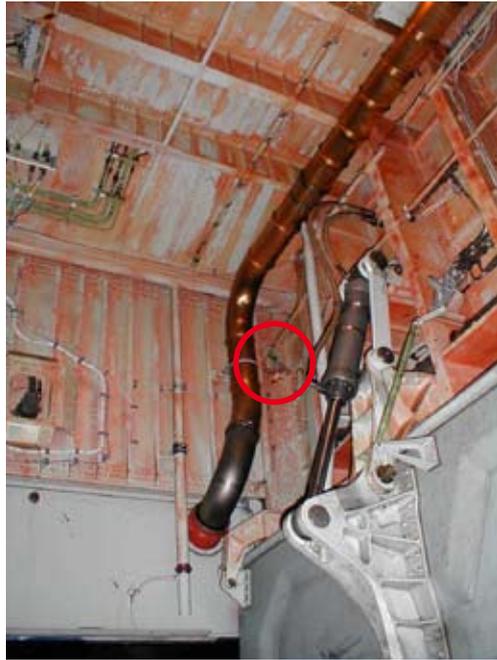
Figure 2

An engineer inspected the aircraft after it arrived at the stand. He noticed a few drips of fuel on the left main landing gear but none on the ground. After opening the left inboard main gear door, he detected a distinct smell of fuel. An inspection inside the gear bay revealed that the centre fuel tank purge door was not in place. The purge door was hanging on a lanyard inside the fuel tank and a plastic bag¹ was attached to the purge door opening. The bag contained fuel and the screws that would normally hold the purge door in place (see Figures 2 and 3).

View inside left main gear bay looking forward at the rear spar of the centre fuel tank. Purge door opening circled in red.

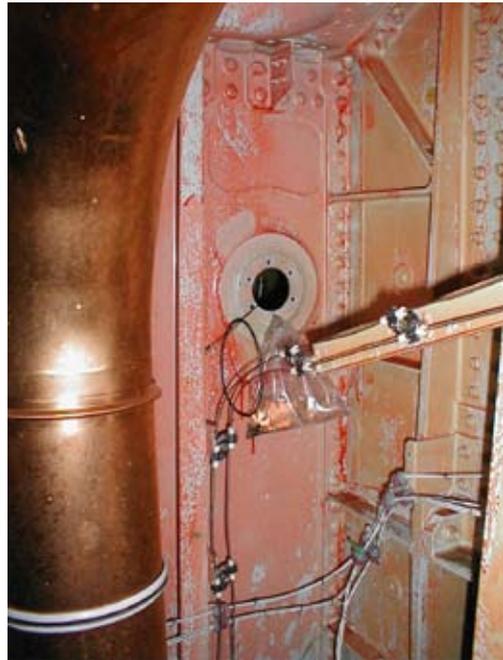
Figure 3

Purge door opening. Fuel and retaining bolts inside plastic bag. Purge door is hanging on a lanyard inside fuel tank. Purge door O-ring visible on lanyard.

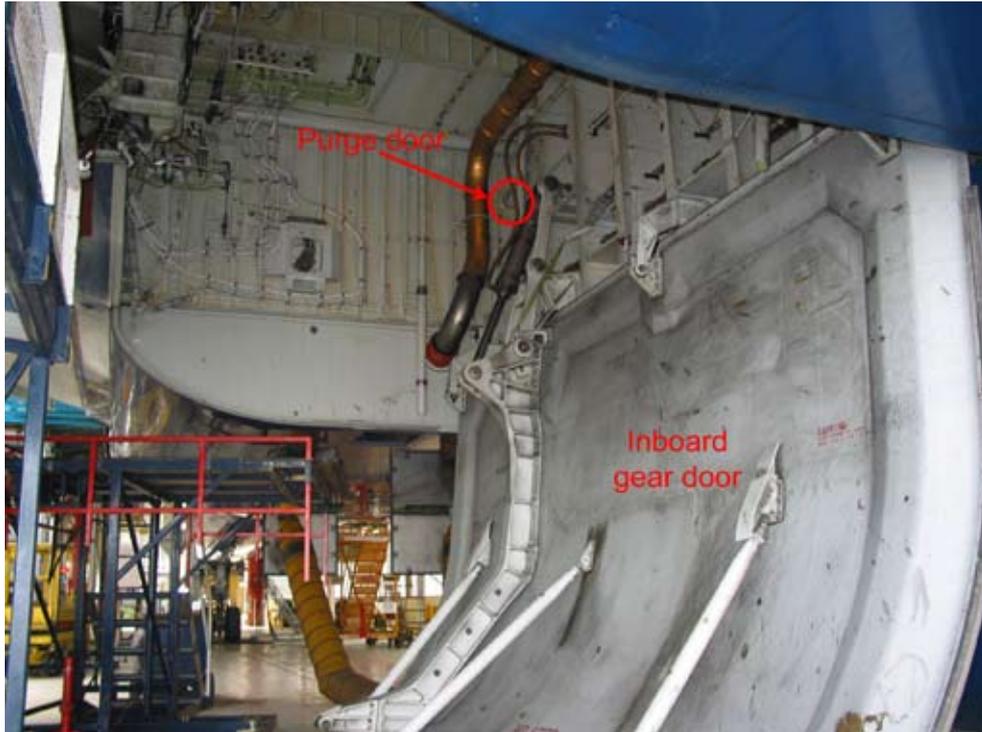
Figure 8

The purge door is located on the rear spar of the centre section of the CWT approximately 7 inches left of the aircraft centreline (see Figures 6 and 8). It can be accessed from inside the left wheel well or from inside the CWT. The purge door is a circular panel of approximately 4.5 inches diameter with 6 bolt holes around its circumference. It is a plug type door which is pressed into the purge door opening from within the tank (see Figure 9). The purge door opening has a diameter of 2.5 inches and is visible from the ground when the left inboard main gear door is open. For all normal operations this main gear door remains closed; it opens only briefly to permit the landing gear to extend and retract. The door can be opened on the ground to conduct maintenance inside the wheel well but it would not be normal to do this during a turn-around between flights. When the inboard main gear door is closed the purge door is not visible from ground level.

Purge door visibility with left main inboard gear door open

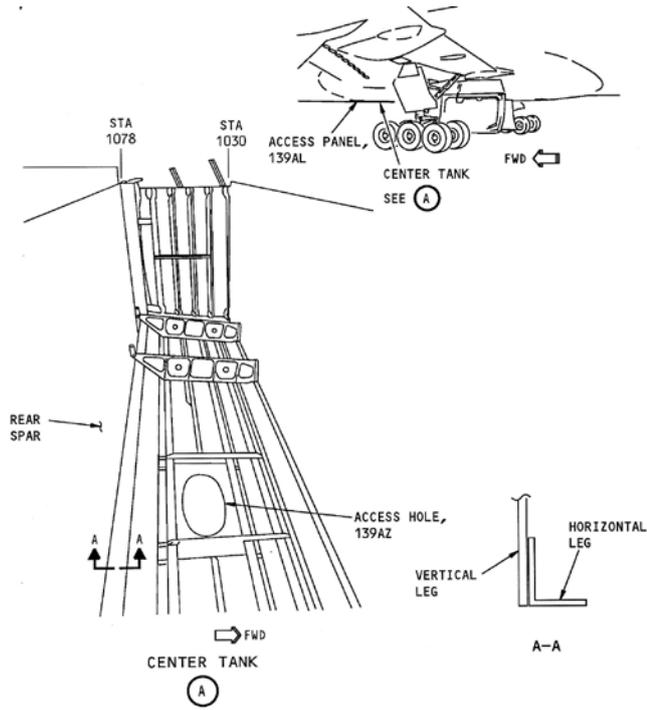
The ensuing instructions simply stated ‘*Do the inspection*’ and then the illustration depicted in Figure 10 followed. The AMM (also last revised 5 May 2003) contained the same instructions and the same diagram.

There are a number of errors in Figure 10 and these can best be visualised by comparing it to a corrected diagram in Figure 11. Both figures depict the forward section of the centre section of the CWT, but Figure 10 has the front spar incorrectly labelled as the rear spar, the STA (station) numbers are reversed and the FWD arrow in the lower diagram of Figure 10 points the wrong way. In Figure 10 the area shown to be inspected (A-A) is the lower section of the front spar but it could be interpreted to be the lower section of the forward spanwise beam due to the FWD arrow pointing the wrong way. A new diagram, Figure 12, clearly shows the aft section of the CWT and the area to be inspected on the rear spar.

Rear spar inspection diagram with errors (Rev 5 May 2003)
(Copied with permission of The Boeing Company)

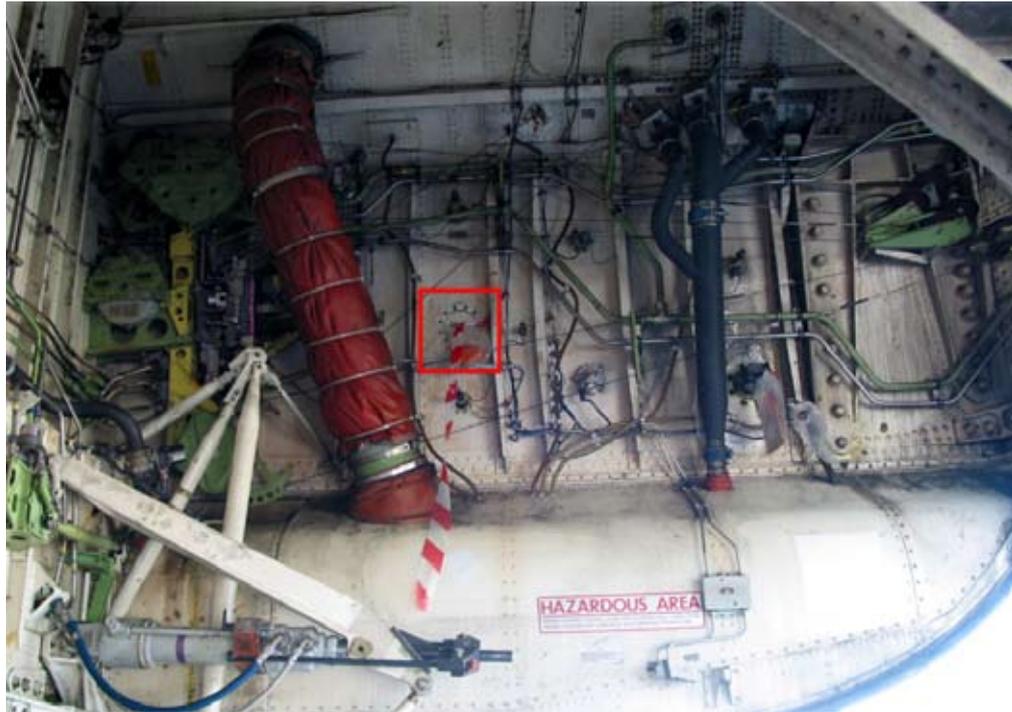
Figure 14

Boeing 747-400 purge door (highlighted by red box) with hazard tape
