# **NATIONAL TRANSPORTATION SAFETY COMMITTEE**

**AIRCRAFT ACCIDENT REPORT**

**Mandala Airlines MDL493**

**Boeing B737-200 Adv PK-RIL**

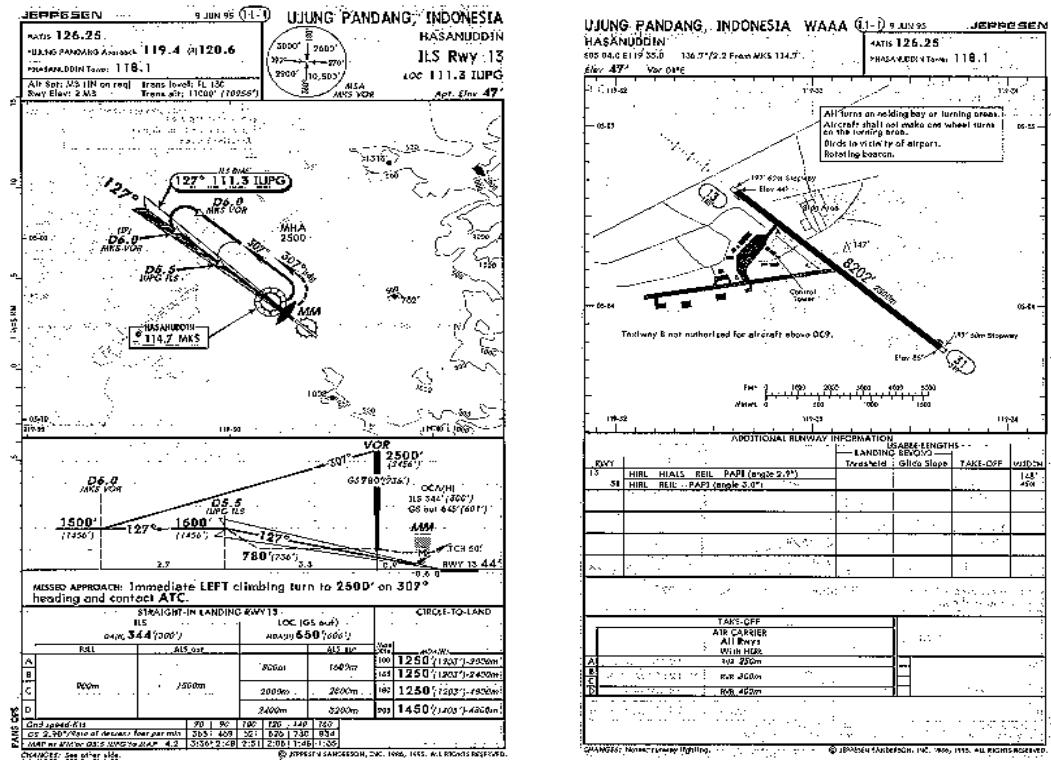
**Figure 1. Airport lay out and ILS approach chart R/W 13 (Current Jeppesen approach chart information)**

The airport has been known to be a difficult for approaches in the months of November to April, which is the rainy season for the region. Westerly winds and turbulence are expected to be encountered on short final to R/W 13.

The airport is managed by PT Angkasa Pura II, a state owned airport management enterprise. Past records showed that the airport is known to be a difficult airport to land on, especially during instrument approaches in rainy conditions. The investigation revealed that similar accidents and incidents occurred under similar weather conditions in the past few years. Three landing incidents (overruns, involving three different operators and three different types of aircraft) happened in the last few weeks prior to the occurrence, again all in similar rainy weather. On several occasions it was reported that during instrument approach in rainy conditions, aircraft were controlled by Ujungpandang Approach, while the local procedures required that Air Traffic Control shall transfer control to the Hasanuddin Tower at least at the point when the aircraft reached decision altitude, which is 344 ft ASL at Ujungpandang.

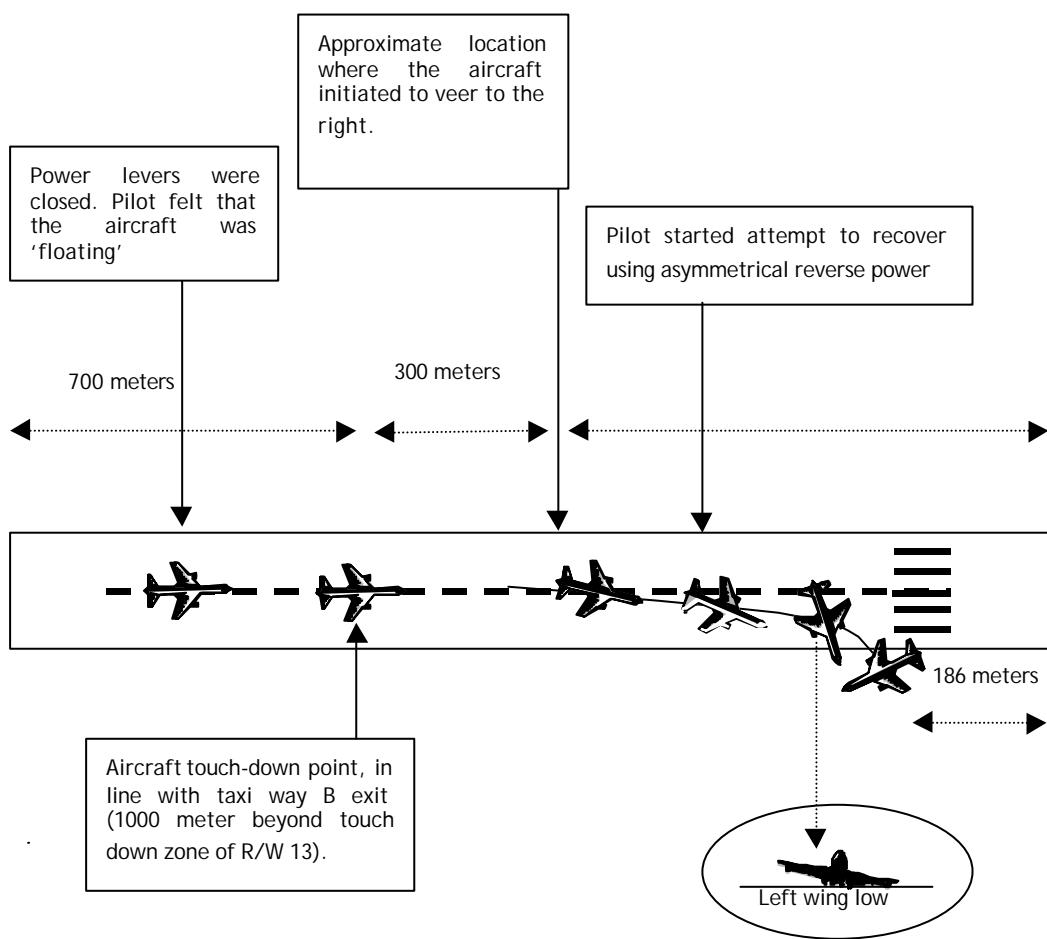
**Figure 2. Aircraft ground roll trajectory (sketch)**

The final position of the aircraft was at 186 meters from the R/W 13/31 threshold. No tire markings of first touch down were found on the runway, although it was reported that the approximate touch-down point was in line with the taxiway B exit, approximately 1000 meters beyond the R/W 13 touch down zone.

No tire brake markings were found along the approximate ground roll trajectory. Rubber deposits were found on R/W 13 at the point where the aircraft started veering to the right, which was at approximately 75 meters before the location where aircraft went off the runway. The significant facts and findings gathered were analyzed. The SHEL concept approach was used in the analysis. The analysis of the events and circumstances which may have contributed to the occurrence were weather conditions, wind measuring equipment, aircraft systems, flight and ground operations procedural deficiencies.

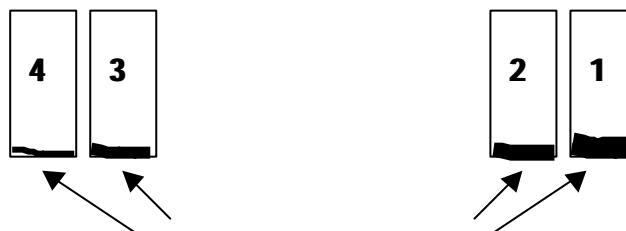
**Figure 3. The tire damage on the main wheel surfaces (worn spots on each main wheel) – front view**

One worn spot in line on all main tires were found and the #1 tire had the worst and followed linearly by #2 tire and #3 tire. The #4 tire was identified having a smaller worn spot mark than the others.

- 6) **Landing gear.** All landing gear tires showed worn out spots. The worst damage was found on the landing gear #1 tire, linearly diminishing in size, the worst or the largest worn out areas were found on landing gear tire #1 gradually diminishing in size on tires #2, #3 and #4. The worn out spot sizes were approximately 20x30 sq cm and less. The #1 landing gear damage is most likely due to high loading during the high speed right turn of the aircraft, which was also evidenced by the separation of the #1 engine.

- The damage to the tire surfaces indicates that the #1 tire experienced the highest loads during the landing maneuver, evidenced also by the separation of the #1 engine during the landing. The existing airport infrastructure was not sufficient to make instrument approaches on R/W 31. The only approach procedures published are ILS and VOR approaches for R/W 13 only. Note that at the time of the occurrence it was raining and the wind velocities and direction were northerly with gusts of up to 20 kts, while the aircraft operation manual procedures stated a tailwind limit of 20 kts during landings. It is noted that the weather monitoring system equipment is located near the tower at about 50 meters distance from the runway. During the landing maneuver, the approach control communicated with, and controlled the aircraft until touch-down.

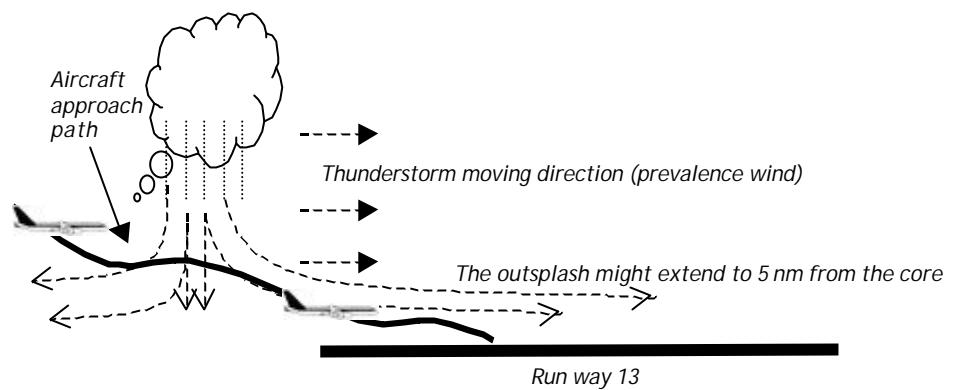
**Figure 4. The aircraft approach path illustration**

The weather conditions (wind velocities and directions) at the Hasanuddin Airport at the time of occurrence were analyzed for possible discrepancies between values provided by various sources, such as the meteorological office, the tower, and from the onboard instruments of aircraft into Hasanuddin Airport. The result of the analysis showed that the minimum value of the velocity differences was 10 to 13 knots, and the maximum value of the direction changes or differences was found to be 50 degrees. These values indicate the uncertainty of accuracy of the weather information the pilot may acquire from the several sources he has at hand, which may be contributing to ineffective or wrong flight handling of the aircraft, leading towards the inevitability of the occurrence.

Note that these weather data may well point to wind changes that has the characteristics of wind bursts in the Hasanuddin Airport surrounding areas, resulting the aircraft touching down at approximately 3,000 ft beyond the target touchdown point.
