## Boeing 737 Pilot Flying Selects Incorrect Altitude in Holding Pattern, Causes Dangerous Loss of Separation with MD-81

*The B-737 pilot correctly read back an ATC clearance, but set the wrong flight level in the autopilot mode control panel. Separation between the B-737 and a McDonnell Douglas MD-81 in the same holding stack was reduced to less than one-half mile (0.8 kilometer) horizontally and 100 feet (30.5 meters) vertically at their closest.*

FSF Editorial Staff

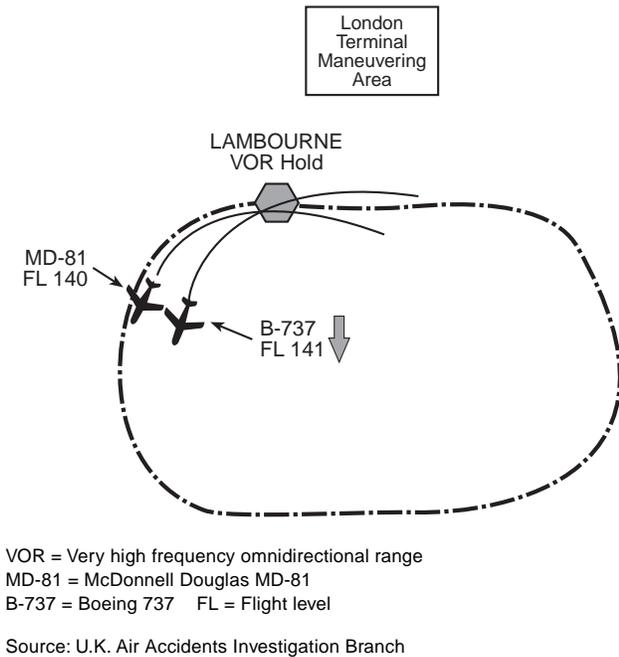
**Figure 1**

At 1643:18, when the B-737 reported entering the hold at LAM, it was 700 feet directly above the MD-81. The two aircraft turned left together in the holding pattern (Figure 1, page 3).

**AIRPROX, Lambourne Sector,  
London Air Traffic Control Centre,  
Nov. 12, 1996**

“The B-737 had executed a slightly smaller-radius turn than the MD-81, which resulted in the B-737 being slightly ahead and to the left of the MD-81 at the time of the closest proximity, with both aircraft having left bank applied for the turn, about 25 degrees in the case of the B-737,” said the report.
