Accident Report Provides Lessons Learned About Preventing Takeoff on a Closed Runway

Safety recommendations of the Aviation Safety Council of Taiwan, based on the Singapore Airlines Flight SQ006 accident, discuss the adequacy of some international standards for runway/taxiway signs, marking and lighting. The Boeing 747 struck concrete barriers, runway-construction pits and construction equipment during takeoff in heavy rain, strong winds and low visibility.

FSF Editorial Staff

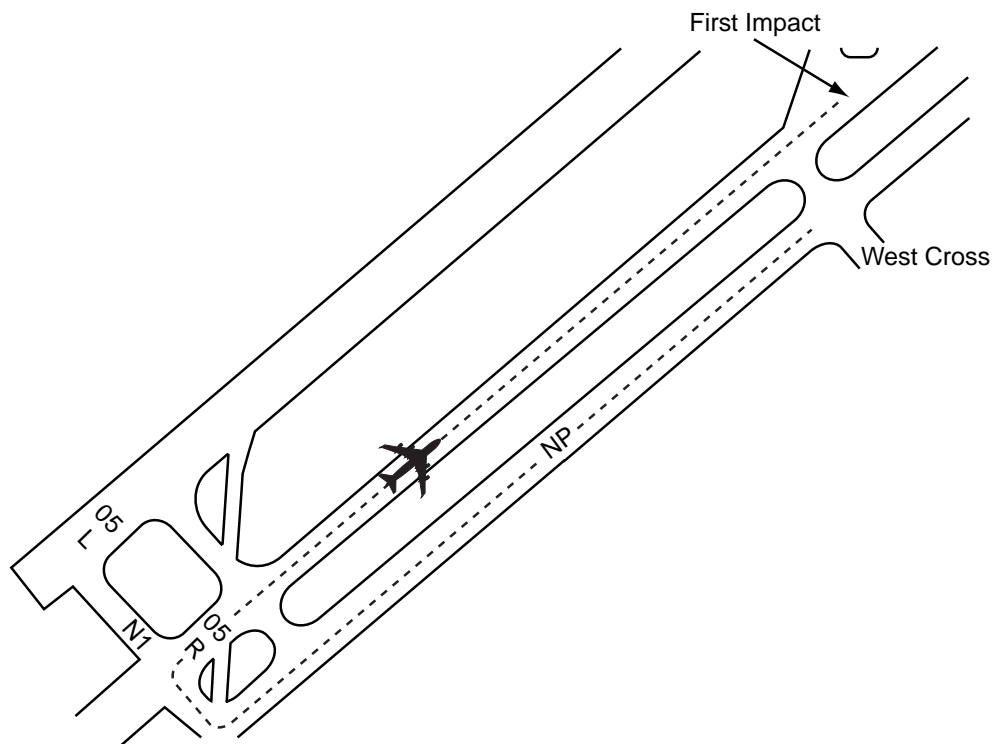
Figure 1

Runway 05L and Runway 05R, Chiang Kai-Shek International Airport, Taoyuan, Taiwan

Note: Runway designations and taxiway designations on Oct. 31, 2000.

[the aircraft] entered Runway 05R and [the captain] commenced the takeoff roll (see Figure 1). [The first officer and the relief pilot] did not question [the captain's] decision to take off;
