**NATIONAL  
TRANSPORTATION  
SAFETY  
COMMITTEE**

**AIRCRAFT INCIDENT REPORT**

Japan Airlines Flight JL726

B747-300 JA8178

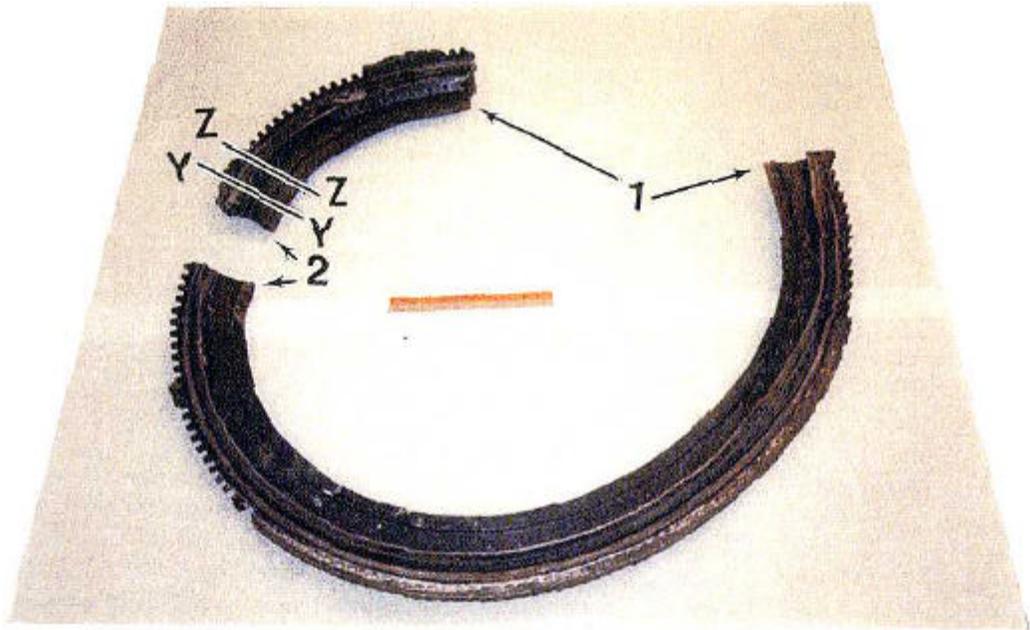
The 5<sup>th</sup> stage LPT disk of No. 1 engine failed, broke into two parts, both parts were ejected out from the inboard side of LPT case with heavy damage sustained by the inboard LPT casing.

Figure 1. The 5<sup>th</sup> stage disk (source: NTSB Report)

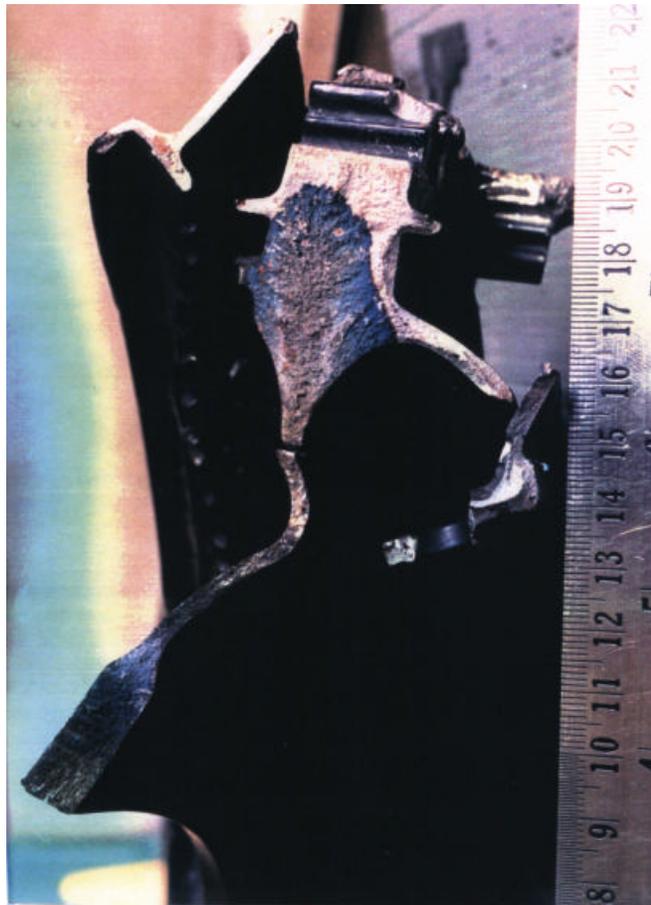
One pair of the fracture surfaces revealed a typical fatigue pattern-fatigue which had a flat surfaces and different color (blue & gold tint) as compared to the adjacent area (see Fig. 2).

Figure 2. Fracture surface of the fatigue area (source: ITB Report)

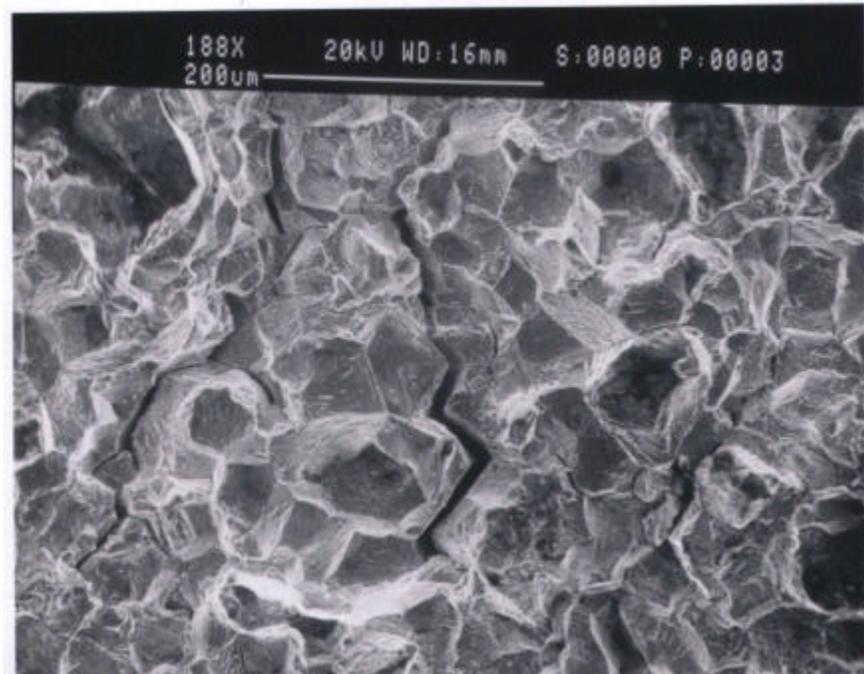
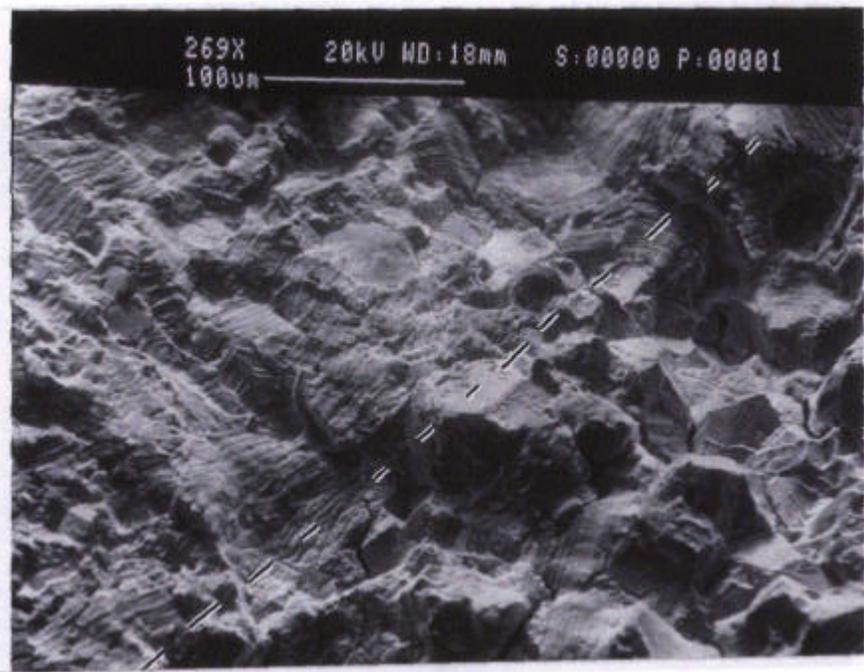
The findings of the examinations revealed that the failure of the disk was attributed to intergranular, elevated temperature fatigue, which had progressed from the surface of the web. The fracture originated in a blended repaired area on the front surface of the disk.

Figure 3. Fracture surface of SEM, the intergranular surface (top) and transition surface (bottom) (source: NTSB Report)

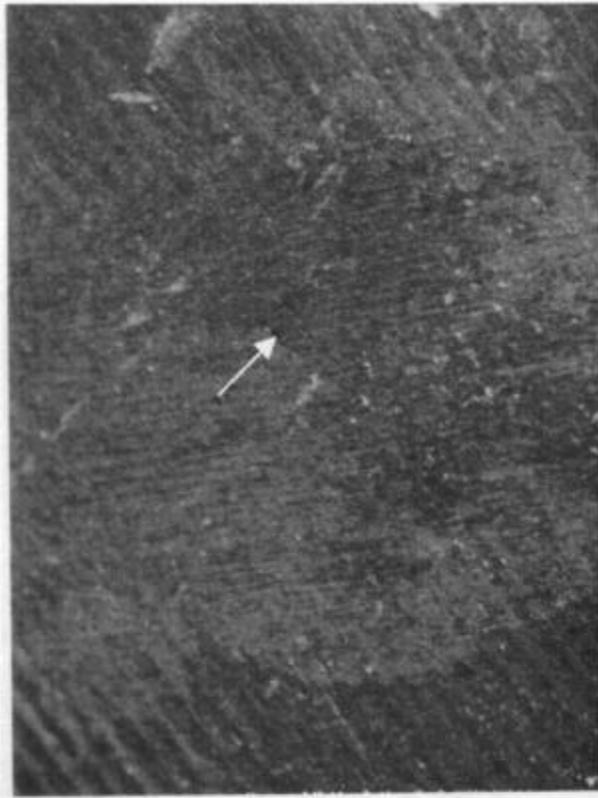
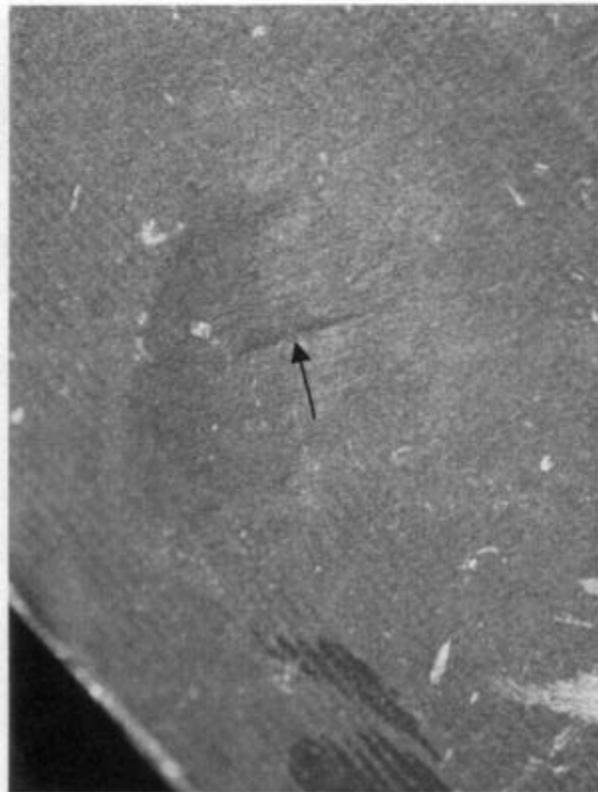
The investigation concluded that blending operation, in particular on a disk or on a highly stressed part carries a high risk of residual damage (worked material or shallow cracks) remaining and these sites are potential sites for fatigue crack initiation. Therefore, the NTSC recommended that;

Figure 4. Blending area of the disk (source: P&W Report)

1. Residual damage seems to be the origin of the fatigue crack on this disk. Such damage could not be detected by available NDI method. To prevent similar occurrence, blending operation on such a particular disk should be reviewed.
2. A disk design review should be undertaken.

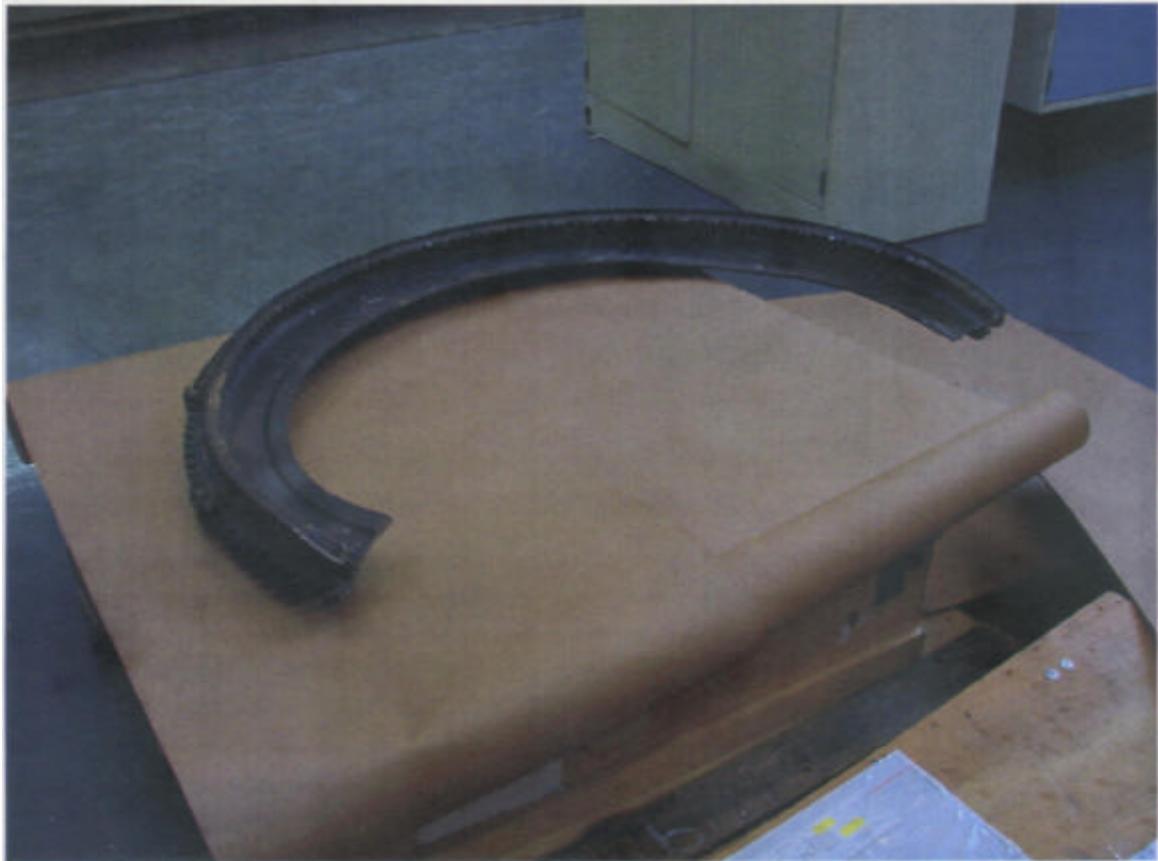
FIGURE 1

PHOTOGRAPH SHOWING APPEARANCE OF LARGE PORTION OF FRACTURED JT9D FIFTH STAGE TURBINE DISK WHICH WAS RECEIVED FOR EXAMINATION IN MATERIALS AND PROCESSES ENGINEERING

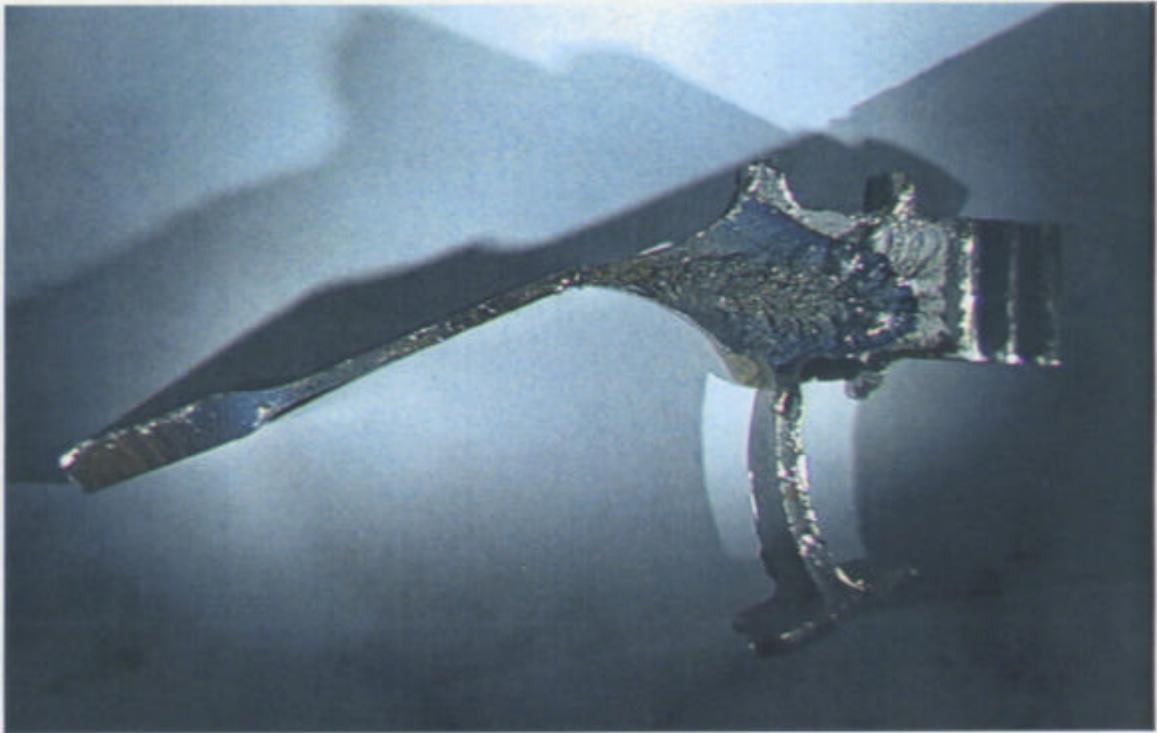
FIGURE 2

OVERVIEW OF PRIMARY RADIAL FRACTURE SHOWING LOCATION OF FLAT, GRANULAR APPEARING, OXIDIZED AREA IN THE WEB.

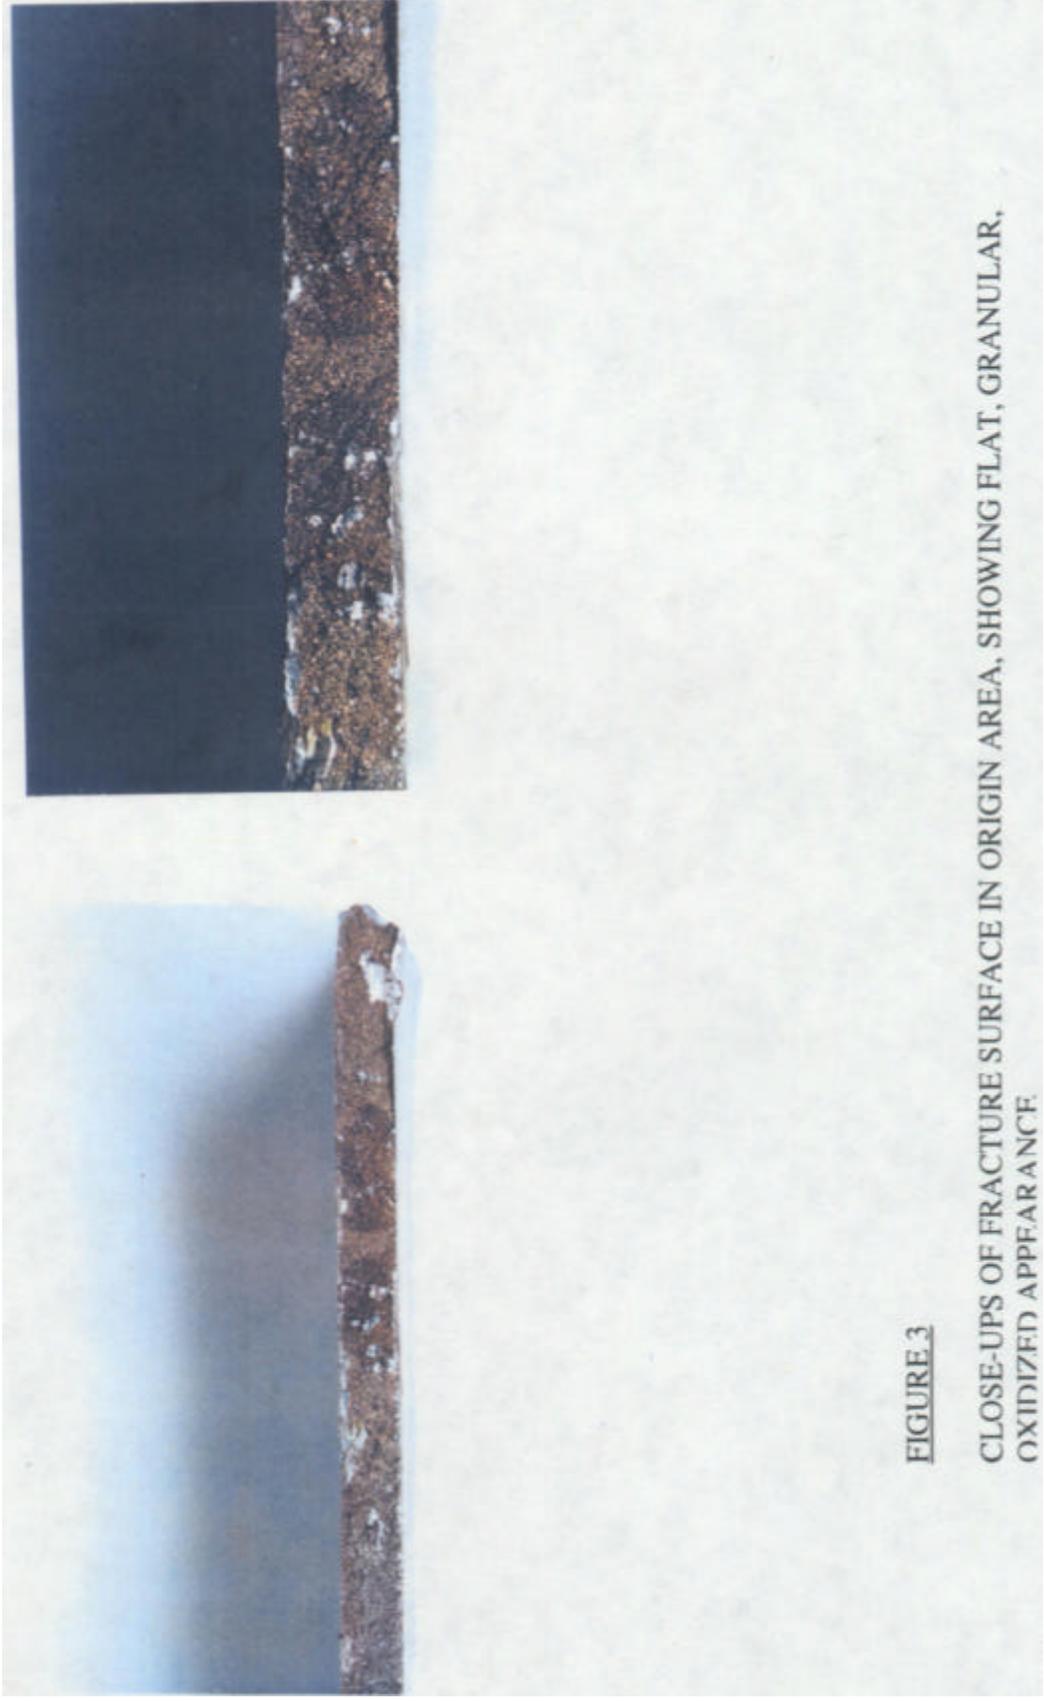
FIGURE 3

CLOSE-UPS OF FRACTURE SURFACE IN ORIGIN AREA, SHOWING FLAT, GRANULAR, OXIDIZED APPEARANCE.

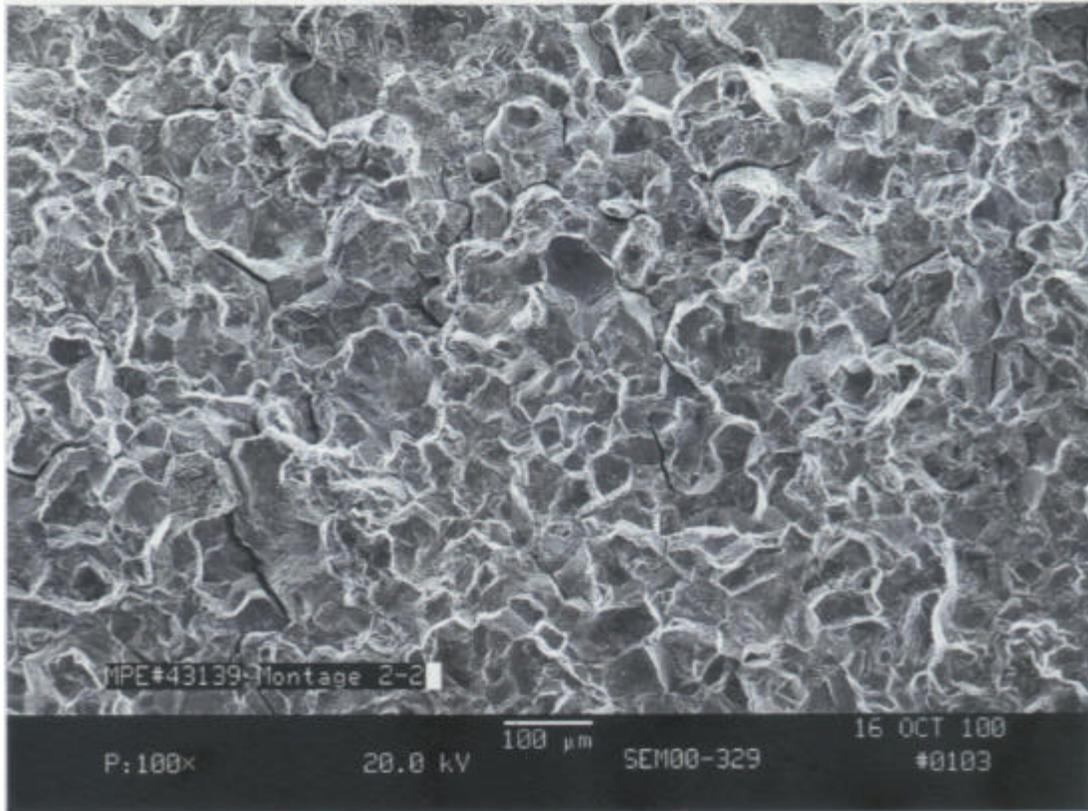
FIGURE 4

SCANNING ELECTRON MICROSCOPE PHOTOGRAPH OF FRACTURE SURFACE IN OUTER PORTION OF WEB, SHOWING INTERGRANULAR FRACTURE APPEARANCE WHICH WAS PRESENT THROUGH THE WEB THICKNESS FOR APPROXIMATELY 0.4 INCHES OF RADIAL DISTANCE.

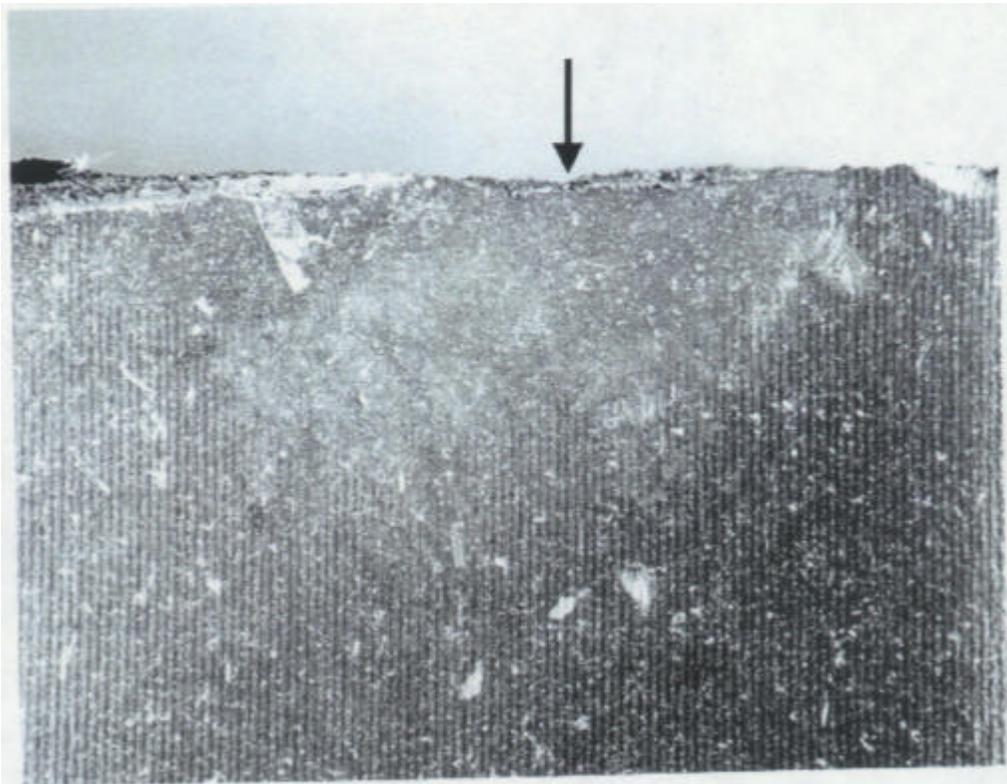
FIGURE 5

CLOSE UP OF FRONT SURFACE OF WEB IN THE AREA OF THE FRACTURE INITIATION, SHOWING SMOOTH, POLISHED APPEARING AREA WHERE ORIGINAL MACHINING LINES HAD BEEN REMOVED, INDICATIVE OF LOCAL BLENDING. ARROW SHOWS APPROXIMATE LOCATION OF FRACTURE ORIGIN.

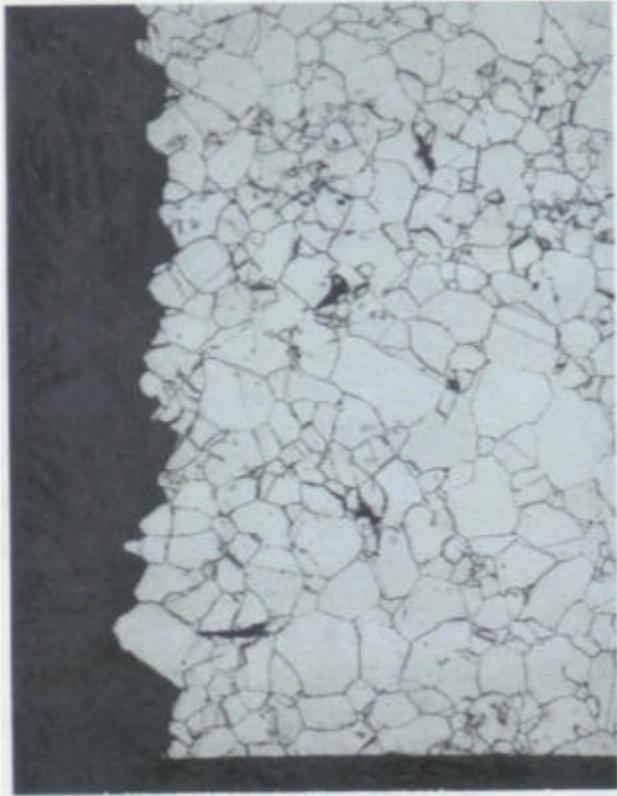
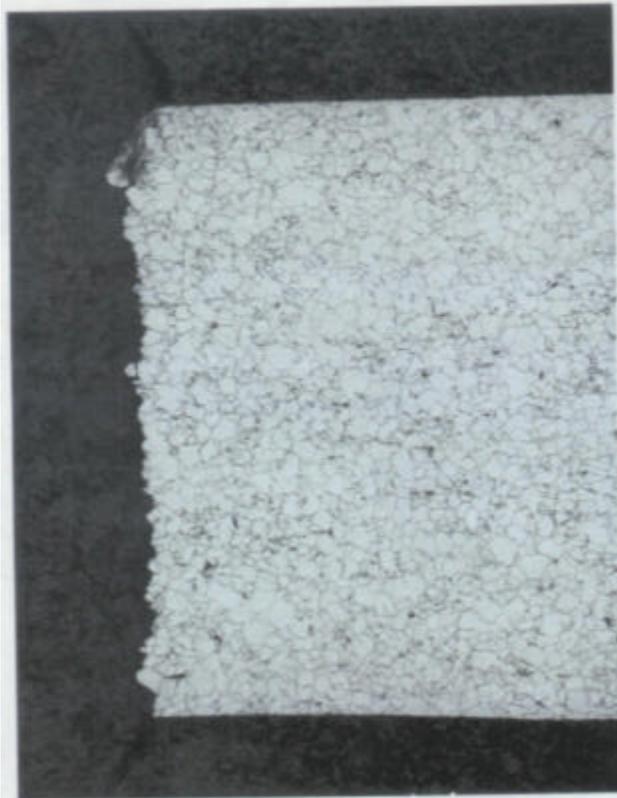
FIGURE 6

PHOTOMICROGRAPHS OF SECTIONS THROUGH VICINITY OF FRACTURE ORIGIN  
SHOWING INTERGRANULAR FRACTURE PATH, AND APPEARANCE OF  
MICROSTRUCTURE

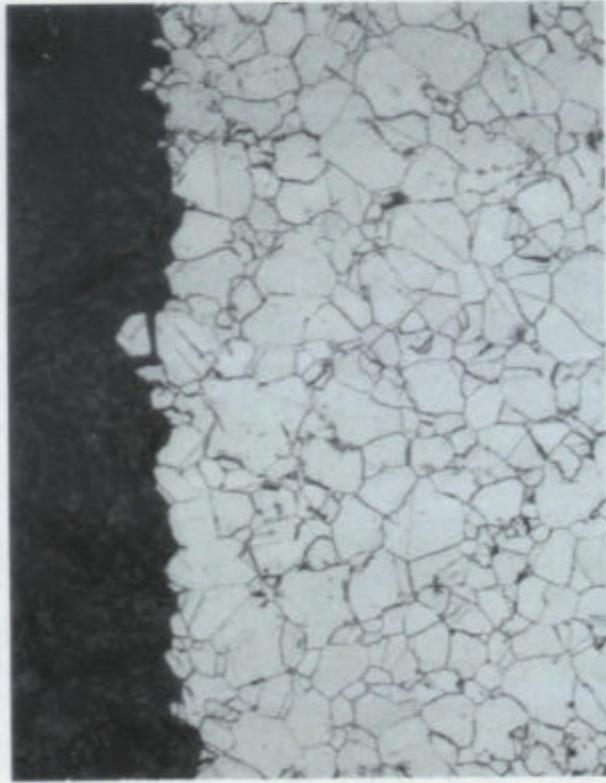
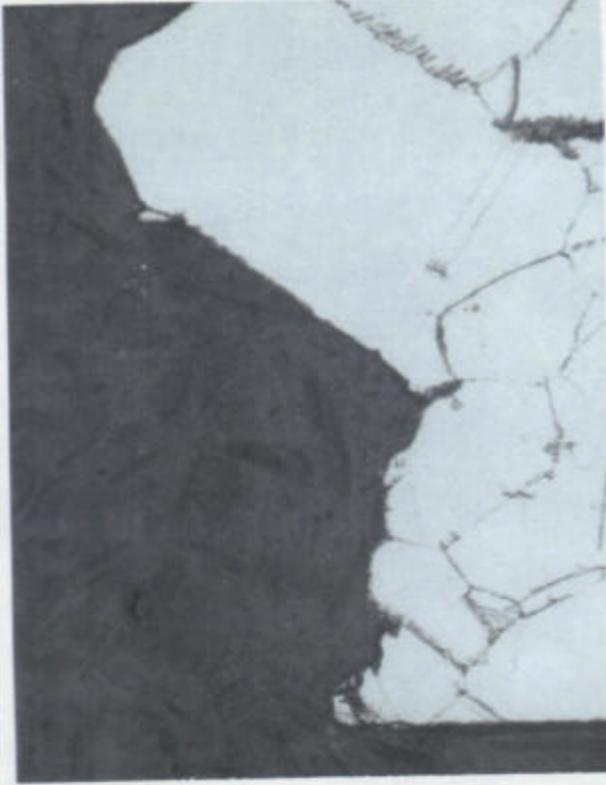
FIGURE 7

PHOTOMICROGRAPHS OF SECTIONS THROUGH VICINITY OF FRACTURE ORIGIN  
SHOWING INTERGRANULAR FRACTURE PATH, AND APPEARANCE OF  
MICROSTRUCTURE

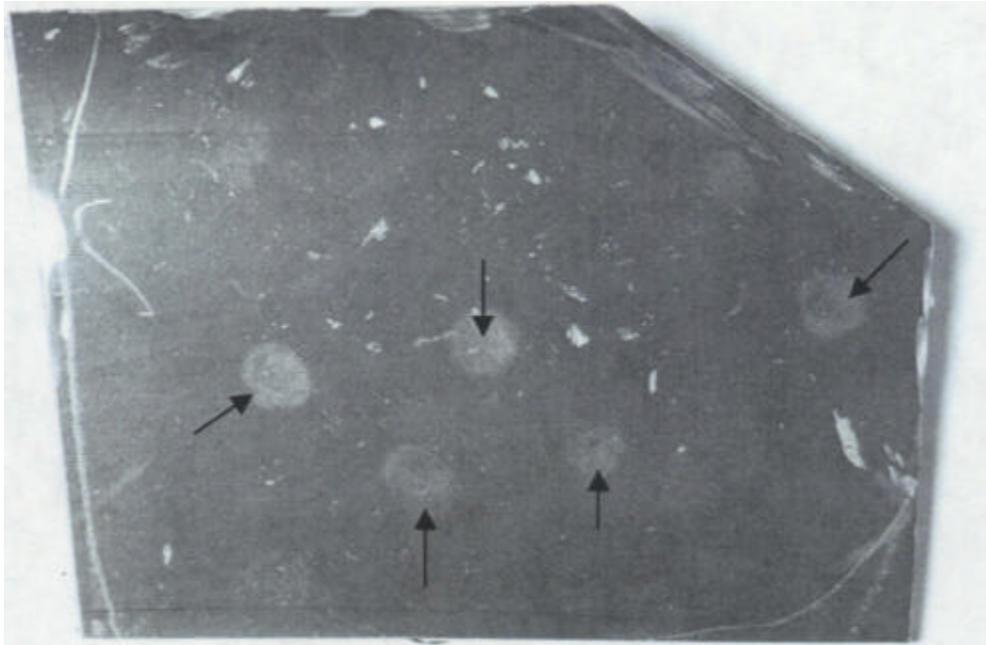
FIGURE 8

VIEW SHOWING APPEARANCE OF SECTION OF DISK WEB  
WHICH WAS SECTIONED OUT FOR EXAMINATION OF  
BLENDS (ARROWS)

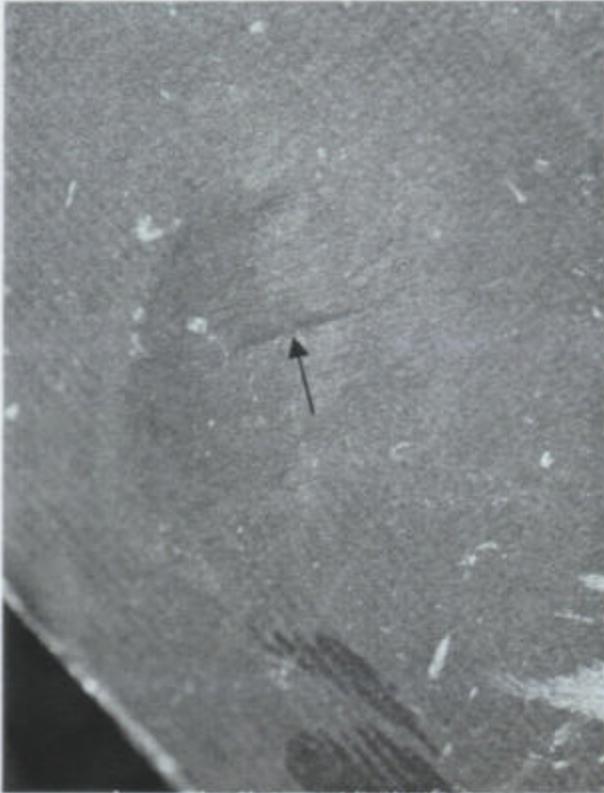
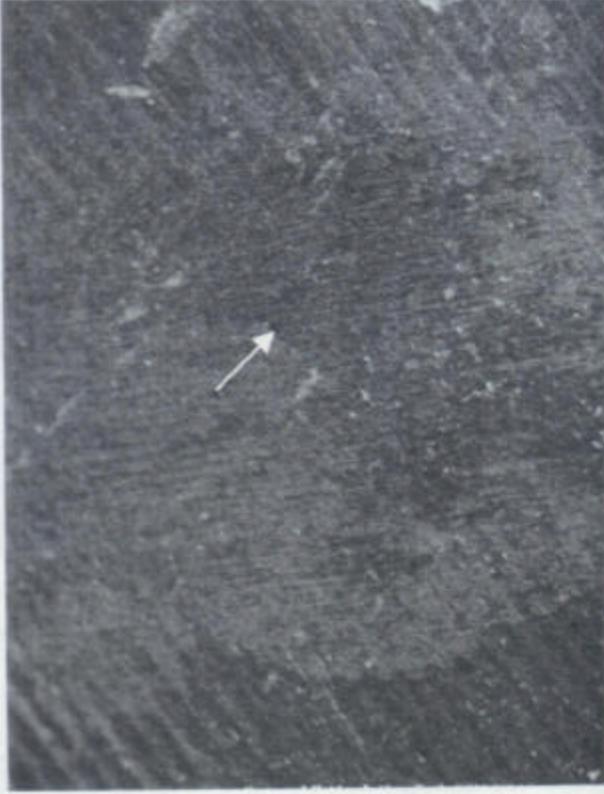
**FIGURE 9**

**CLOSE-UPS OF TWO BLENDS WHICH SHOWED EVIDENCE OF RESIDUAL MECHANICAL DAMAGE (ARROWS)**

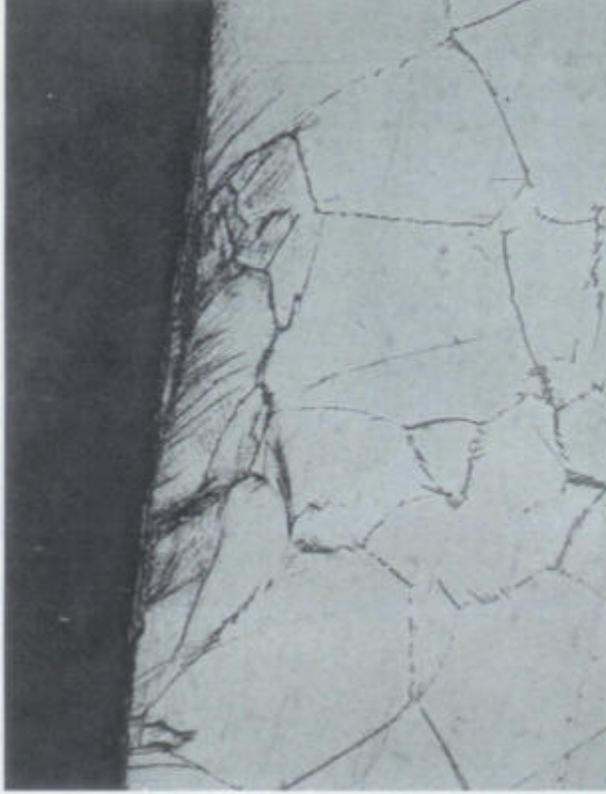
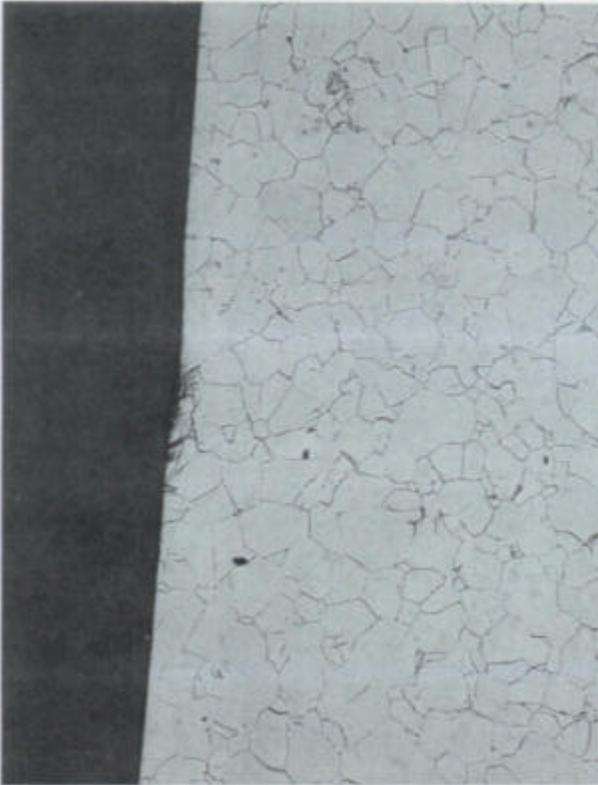
FIGURE 10

PHOTOMICROGRAPHS OF SECTIONS THROUGH BLEND AT LEFT IN FIGURE 9, SHOWING APPEARANCE OF WORKED MATERIAL AT THE BASE OF THE AREA OF MECHANICAL DAMAGE

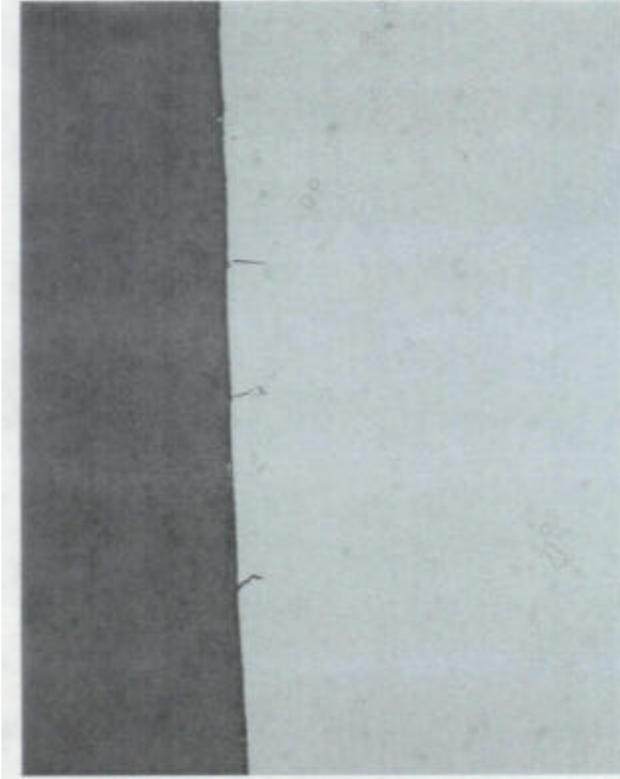
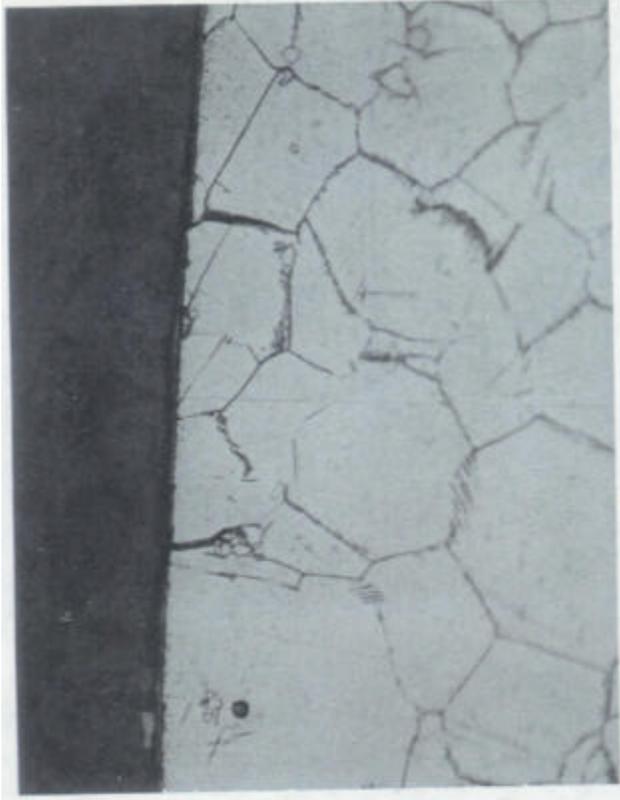
FIGURE 11

PHOTOMICROGRAPHS OF SECTION THROUGH BLEND AT RIGHT IN FIGURE 9  
SHOWING SHALLOW INTERGRANULAR CRACKS NEAR CENTER OF THE BLENDED  
REGION

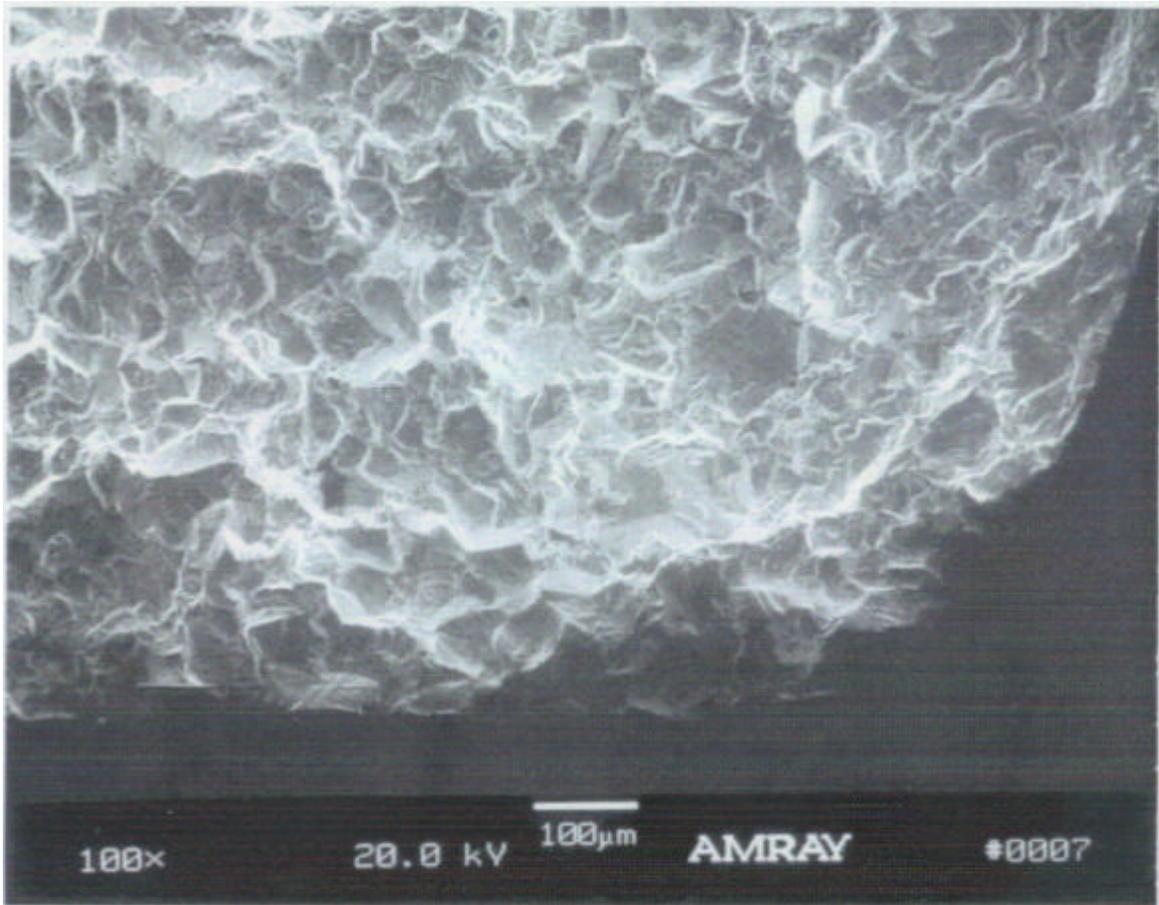
**FIGURE 12**

SCANNING ELECTRON MICROSCOPE PHOTOGRAPH OF FATIGUE SPECIMEN TESTED AT 1000°F, WITH FIVE MINUTES DWELL AT MAXIMUM STRESS. NOTE INTERGRANULAR FRACTURE APPEARANCE.

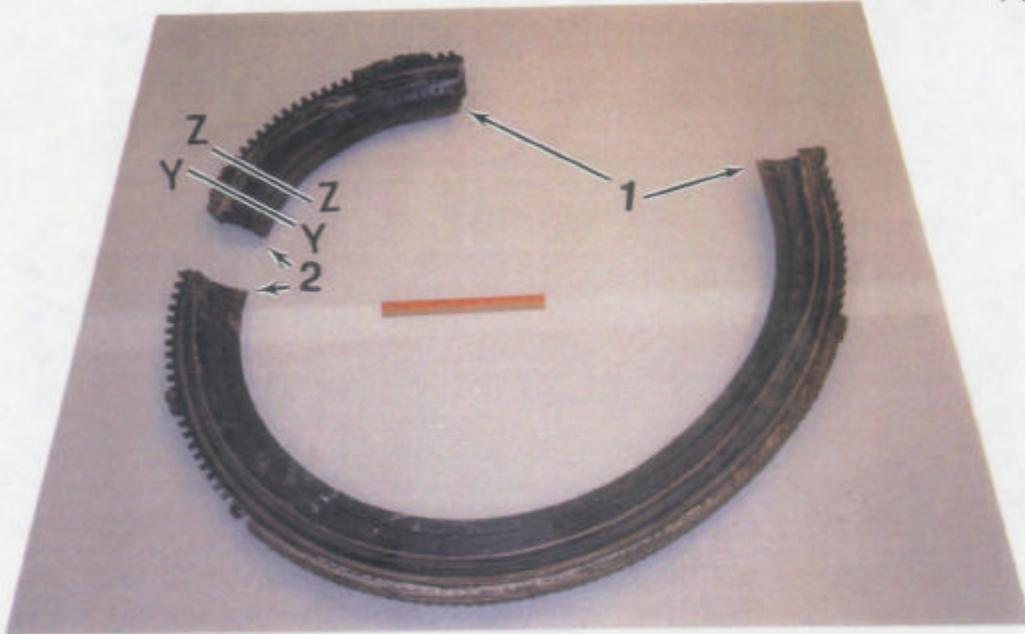
Figure 1. As-received disk that separated in the areas indicated by arrows "1" and "2".

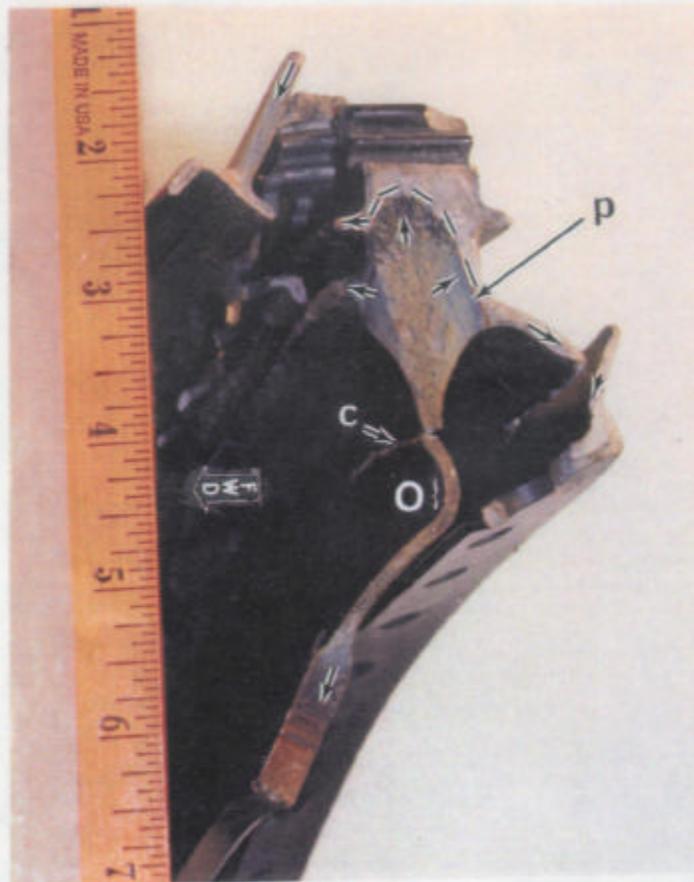
Figure 2. Photograph of fracture "2" on the smaller piece of the disk.

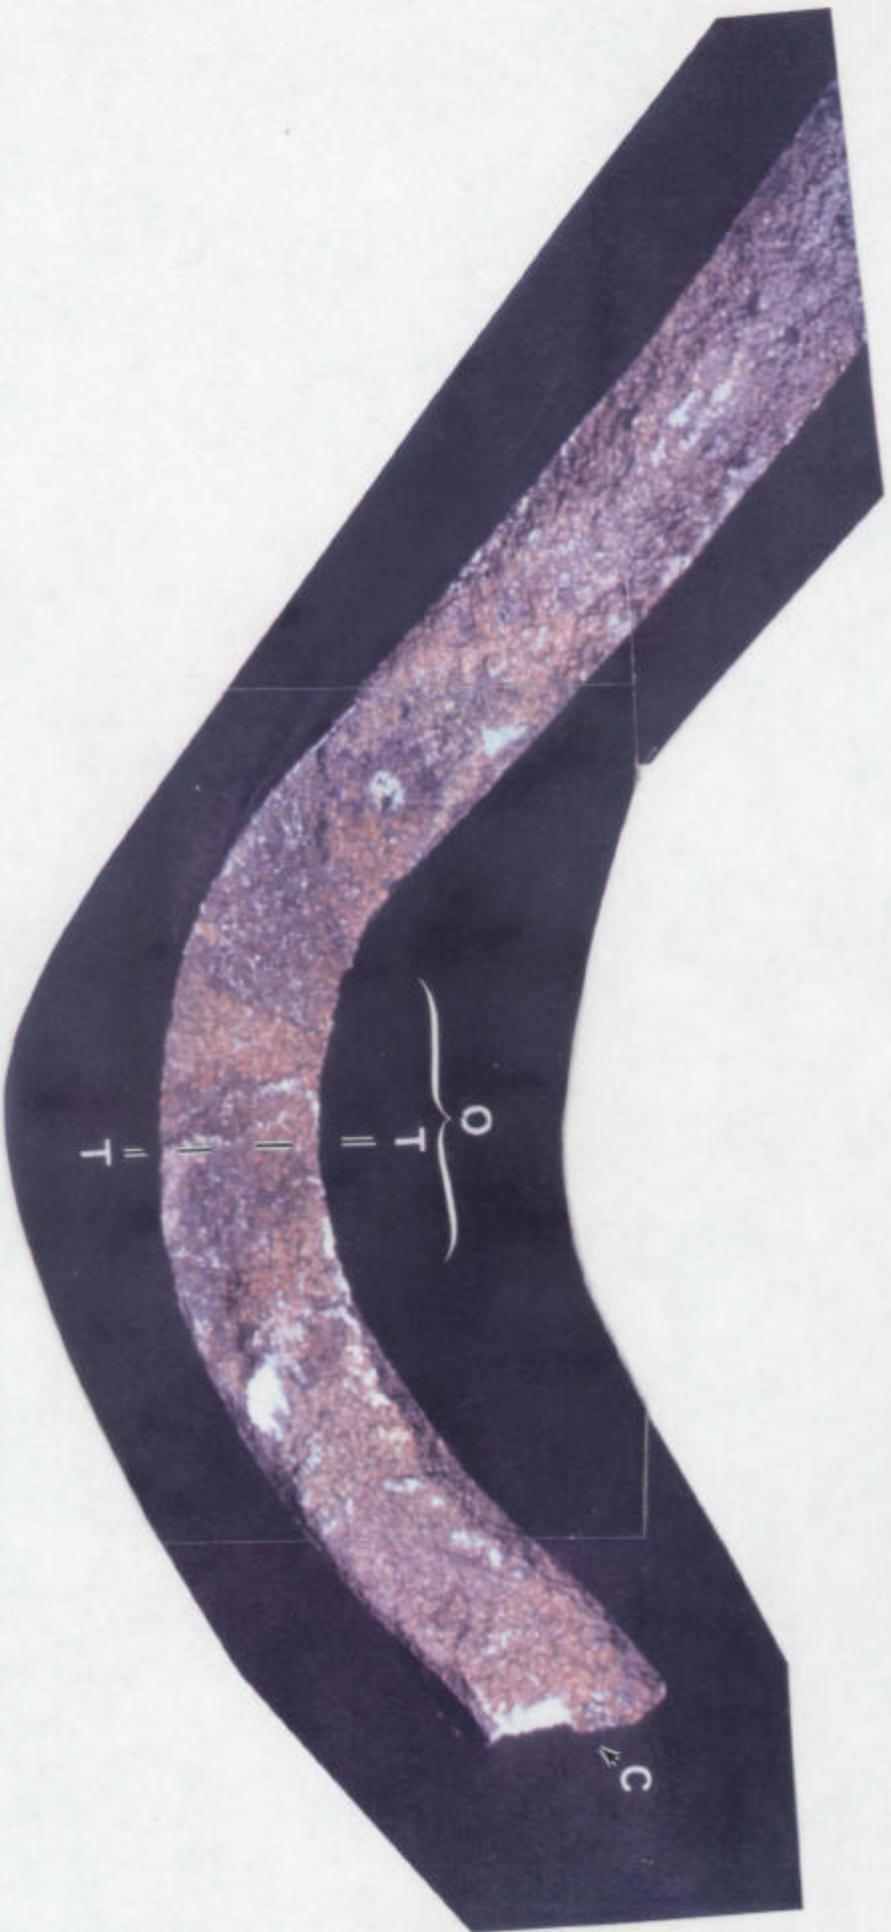
Figure 3. Close-up photograph of the fracture origin indicated by bracket "O". Arrow "C" indicates a circumferential crack that intersected the radial fracture face. (7.5X)

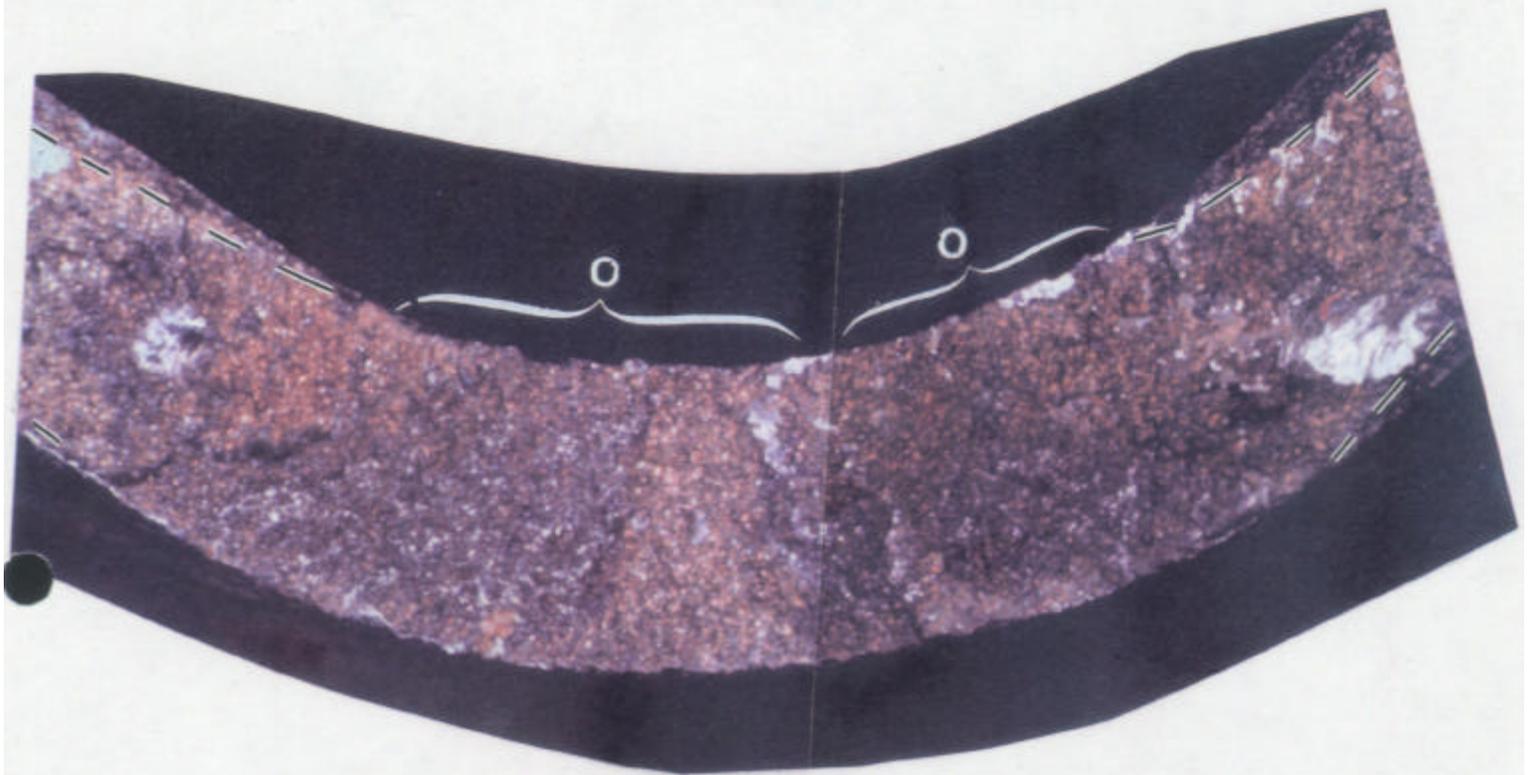
Figure 4. Higher magnification photograph of the fracture origin area, indicated by brackets "O" in figure 3. Areas between dashed lines and outside edges indicate location of shear lips. (15X)

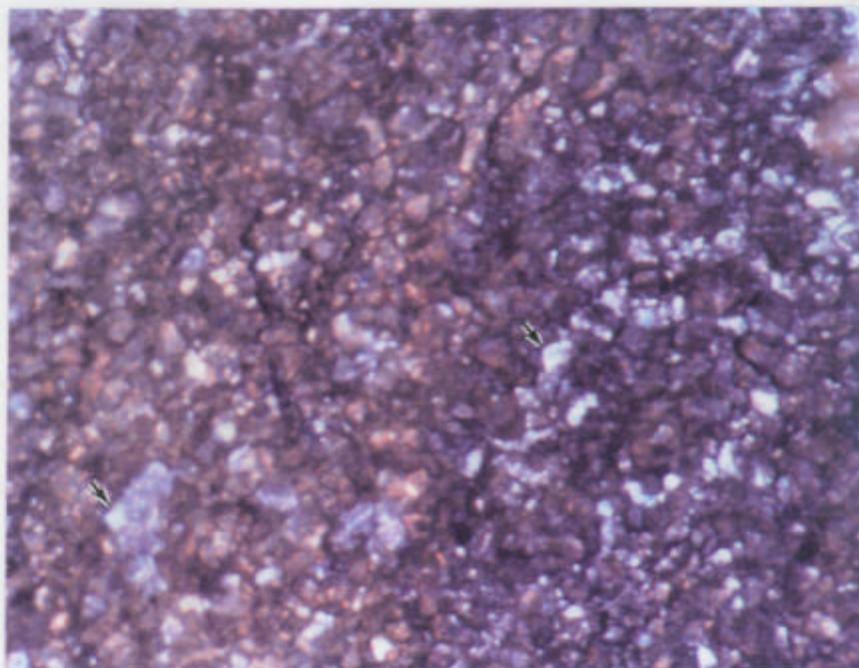
Figure 5. Close-up photograph of the granular features in the fracture origin area. (55X)

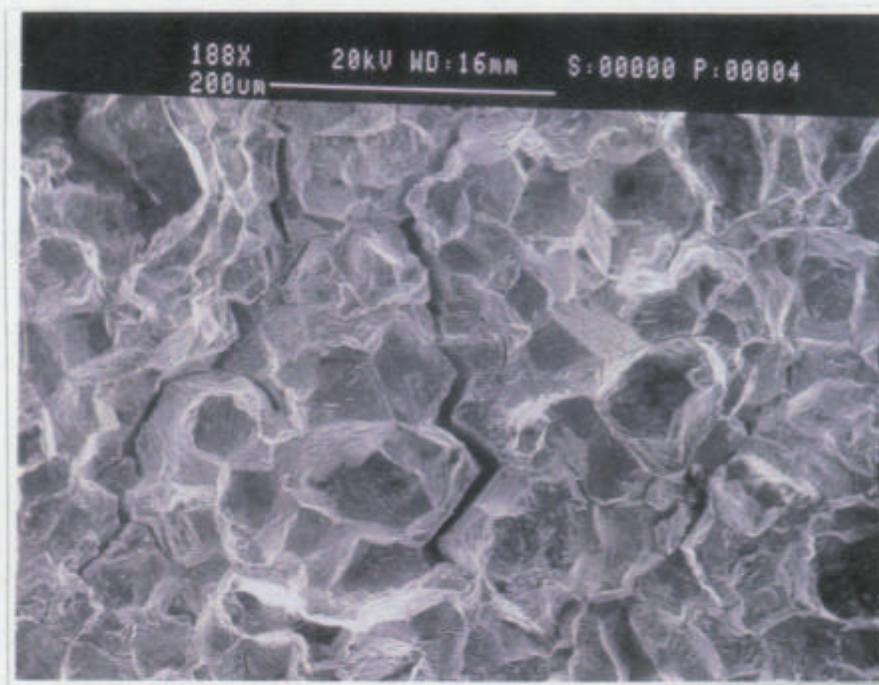
Figure 6. Scanning electron microscope (SEM) photograph of typical intergranular fracture features in the fracture origin area. (188X)

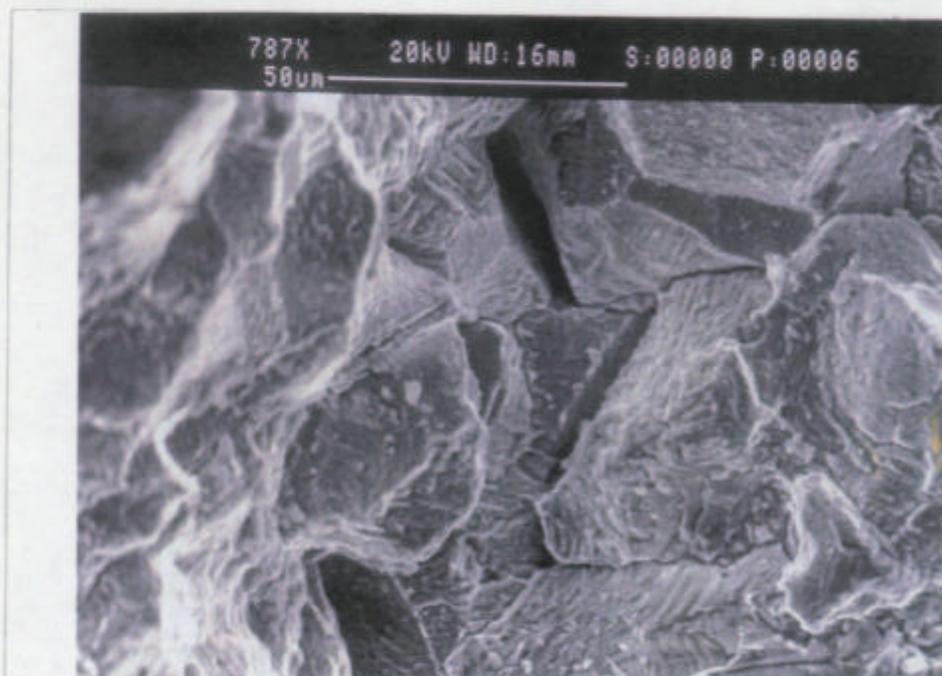
Figure 7. Higher magnification SEM photograph of the intergranular fracture features in the origin area. (787X)

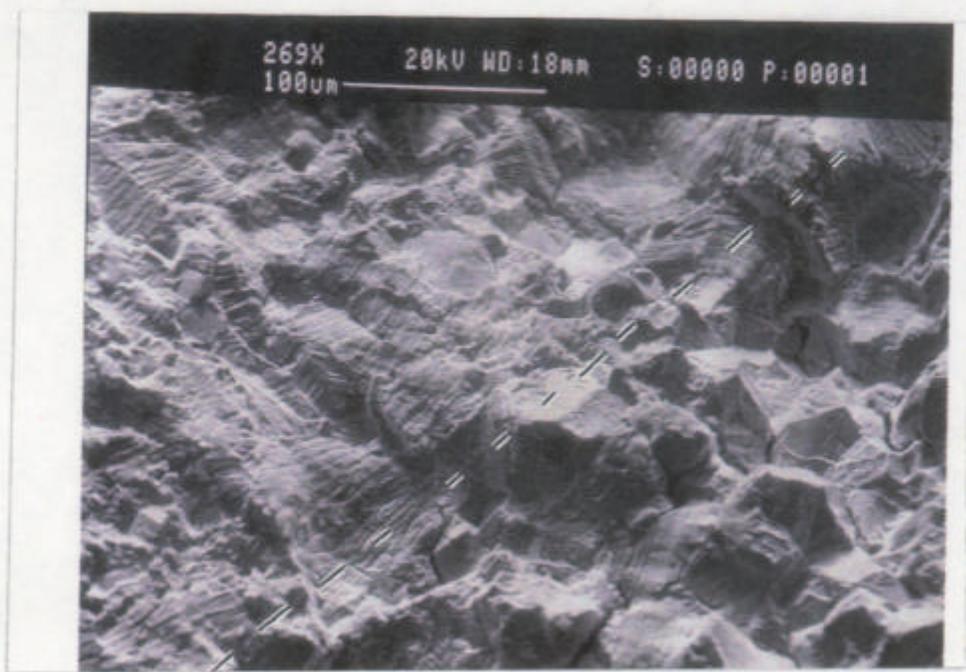
Figure 8. SEM photograph of the transition region, indicated by dashed line, between the shear lip at the forward edge of the disk (left of the dashed line) and the rim (right of the dashed line). Note the fatigue striations at the left and the granular features at the right. (269X)
