**NATIONAL  
TRANSPORTATION  
SAFETY  
COMMITTEE**

**AIRCRAFT INCIDENT REPORT**

Japan Airlines Flight JL726

B747-300 JA8178

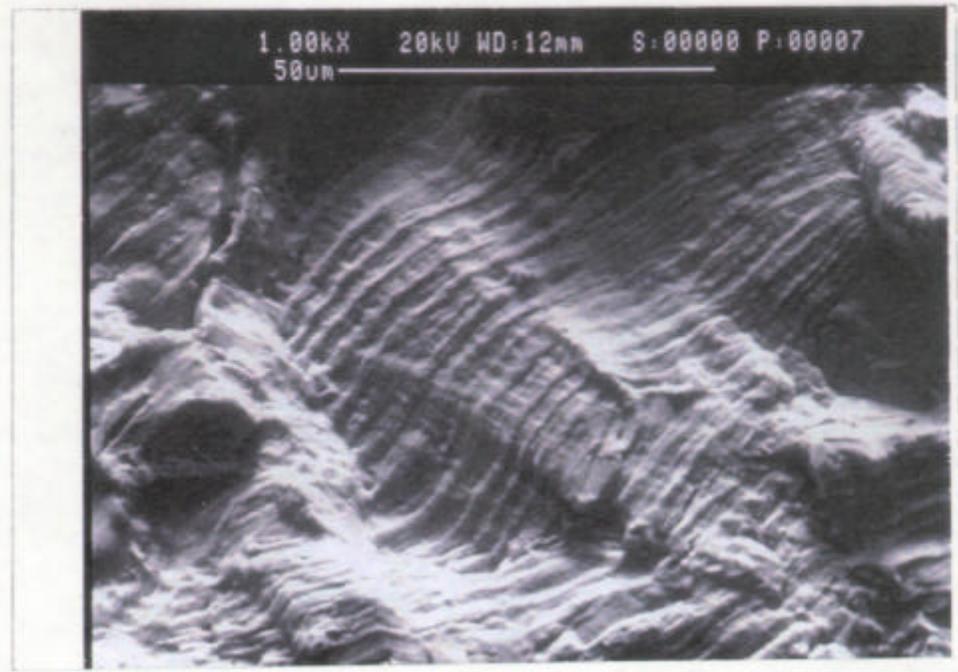
Figure 9. Higher magnification SEM photograph of the fatigue striations in figure 8. (1,000X)

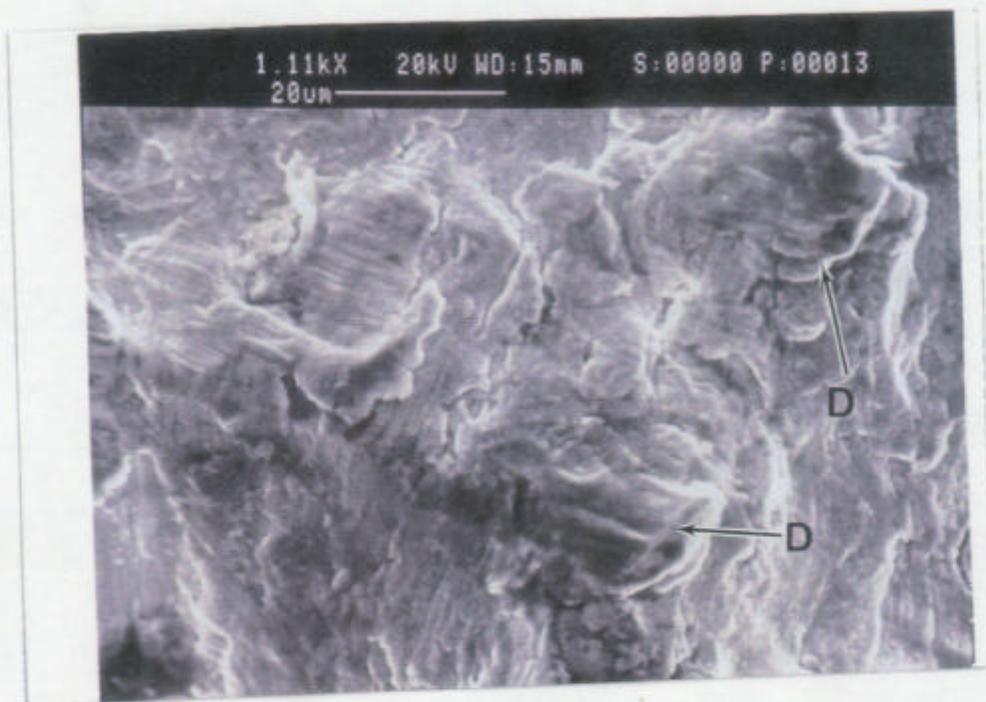
Figure 10. SEM photograph of the fracture features in the web in an area located between the fracture origin area and the bore showing mechanical damaged areas ("D") and striation-like features. (1,110X)

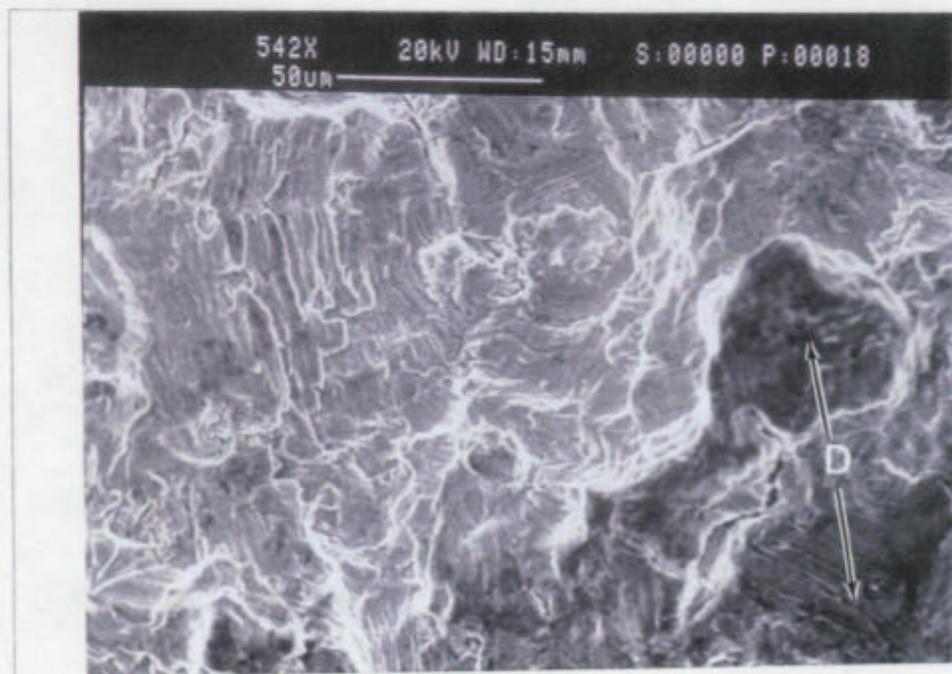
Figure 11. SEM photograph of the fracture features in the transition between the web and the bore showing mechanical damaged areas ("D") and striation-like features. (542X)

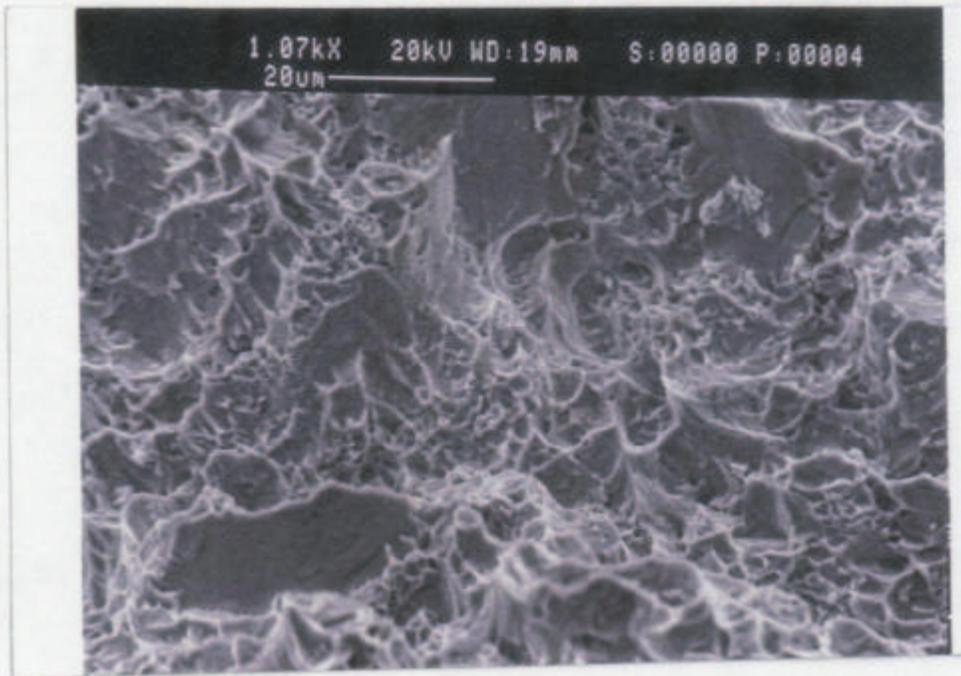
Figure 12. SEM photograph of ductile dimple features in the bore area (1,070X)
