Aviation Occurrence Report Volume I

IN-FLIGHT BREAKUP OVER THE TAIWAN STRAIT

CHINA AIRLINES FLIGHT CI611

BOEING 747-200, B-18255

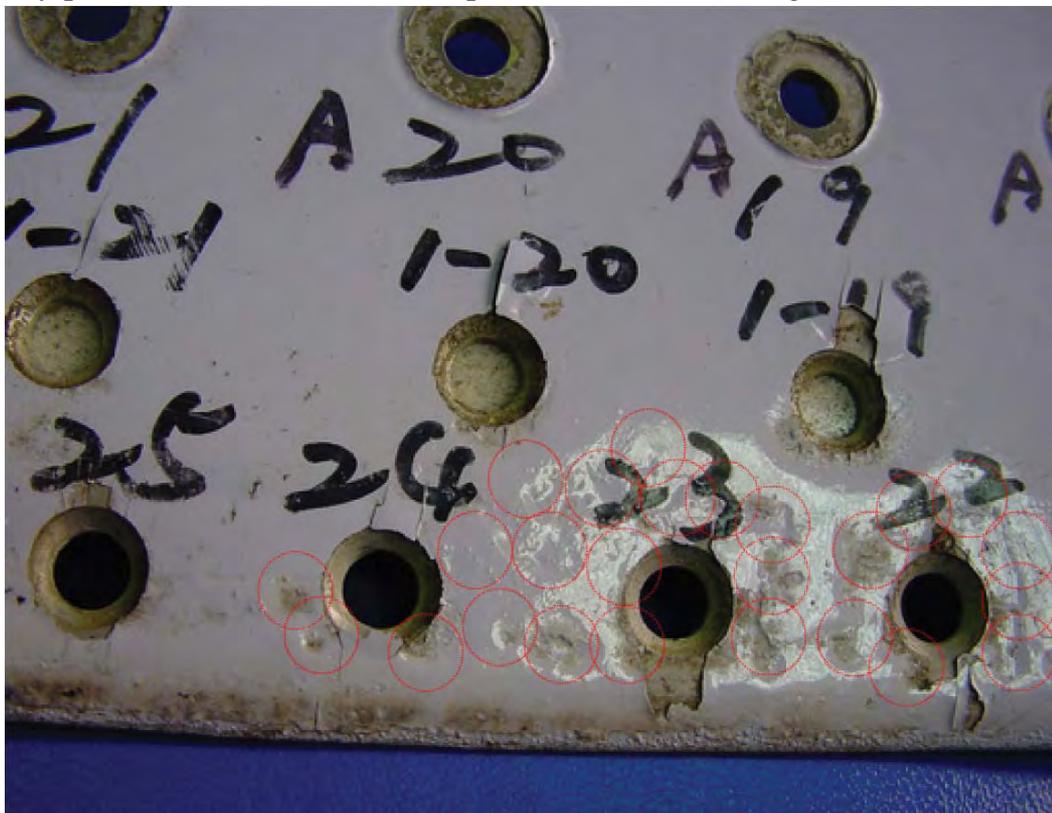
Figure 1.6-10 Various types of cavities along the doubler edge

The exterior skin of number-16 doubler with various types of cavities around the rivets and along the edge of doubler can be observed as shown in Figure 1.6-10. Paint (topcoat) was present up to the edge of the doubler without sealant. In the same doubler paint (topcoat) was removed from the edge of the doubler during the doubler disassembly process, the sealant was still present, as shown in Figure 1.16-11.

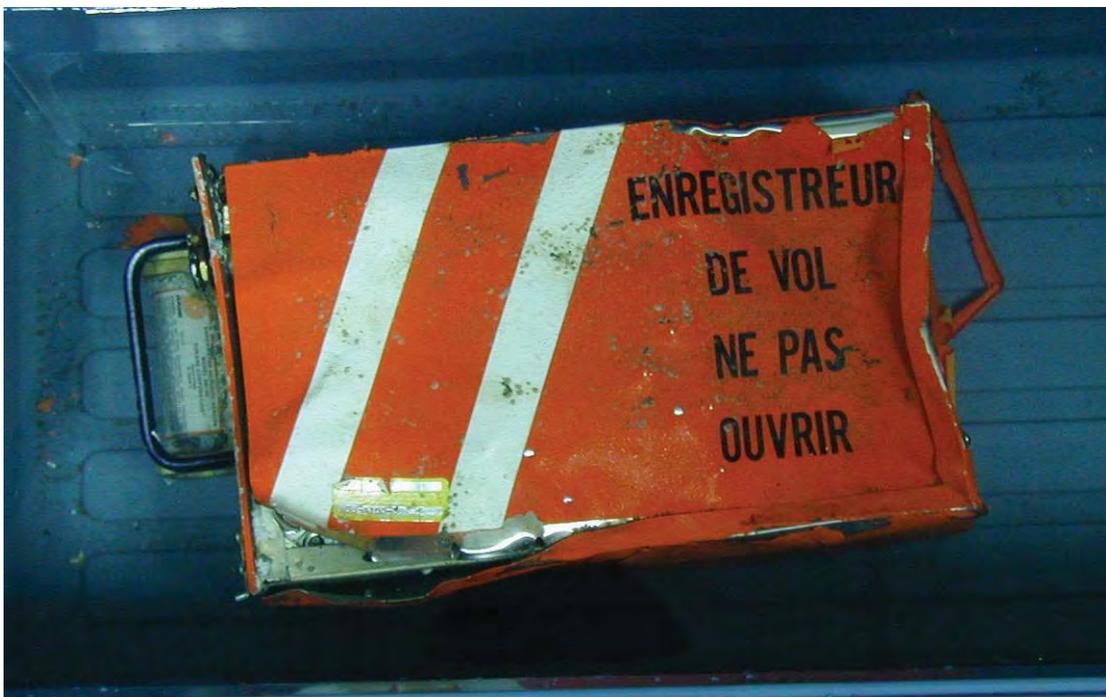
Figure 1.11-1 Damaged CVR in the water cooler

The Fairchild model A100A CVR, serial number 60156, was recovered from seabed of the Taiwan Strait at position (23°58'58.61"N, 119°41'36.74"E) on June 18 2002. The recorder was transported in a water cooler filled with fresh water (as shown in Figure 1.11-1) to Aviation Safety Council laboratory on June 19 2002. Quality of the recording was good and a transcript was prepared of the entire 31 minutes and 51 seconds as shown in Appendix 9.

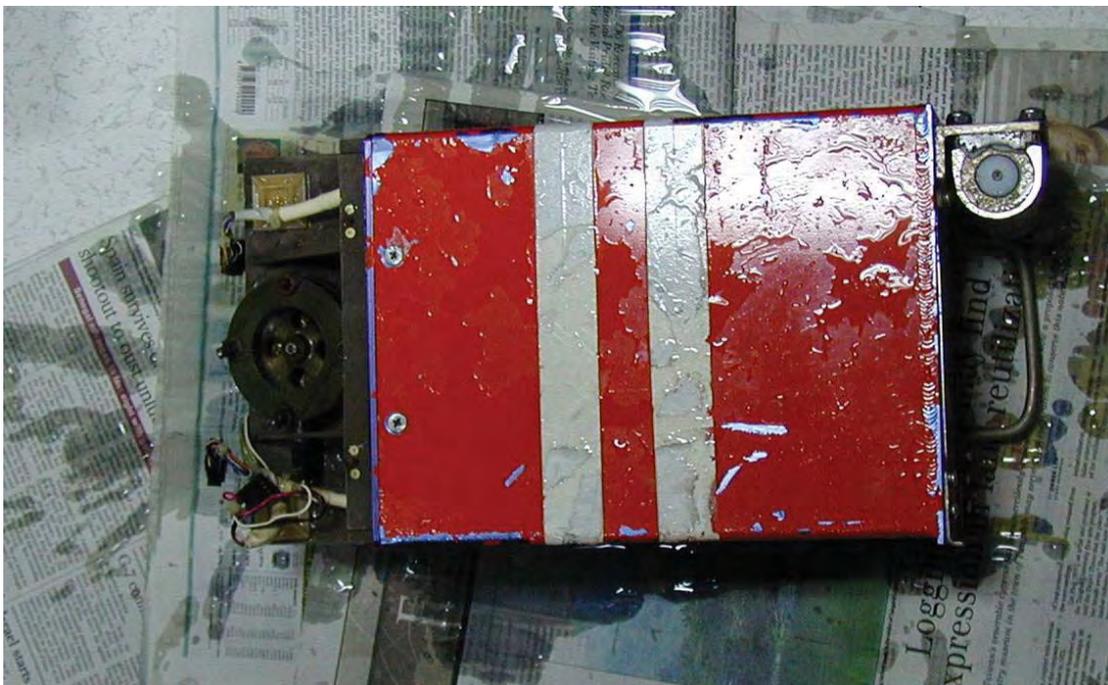
Figure 1.11-2 Damaged FDR in the water cooler

The accident aircraft was equipped with a Lockheed model 209F FDR, part number 10077A500-107, serial number 2537, which was configured to record 21 parameters as listed in Appendix 11. The FDR was recovered from the seabed of the Taiwan Strait on June 19 2002 at position (23°58'58.46"N, 119°41'17.71"E). The enclosure was immediately transported to the Aviation Safety Council laboratory in a water cooler filled with fresh water as shown in Figure 1.11-2.

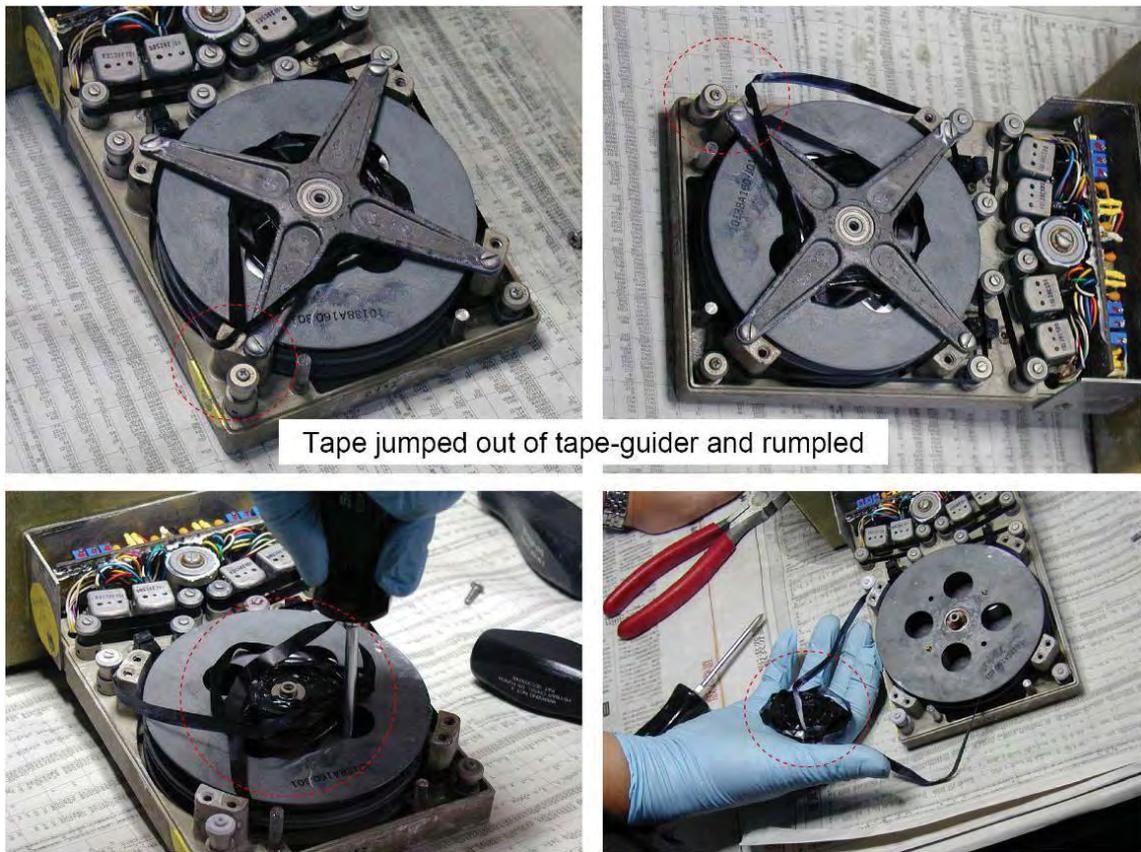
Figure 1.11-3 Photographs of damaged magnetic tape

Upon arrival, the FDR enclosure was open immediately and the magnetic tape was found damaged. Pictures of the damaged FDR tape are shown in Figures 1.11-3 and 1.11-4. There are six crinkle marks on the tape.

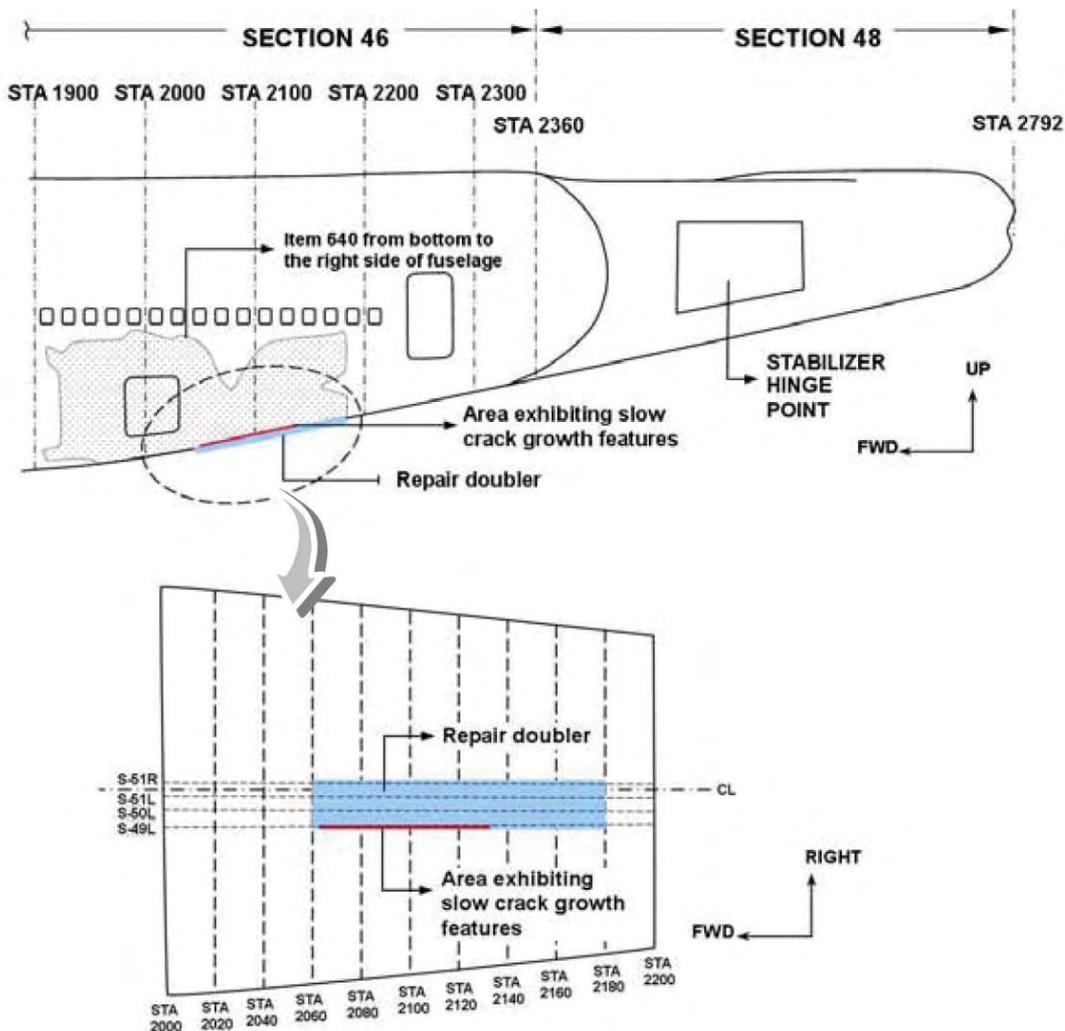
Figure 1.12-7 Item 640 and the repair doubler

4. Evidence of fatigue damage was found in the lower aft fuselage centered about STA 2100, between stringers S-48L and S-49L, under the repair doubler near its edge and outside the outer row of securing rivets. Multiple Site Damage (MSD), including a 15.1-inch through thickness main fatigue crack and some small fatigue cracks were confirmed. The 15.1-inch crack and most of the MSD cracks initiated from the scratching damage associated with the 1980 tail strike incident. (1.16, 2.2)

1. Perform structural repairs according to the SRM or other regulatory agency approved methods, without deviation, and perform damage assessment in accordance with the approved regulations, procedures, and best practices. (1.6, 2.3,2.4)-ASC-ASR-05-02-001

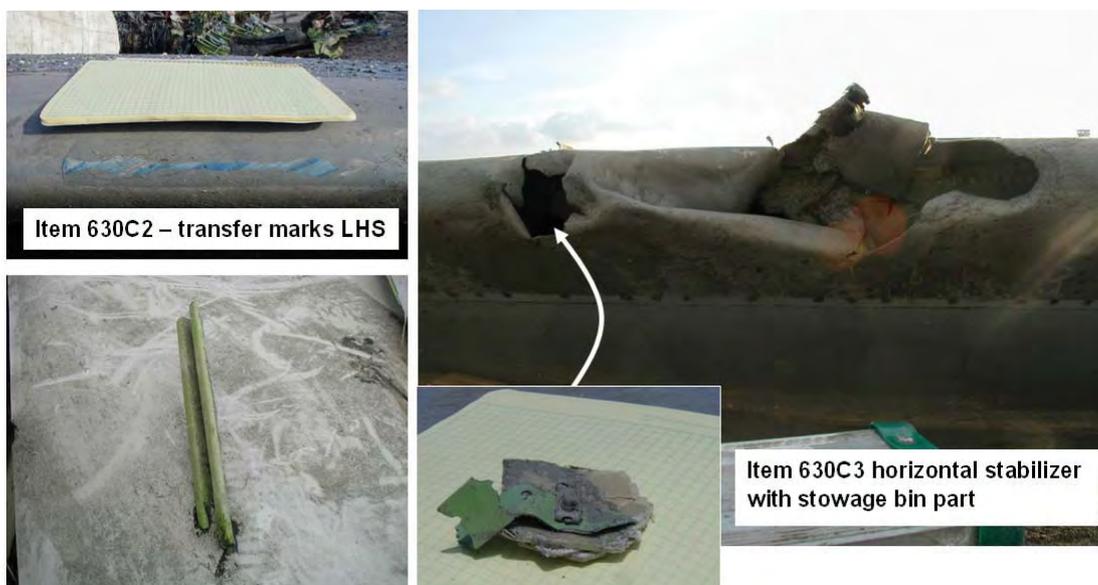
The right horizontal stabilizer (RHS) is considerably more damaged than the left horizontal stabilizer (LHS). The inboard portion of the RHS leading edge is deformed upwards. At the root of the RHS, the inboard 10 feet showed considerable impact damage along with upwards deformation of the compromised structure. A portion of seat support was found inside a puncture common to the lower surface of the LHS. A small segment of fuselage stringer was also found imbedded in the RHS elevator (Figure 1.12-10 left-down). A small fastener and shim from a stowage bin assembly were found inside a puncture common to the RHS leading edge (Figure 1.12-10 right).

Figure 1.12-10 A small segment of fuselage stringer imbedded in the RHS elevator (left-down). A small fastener and shim were found inside the RHS leading edge (right).

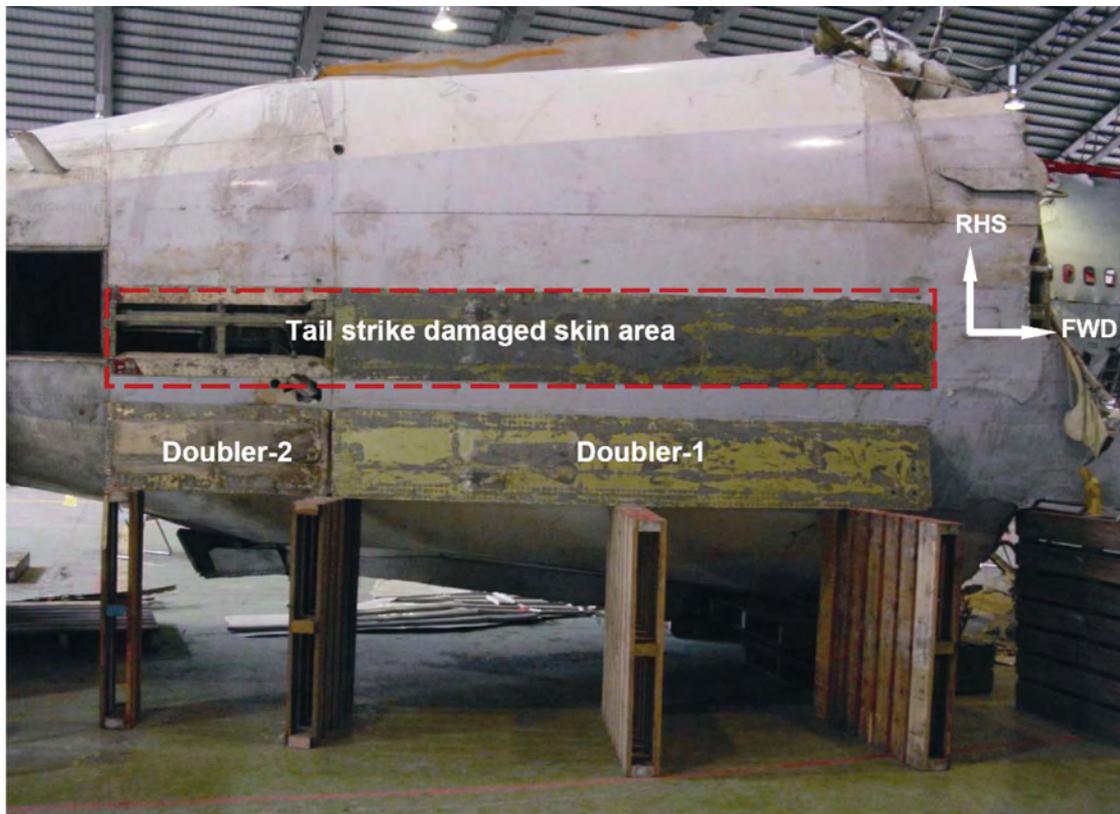
Figure 1.12-13 Doublers in section 48

The belly area of item 630 between STA 2484 to STA 2658 was examined, and two adjacent doublers were removed during wreckage examination as shown in Figure 1.12-13.

It was noted that the former topcoat, enamel and primer (original painting before the skin repair) remained on the skin covered by Dubler-2.

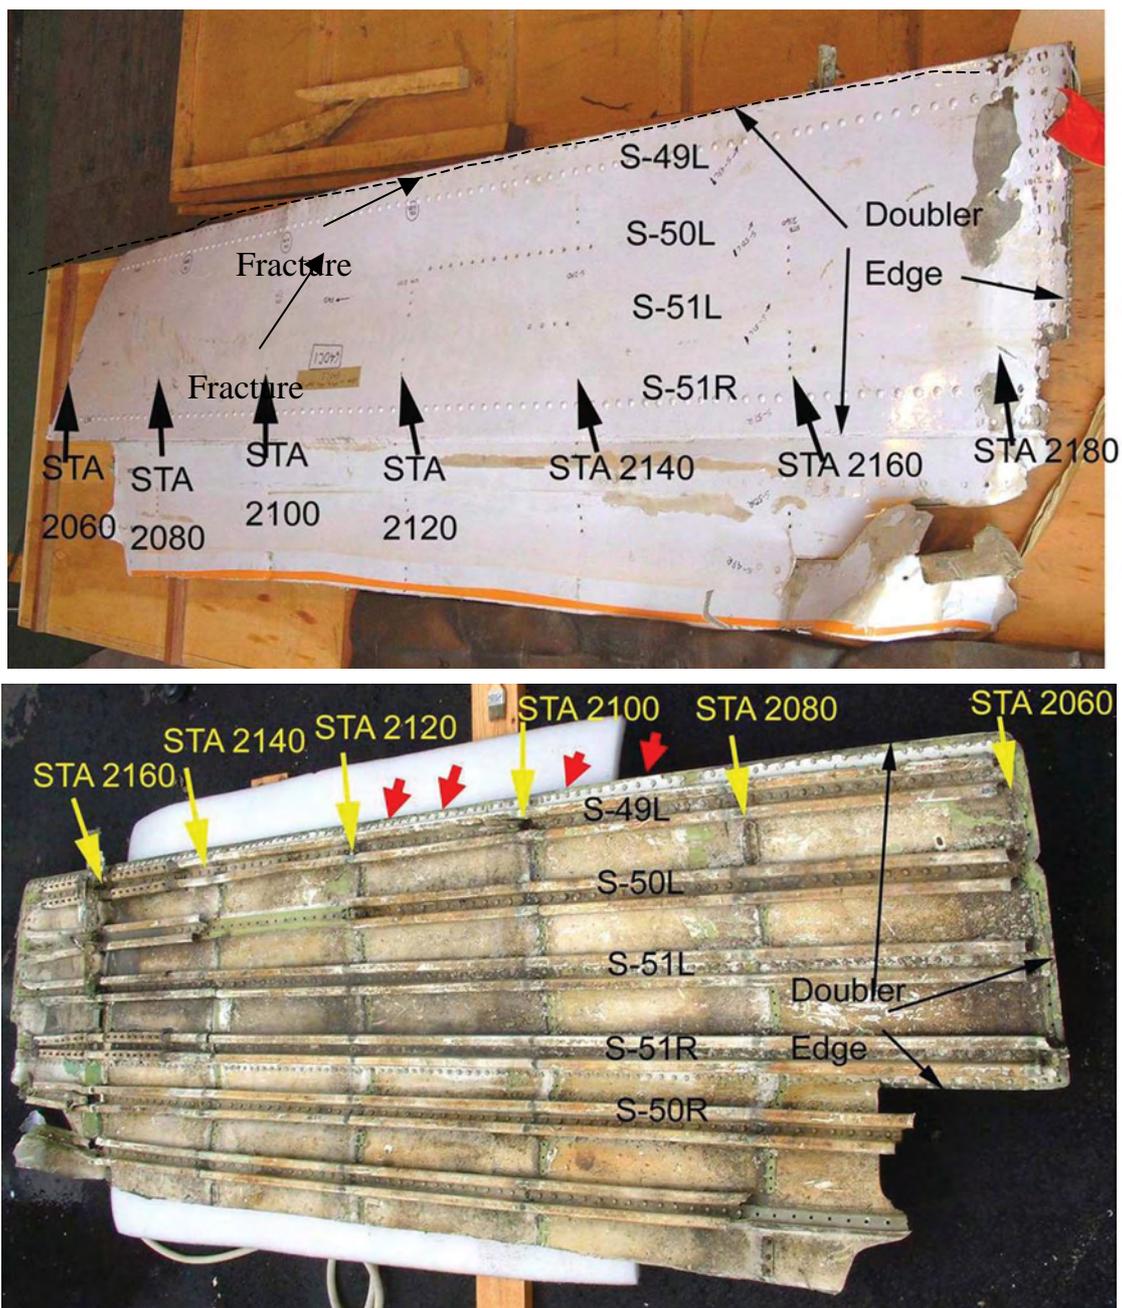
doubler was attached to the skin by two rows of countersunk rivets around its periphery as well as by fasteners common to the stringer and shear tie locations. Universal head rivets were used at S-51R and S-49L while countersunk rivets were used at S-50L and S-51L.

Figure 1.16-1 Exterior (up) and interior (down) of Item 640C1

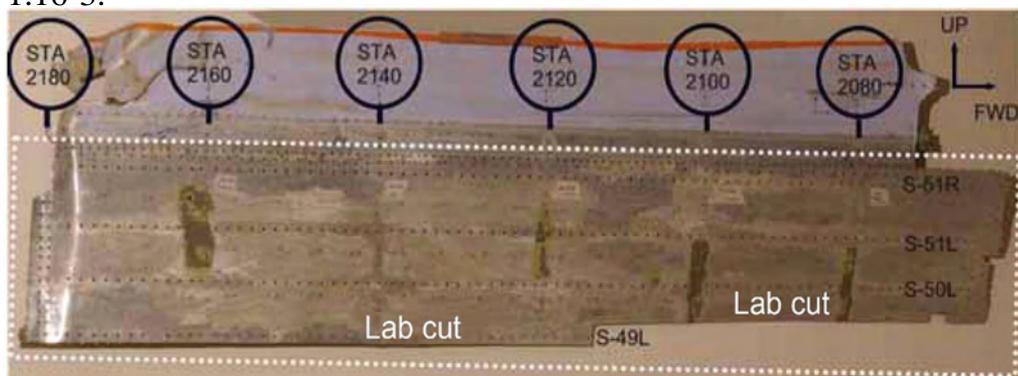
After disassembling the doubler from the skin and removal of the protective finishes, scratching damage was noticed on the faying surface of the skin (Figure 1.16-2). This damage consists of primarily longitudinal scratching distributed in an area of 120 inches by 20 inches. The most severe scratching typically occurred at the skin stiffening members such as skin stringers and body frame shear ties. Evidence of an attempt to blend out these skin scratches, in the form of rework sanding marks, was noted over much of the repair surface. A close view of the skin area near STA 2080 is shown in Figure 1.16-3.

Figure 1.16-2 Faying surface with the repair doubler and protective finishes removed

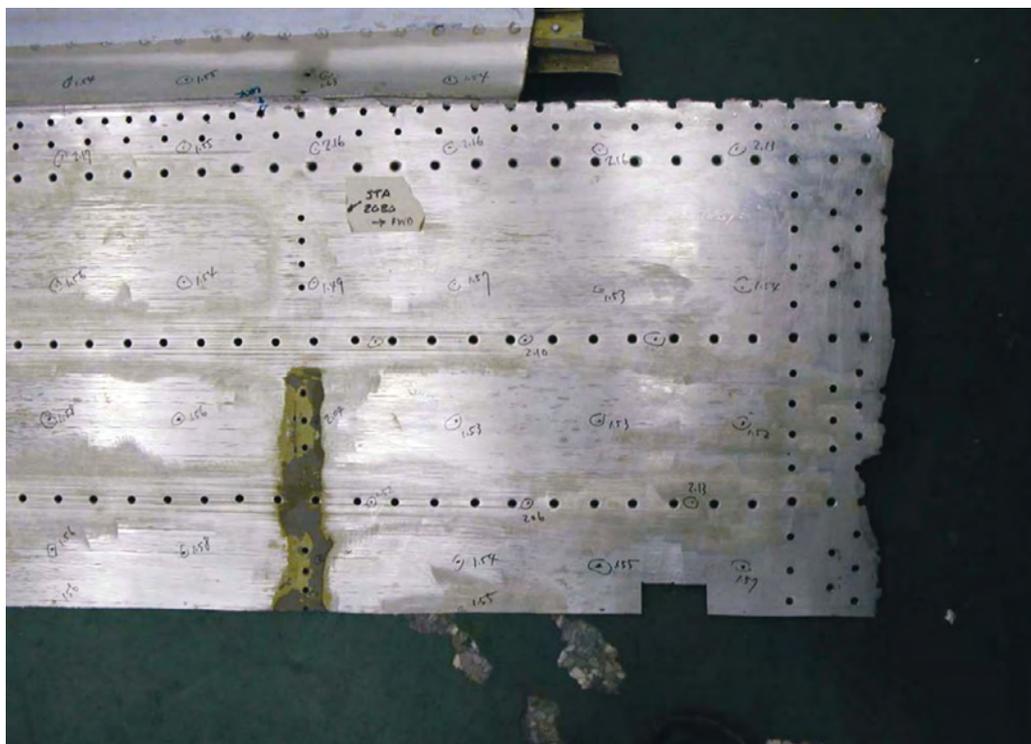
Figure 1.16-3 A close view of the repair faying surface near STA 2080

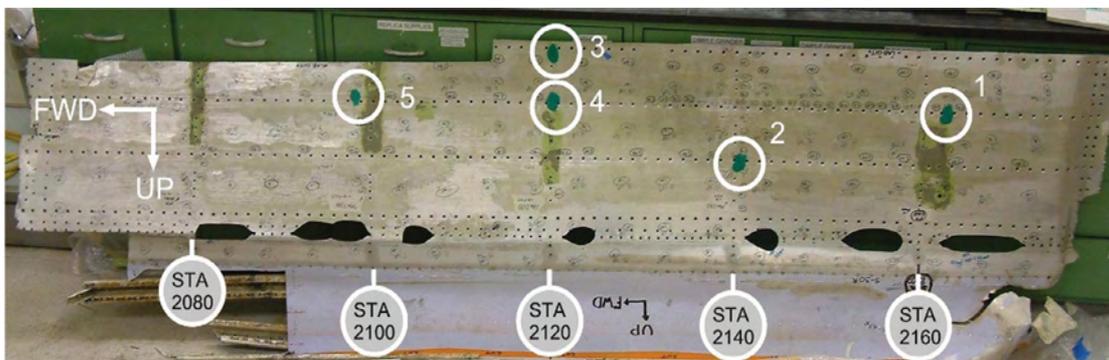
Five locations exhibiting major scratches on the repair faying surface of the skin as shown in Figure 1.16-4, were chosen for the examination of the scratch geometry and depth. The maximum scratch depth measured in each location is shown in Table 1.16-1.

Figure 1.16-4 Locations chosen for scratch depth measurement

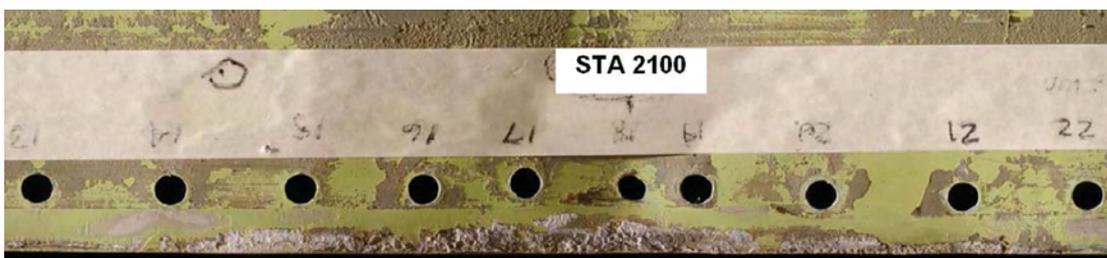
analysis utilizing Fourier Transform Infrared Spectroscopy (FT-IR) of the deposit revealed that the spectra of the light colored deposit matches with the reference light blue exterior paint on the doubler (Figure 1.16-7).

Figure 1.16-6 Light colored deposit on the faying surface of the repair

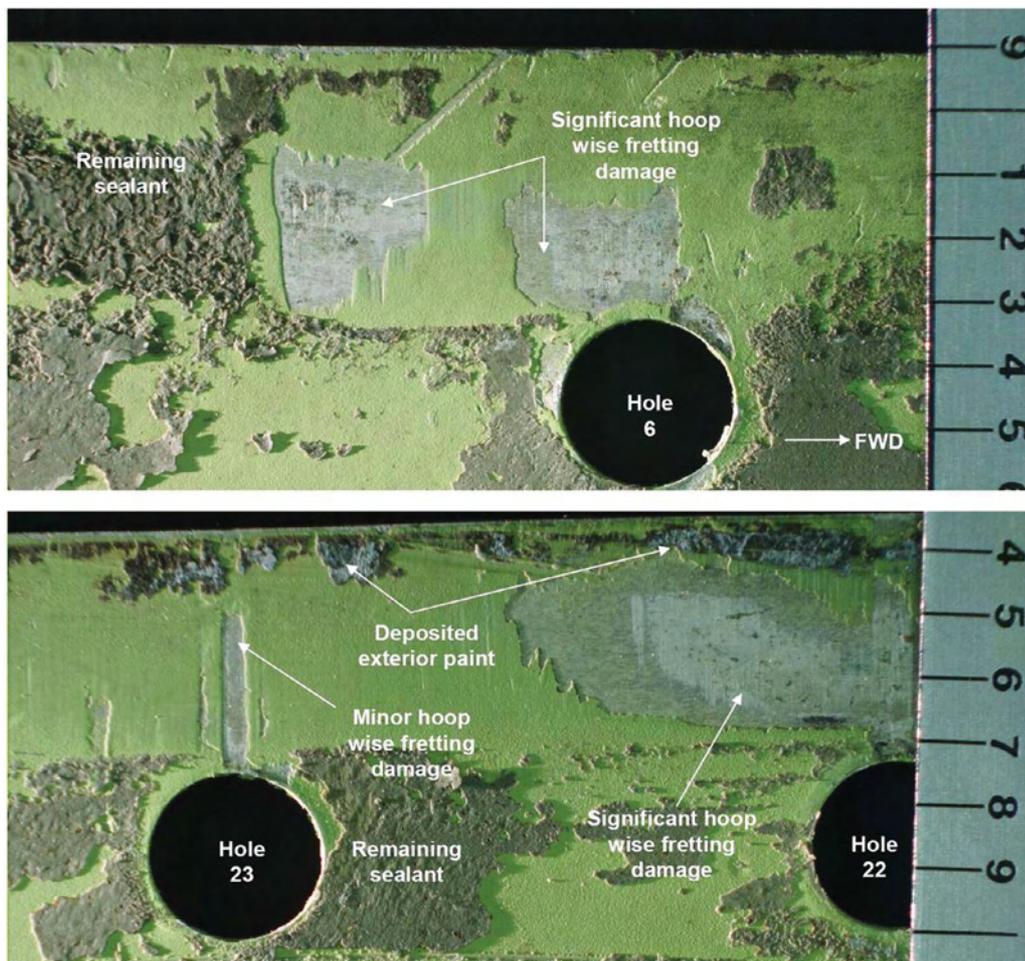
- The fretting marks observed from STA 2061 (hole +16) to STA 2132 (hole 49) are associated with most of the rivet locations. The most significant fretting damage was present between holes 8 and 43.
- The fretting marks near hole 32 and an optically magnified photograph of the area of contact is shown in Figure 1.16-9. It shows that the area of contact exhibits many colors and some hoop-wise scratches (marked by arrows).
- Two cross-section locations were chosen to characterize the area of contact. Figures 1.16-10 and Figure 1.16-11 show the metallographic photographs through the area marked by data sampling cut #1 and data sampling cut #2 respectively. It is observed that there was some material superimposed over the grooves of the scratches.

Figure 1.16-8 Fretting damage observed on faying surface of the repair doubler

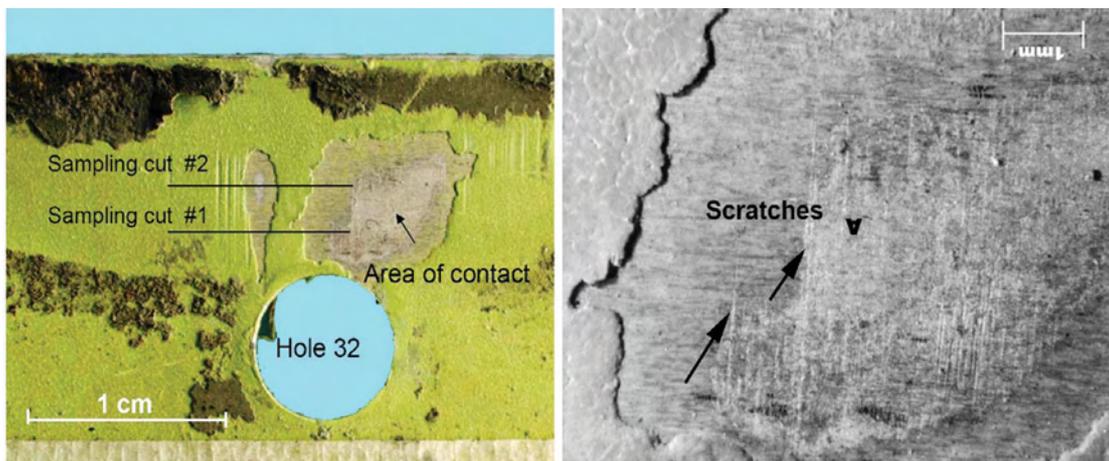
Figure 1.16-9 Area of contact near hole 32 showing the different colors (left) and scratches present (right)

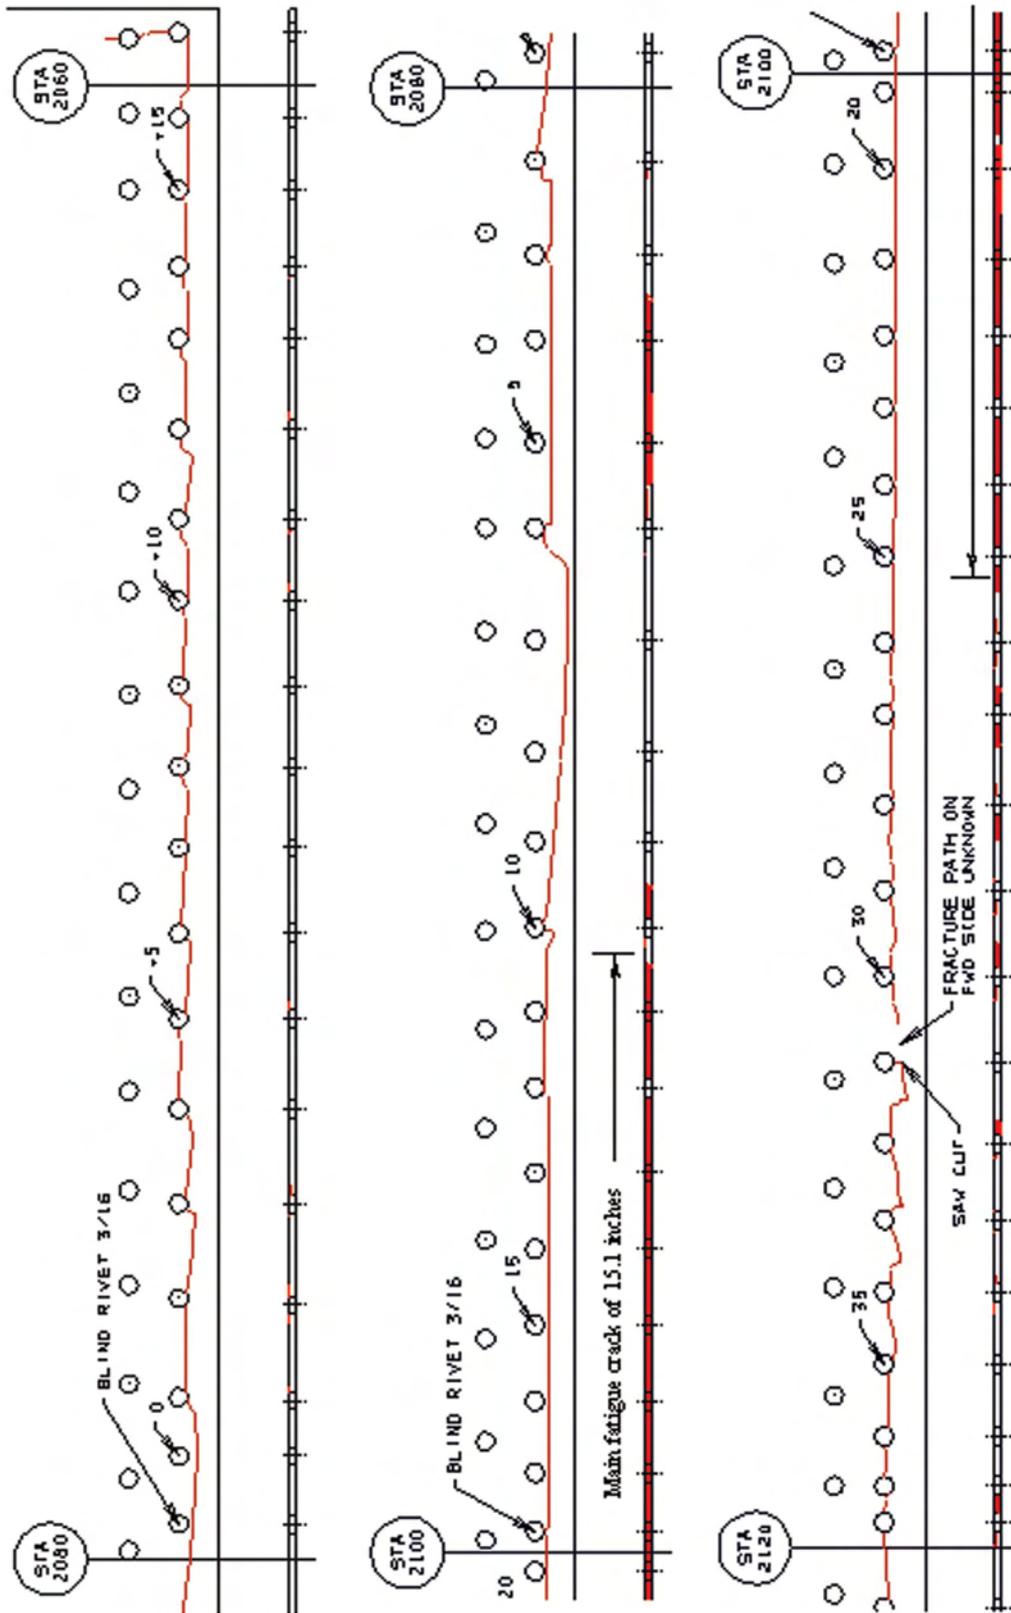
Figure 1.16-12 Distribution of the fatigue cracks (from STA 2060 to STA 2120)

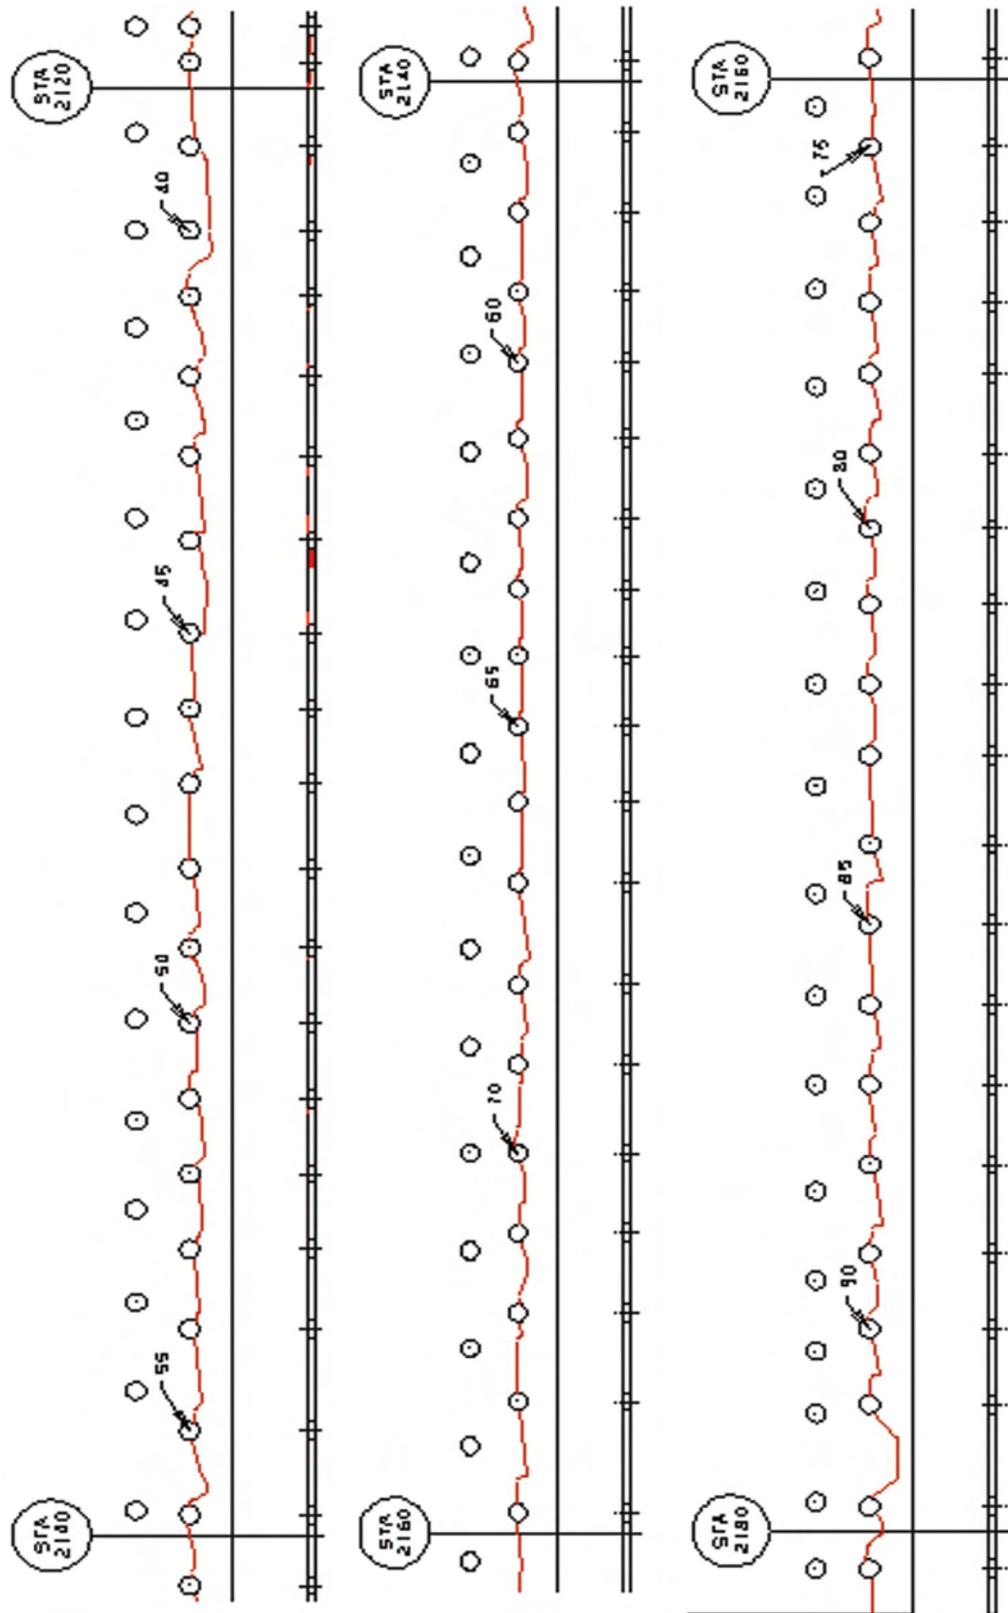
Figure 1.16-13 Distribution of the fatigue cracks (from STA 2120 to STA 2180)

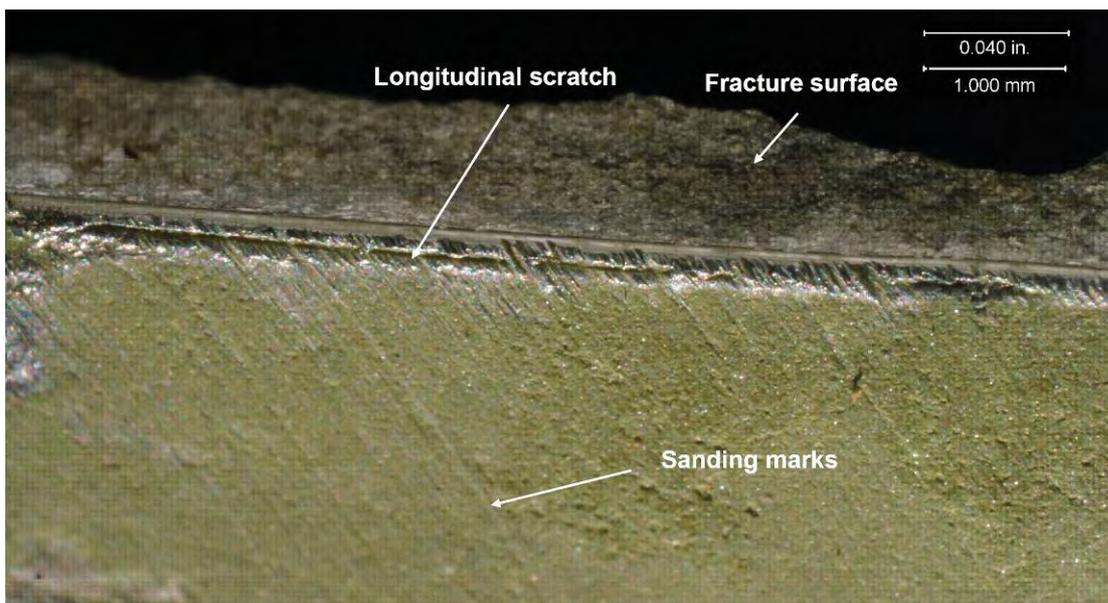
Figure 2.2-6 Fatigue crack originated from the scratch near hole 20

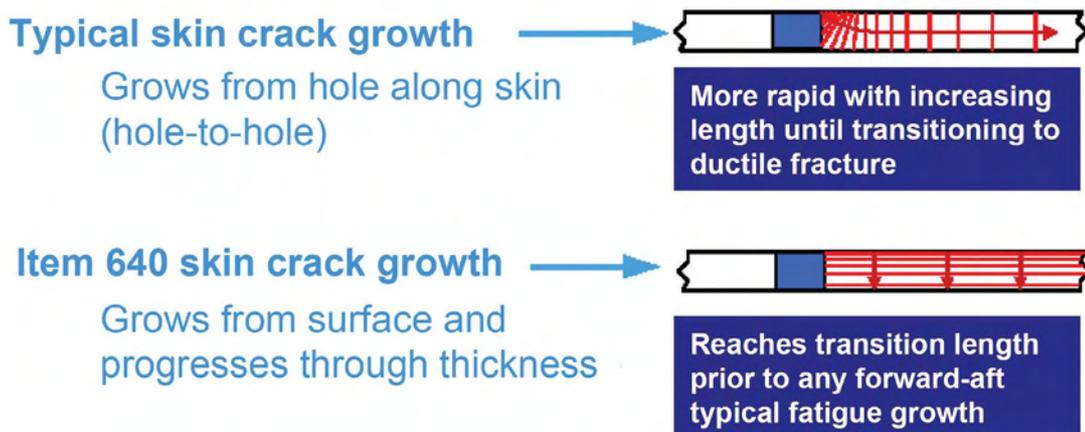
Figure 2.2-7 Cracking on Item 640 differs from typical fatigue crack

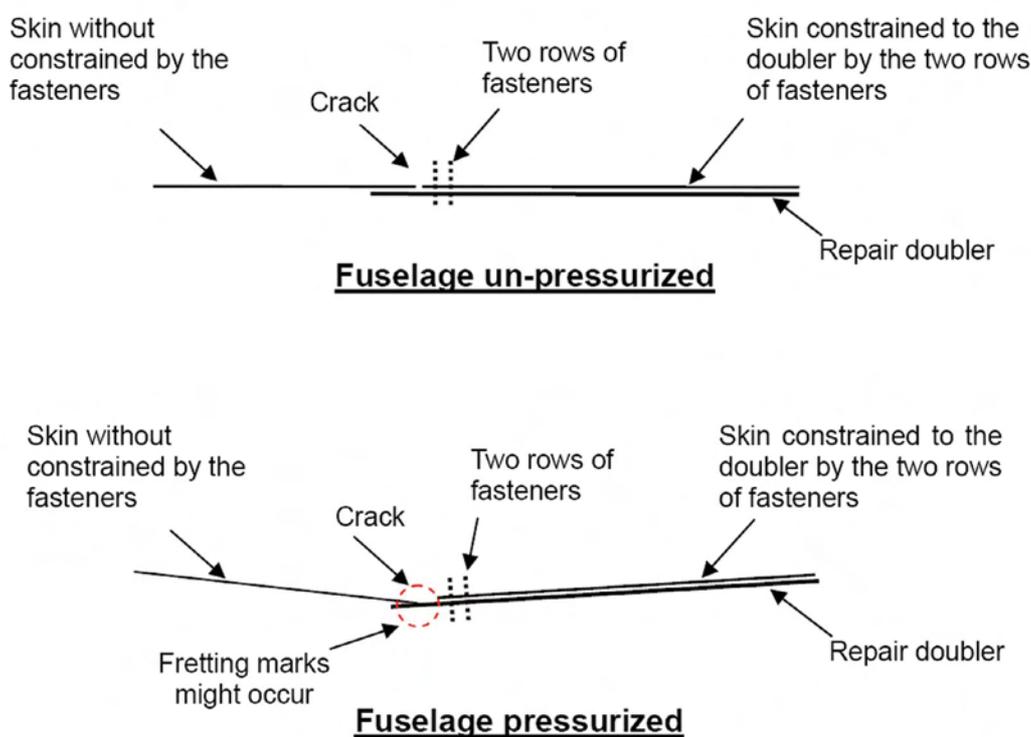
Figure 2.2-8 The fretting marks caused by the pressurization cycles

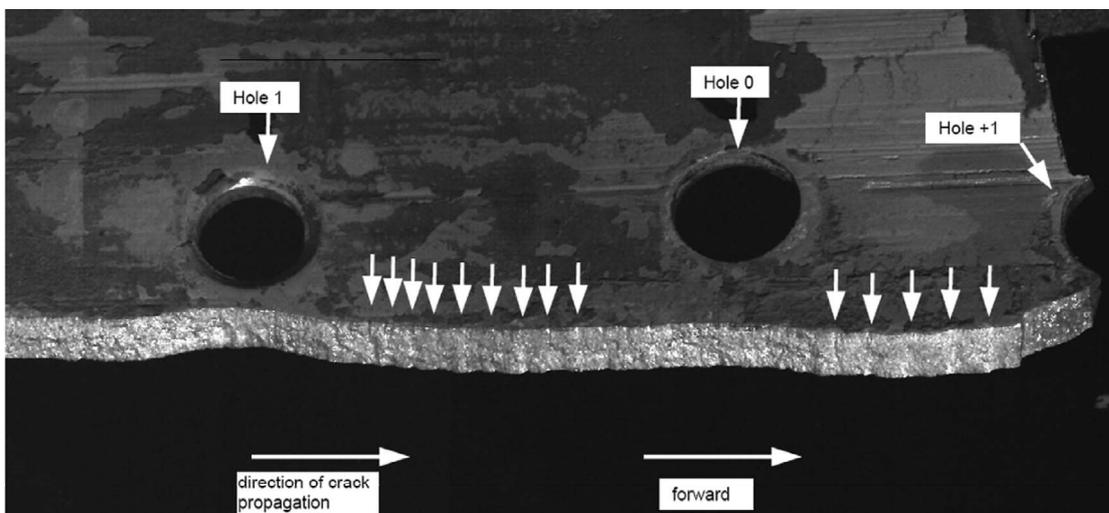
Figure 2.2-9 The regular spacing of cracking increments found on Item 640

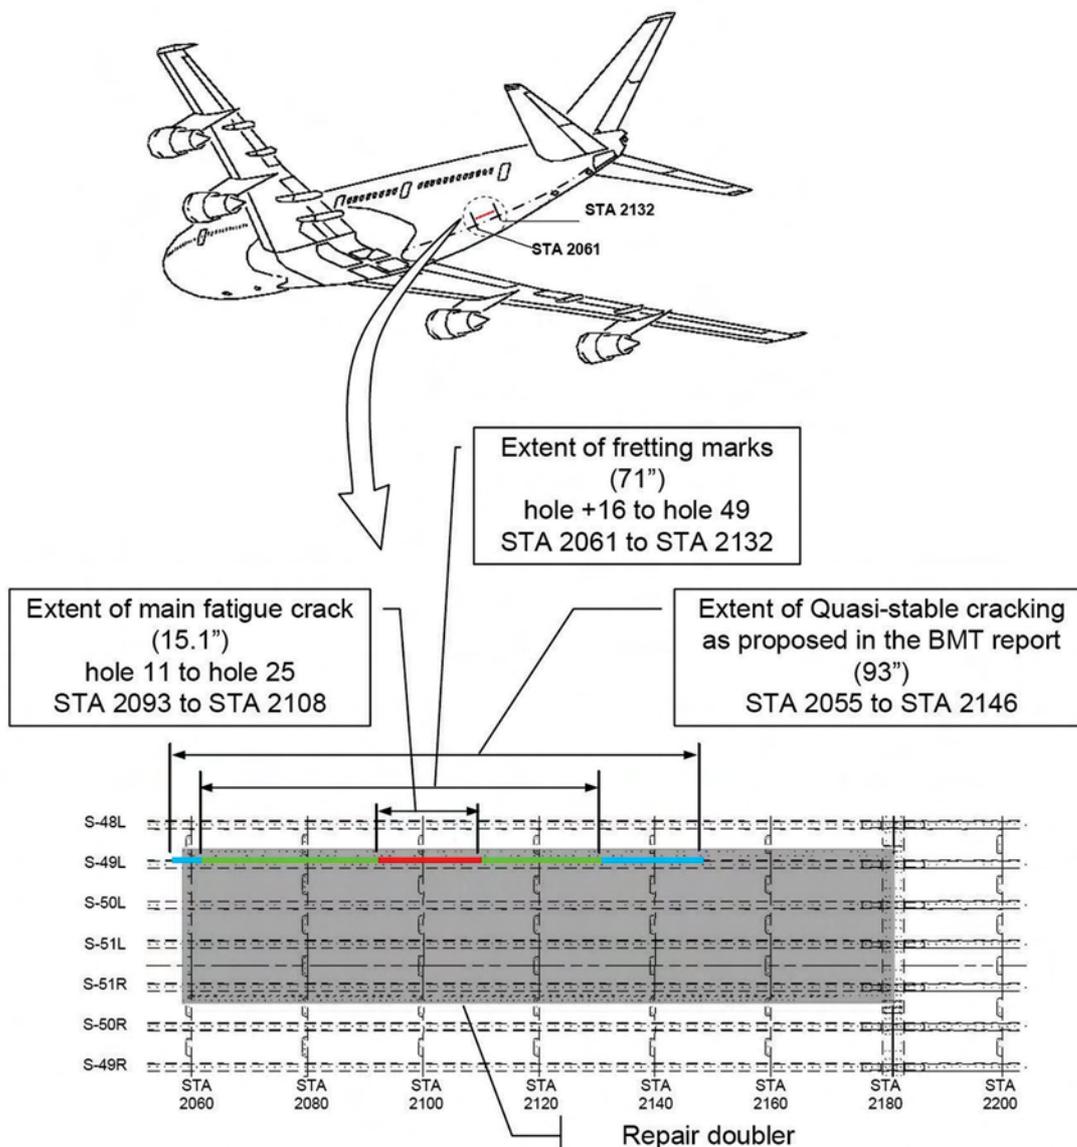
Figure 2.2-12 Different signs of cracks
