## Runway Overrun Occurs After Captain Cancels Go-around

*The Boeing 747 was configured for a dry-runway landing when heavy rain occurred on final approach to Bangkok, Thailand. The captain told the first officer (the pilot flying) to go around but then retarded the throttle levers when the main landing gear touched the runway. The airplane was substantially damaged. None of the occupants was injured seriously during the approach-and-landing accident, but the delay in evacuation of the aircraft focused attention on improving training for emergencies.*

[This article, except where specifically noted, is based on Australian Transport Safety Bureau Investigation Report 199904538: *Boeing 747-438, VH-OJH, Bangkok, Thailand, 23 September 1999*. The 170-page report contains diagrams, tables, photographs and appendixes.]

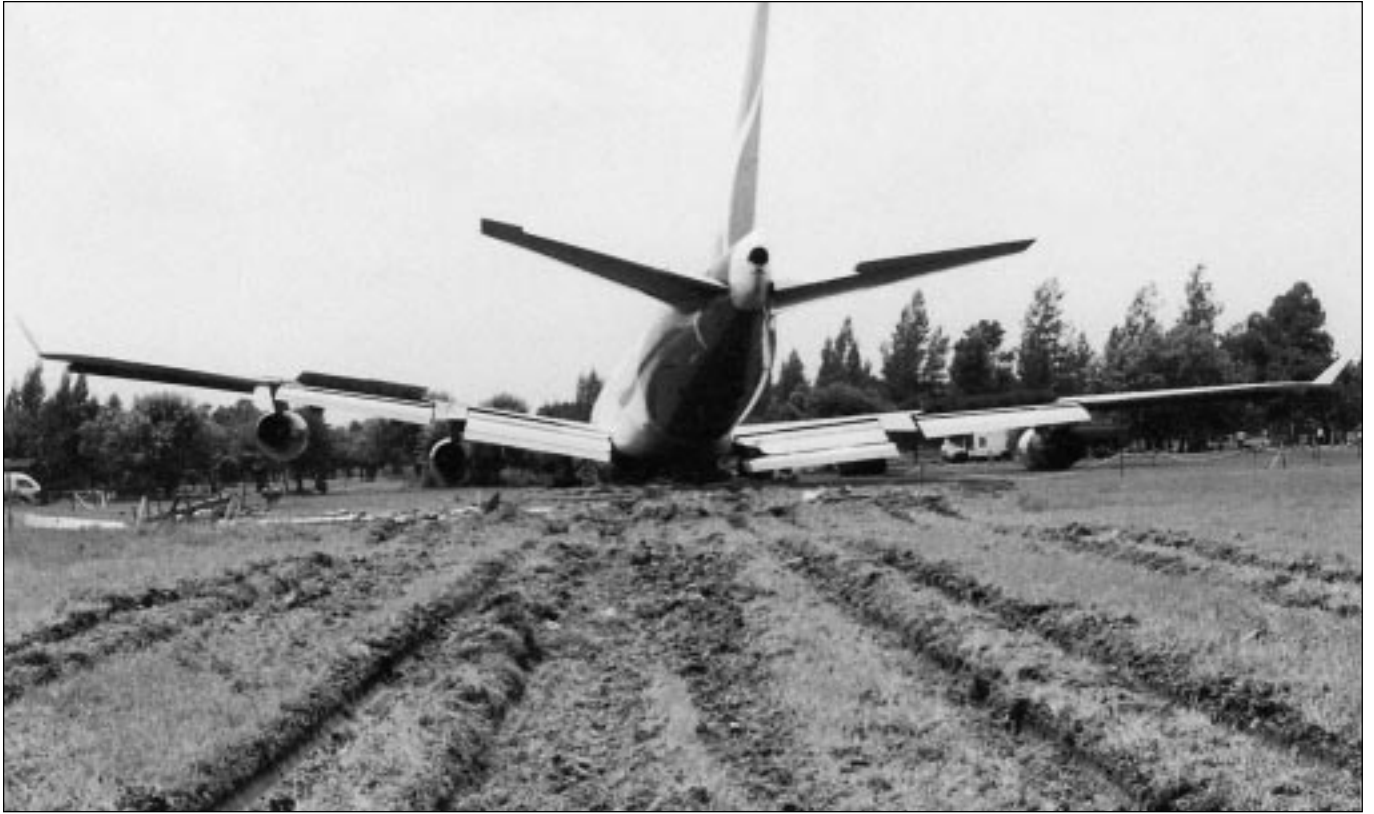
*The nose-landing gear and the right-wing landing gear collapsed when the airplane struck the instrument landing system localizer antenna. The airplane continued over wet ground and came to a stop 220 meters (722 feet) from the end of the stopway.*  
(Photo: Australian Transport Safety Bureau)

customer-service manager (CSM) on the cabin-interphone system. (The controllers for the public-address system and cabin-interphone system were damaged when the nose-landing gear collapsed.) The captain then told the second officer to go to the cabin and tell the CSM to come to the flight deck.

- “[The U.S. Federal Aviation Administration and the European Joint Aviation Authorities should] review the design requirements for high-capacity aircraft to ensure the integrity of the cabin interphone and passenger-address systems, particularly with respect to cabin/flight deck communications, in the event of runway overruns and other relatively common types of events which result in landing-gear [damage] and lower-fuselage damage;

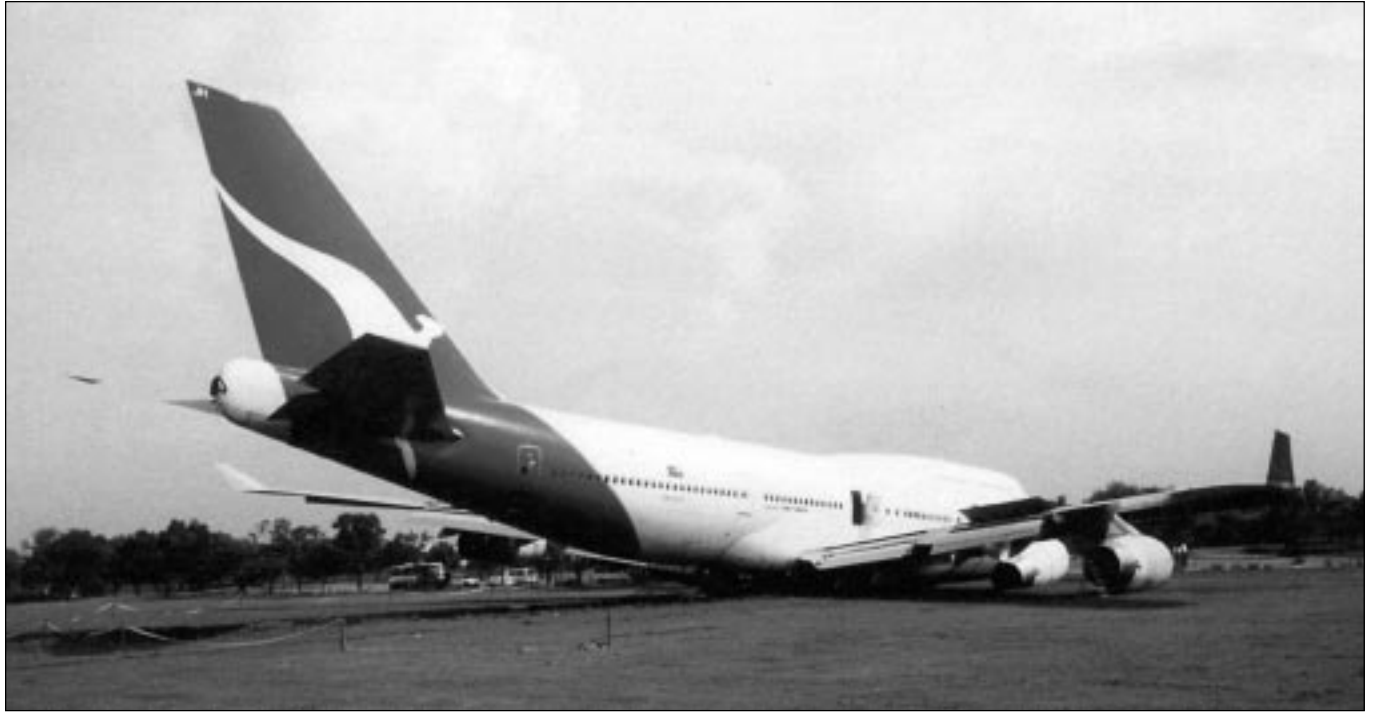
*The airplane's landing gear, no. 3 engine nacelle and lower fuselage were damaged during the runway overrun. The airplane came to rest with its nose on an airport-perimeter road. (Photo: Australian Transport Safety Bureau)*

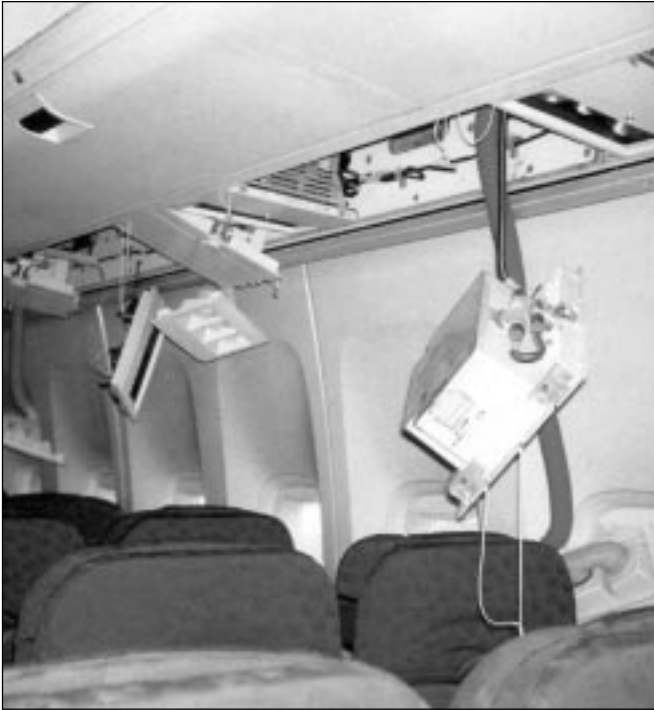
*Three passengers said that they were struck by passenger service units that dislodged during the accident.* (Photo: Australian Transport Safety Bureau)
