THE "CALI" ACCIDENT

Original idea from the Flight Safety Foundation

The crew of a Boeing 757-223, Flight 965, was transitioning from cruise flight to a very high frequency omni-directional radio range (VOR) / distance measuring equipment (DME) instrument approach to runway 19 at the Alfonso Bonilla Aragon International Airport (SKCL), Cali, Colombia, when the aircraft collided with a mountain 53 kilometers (33 miles) northeast of the CALI VOR.

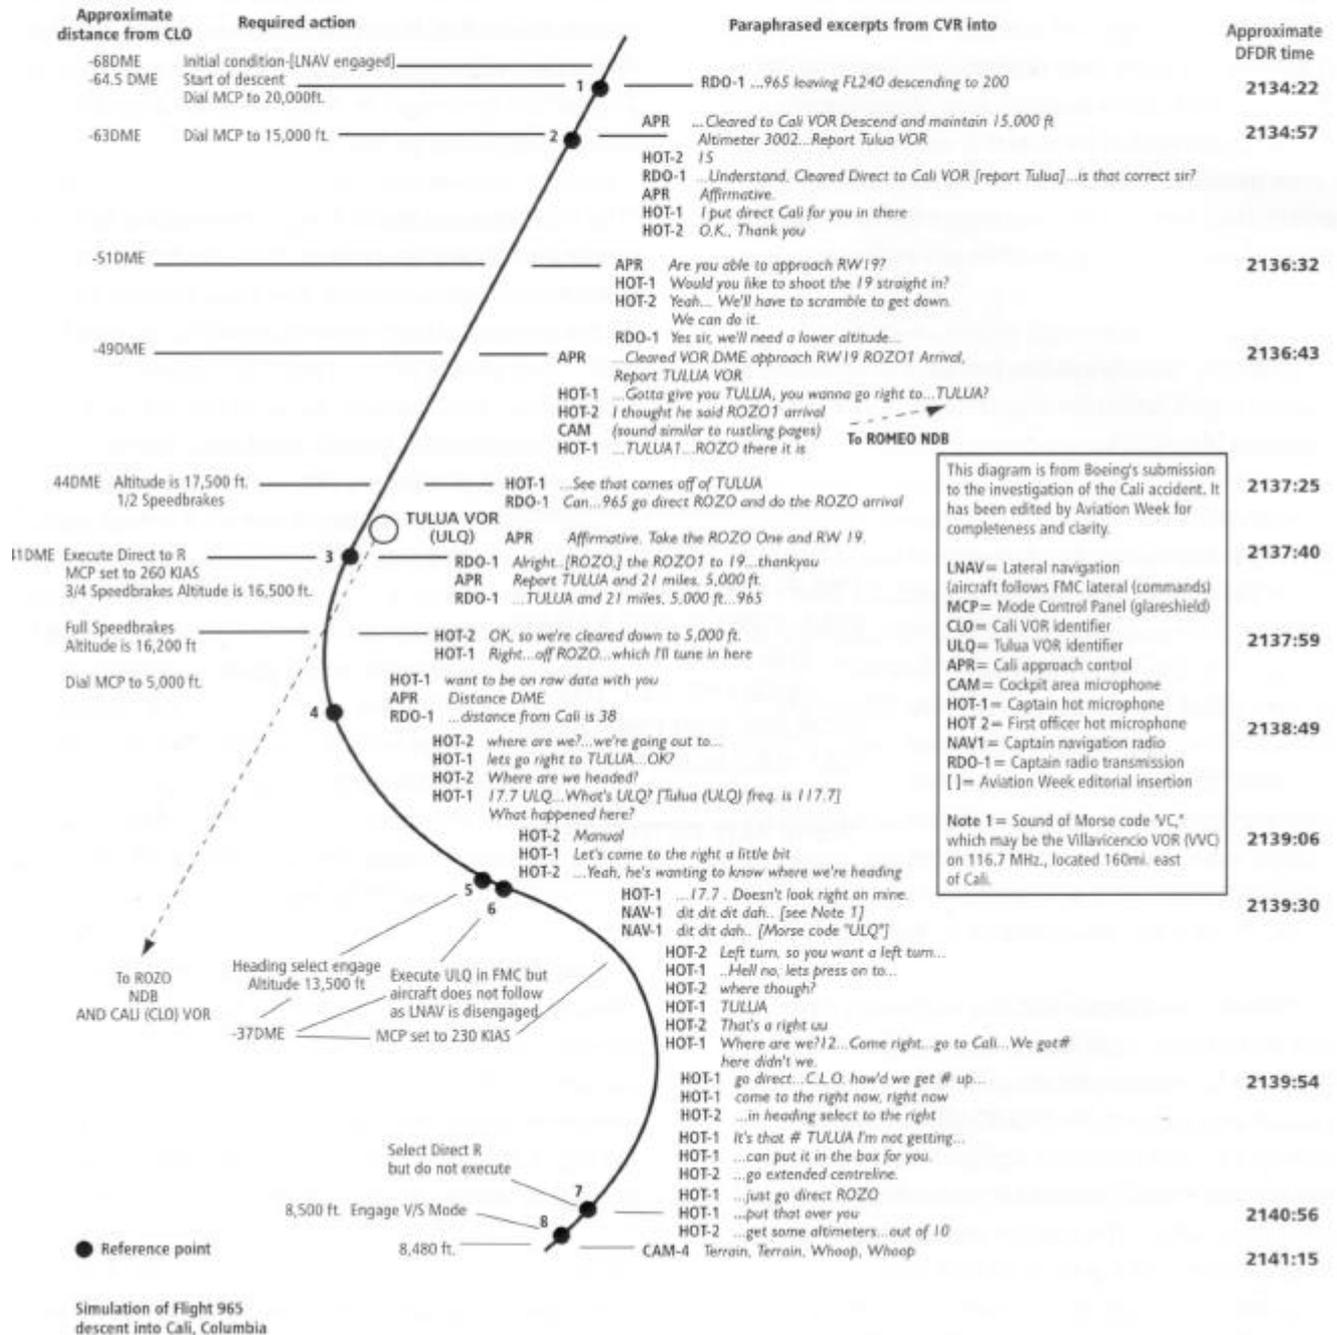
The B757 Flight Path Crew Actions/CVR

(The aircraft's flight data recorder showed that the flight passed TULUA during this exchange and *"began to turn left of the cleared course and flew on an easterly heading [of 100 degrees] for approximately one minute,"* the report said. "Then the aircraft turned to the right. while still in the descent.")

At one point, the crew apparently realized they had passed TULUA and the first officer asked, *"... So you want a left turn back around to ULQ?"* The captain responded that they should *"press on"*, and told the first officer to *"come to the right"* and proceed to the CALI VOR.

The cockpit conversation suggested that the crew was still experiencing difficulty getting orientated to the TULUA VOR on the FMS display. The first officer finally said, *"I don't want TULUA. Let's just go to the [runway 19] extended centreline"*
